Building Services Survey Report

Historic England

1703 – Decarbonisation of Cultural Heritage Buildings : Shire Hall Museum

Revision 1.0 - 03.03.2025 - For Information

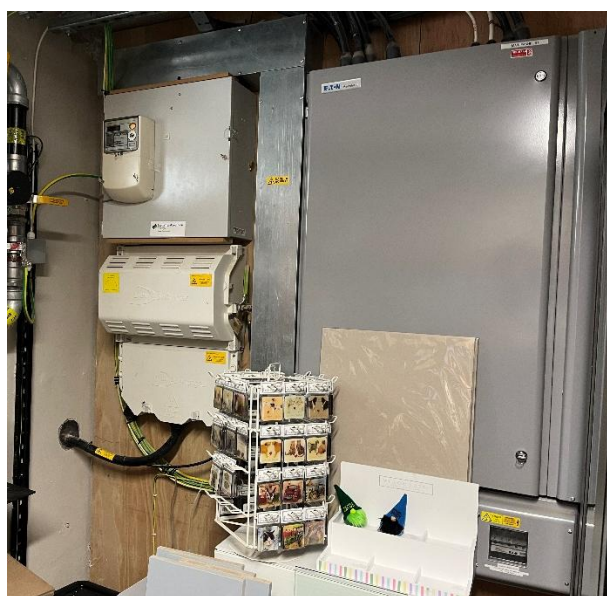
Figure 5-1 Incoming electrical supply & utility meter in store off Introduction area

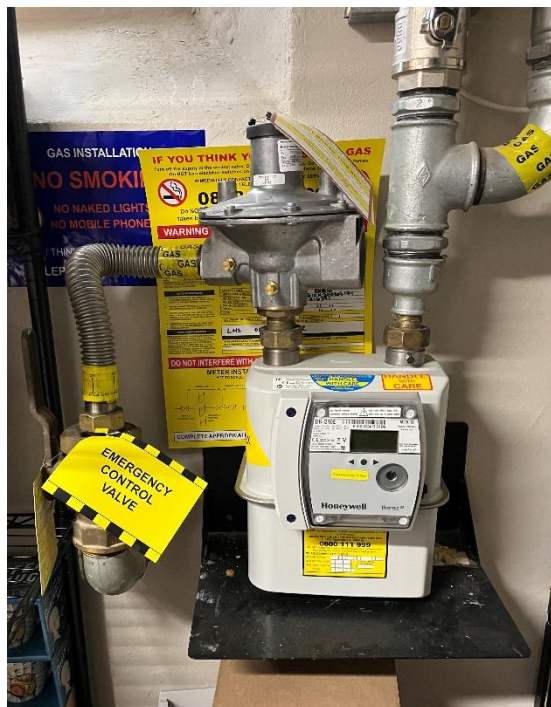
Figure 5-2 Gas meter located in store off Introduction Area

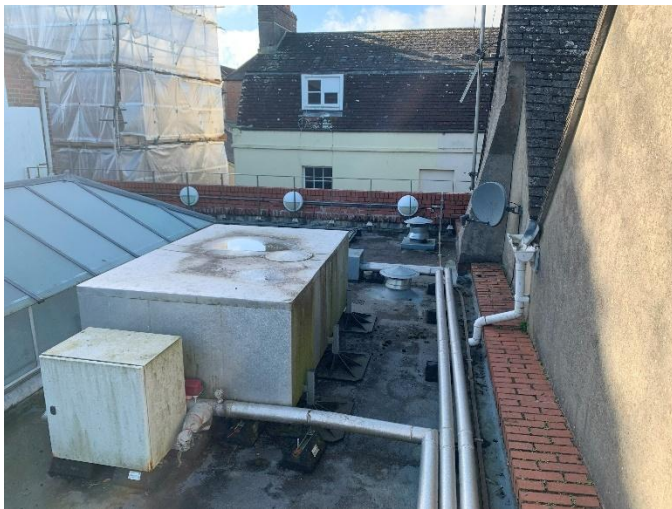
Figure 5-3 Possible water tank on Learning space roof. Access not possible.

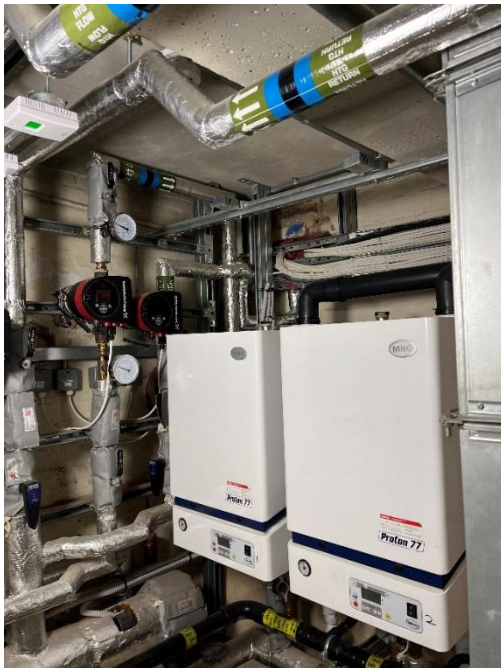
Figure 5-4 Boilers mounted on rear wall of plant room

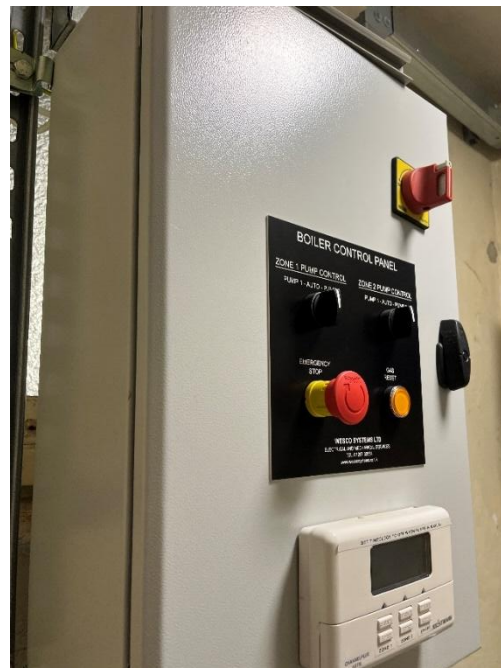
Figure 5-5 Boiler & pump control panel

Boilers were set up with programmable timer during the works, however this is currently disabled. It is unclear if the controller is broken or just disabled. No heating thermostats appear to be present throughout the building.

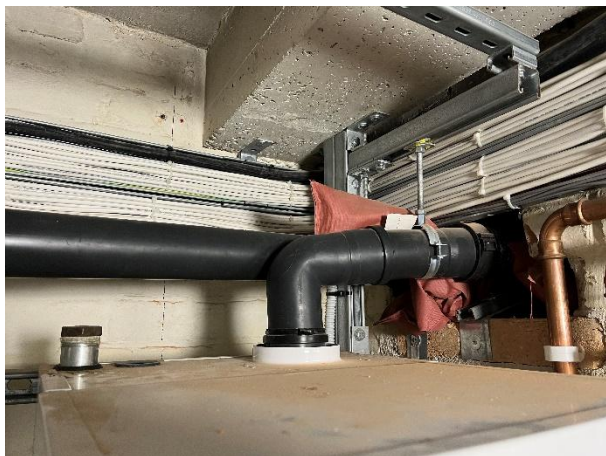
Figure 5-6 Boiler flues entering existing chimney

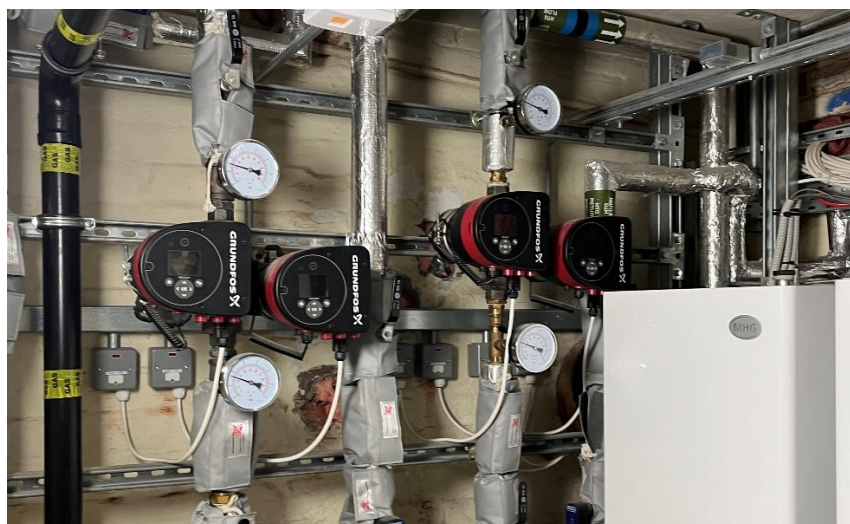
Figure 5-7 Heating pumps serving zones 1 & 2

It is unclear which zone serves the museum reception & shop.

A schematic of the heating system is not present in the plant room.

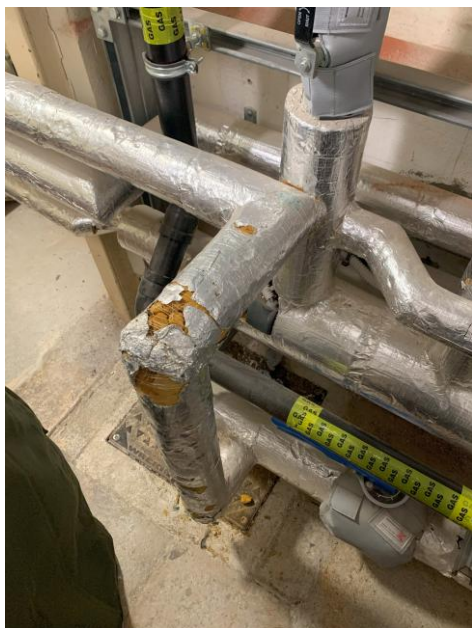
Pipework is generally insulated throughout in foil faced insulation, but with damaged insulation to some areas. High level services in museum areas on lower ground floor/basement are painted out in black.

The ancillaries are insulated to a varying degree. Valve bags are generally present, but gaps between rigid insulation and valve bags.

Figure 5-8 - Damage to pipework insulation in plant room

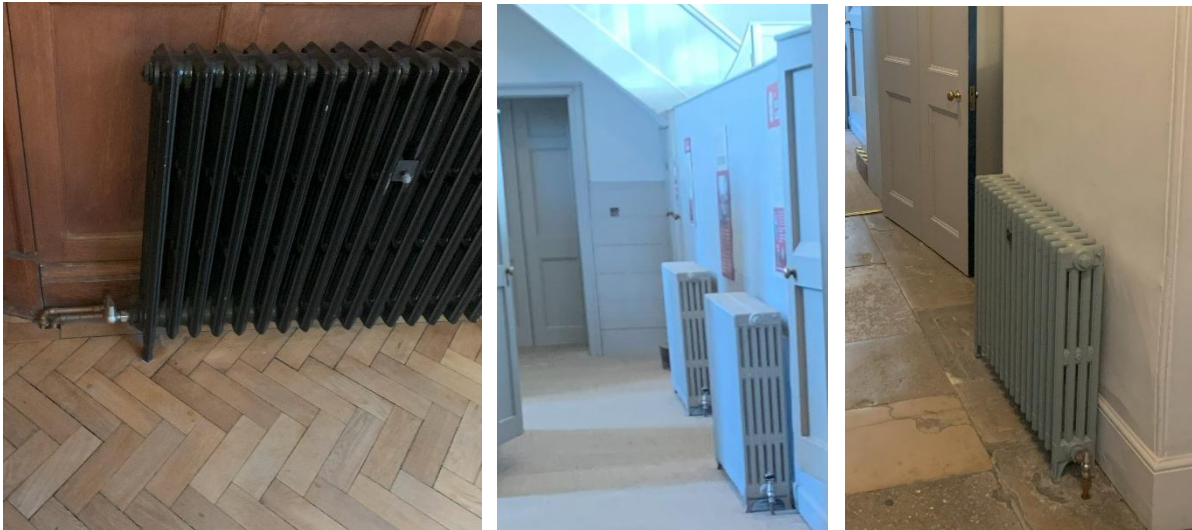
Figure 5-9 Cast iron radiators to Learning space (left), Crown court (middle) & circulation space (right)

TRVS are present to some radiators, but not all.

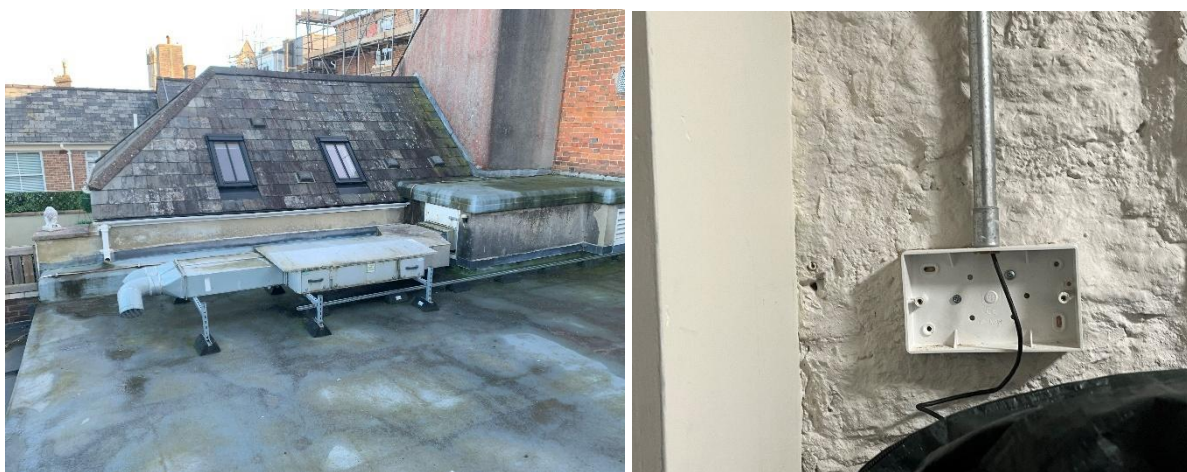
- Supply & extract ventilation
- System name: Unknown
- Fan location: Assumed to be located externally on low rear roof. Refer to image below.
- Controls
 - Fan controller located in store adjacent to cells in basement
 - Controller broken/disassembled. Empty back-box on wall and Nuair cover on floor.

Figure 5-10 Left: MVHR unit located on low rear roof assumed to server basement museum areas. Access up to unit not possible. Right: assumed system controller location in store at basement level.

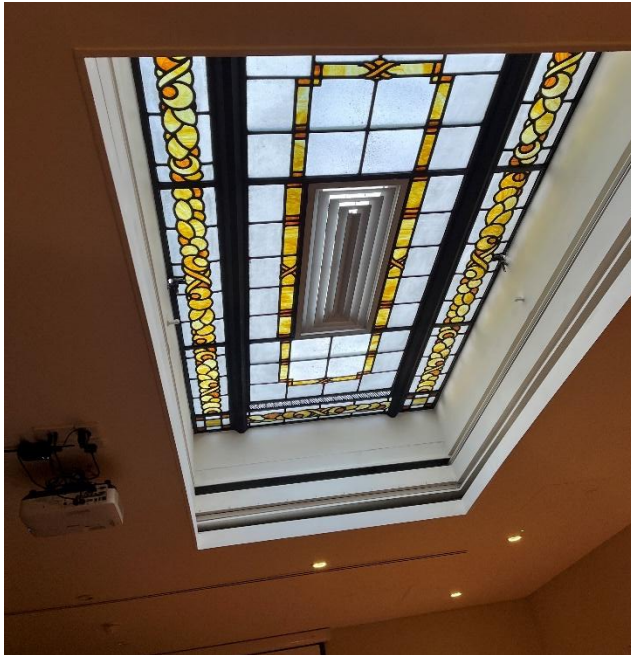
Figure 5-11 Open ventilation grille in centre of rooflight to learning space. Glazed lantern at roof level above rooflight.

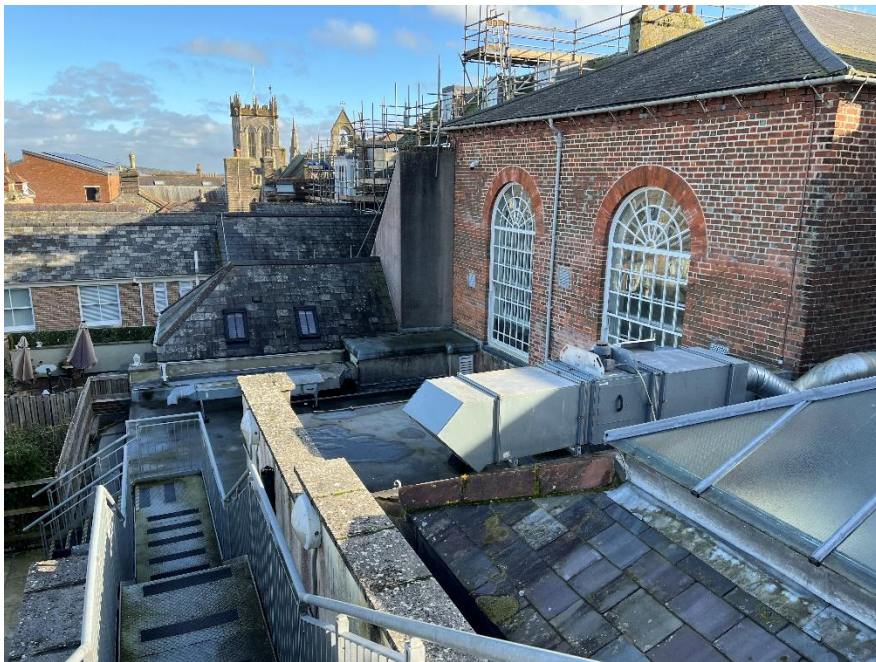
Figure 5-12 Cafe extract fan on low rear roof

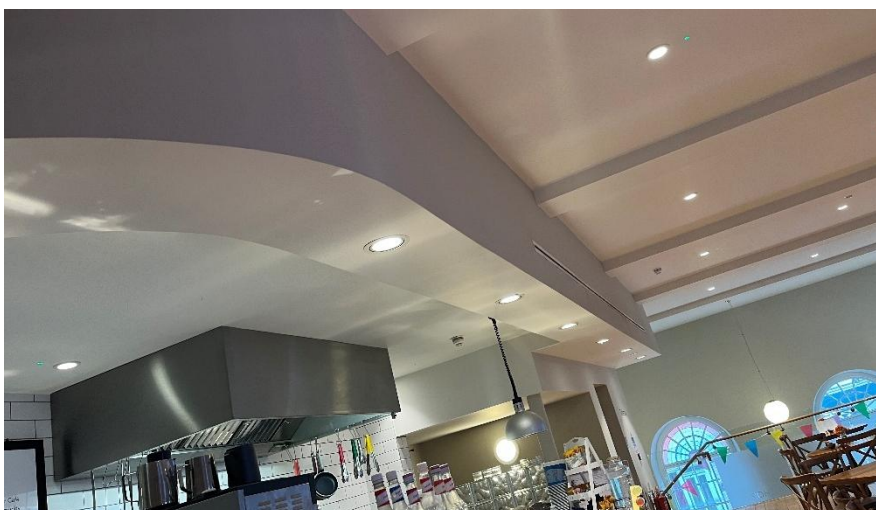
- System name: Café supply air SF1
- Controls
 - Fan controller on wall adjacent to café servery
 - System set to manual controls
 - Heater in fault during site visit
- Fan location: assumed to be located on lower roof to rear of building.
- Kitchen extract running during site visit

Figure 5-13 - Cafe supply & extract ventilation

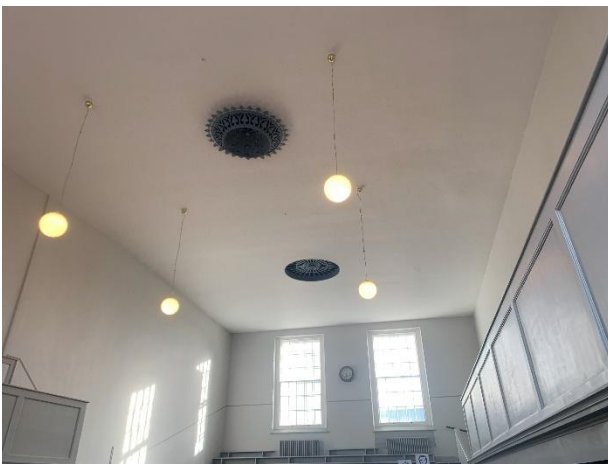
Figure 5-14 Historic ornate ceiling grilles in the Crown Court

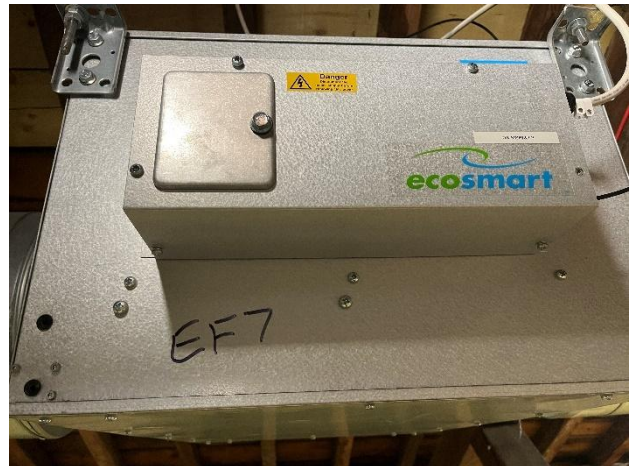
Figure 5-15 Extract fan EF7 located in roof void

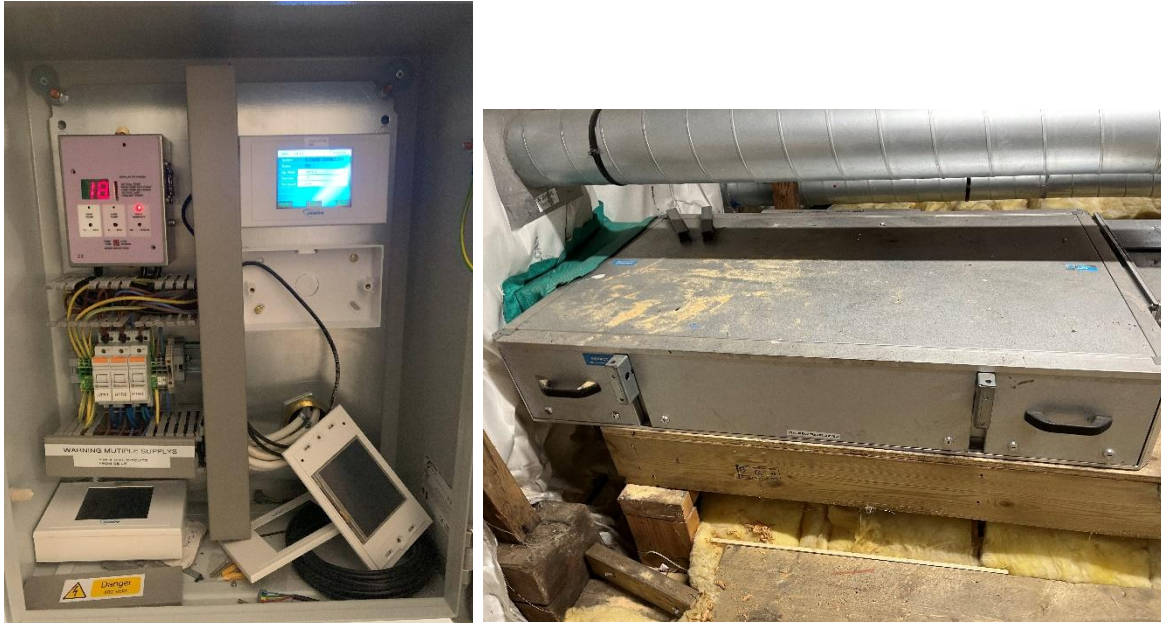
- Mechanical supply and extract ventilation with heat recovery (MVHR).
 - Extract through historic ornate ceiling grille
 - Supply location not identified
- System name: unknown
- MVHR unit located in roof void
- Controls
 - Fan controller located in the Grand Jury Room
 - Ventilation system disabled and controller disassembled.

Figure 5-16 Right: Grand Jury Room fan controller disassembled (right bottom). Left: MVHR unit in roof void assumed to serve grand Jury room

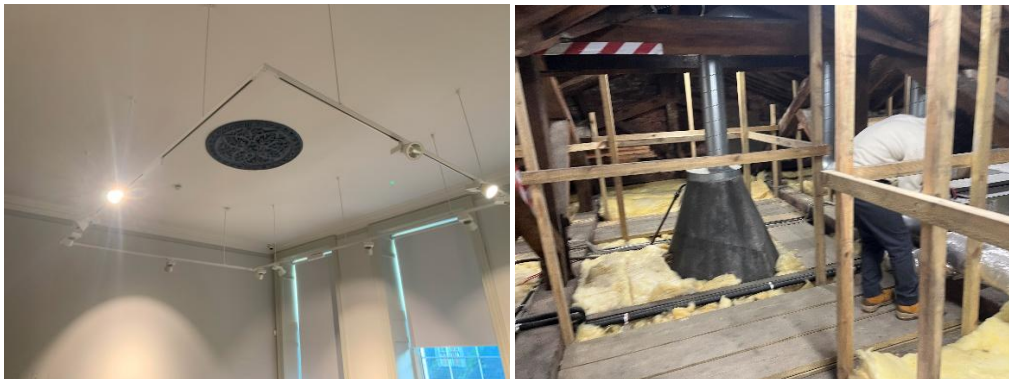
Figure 5-17 Left: Ornate ceiling grille in Grand Jury Room. Right: ductwork connection onto ceiling grille in roof void.

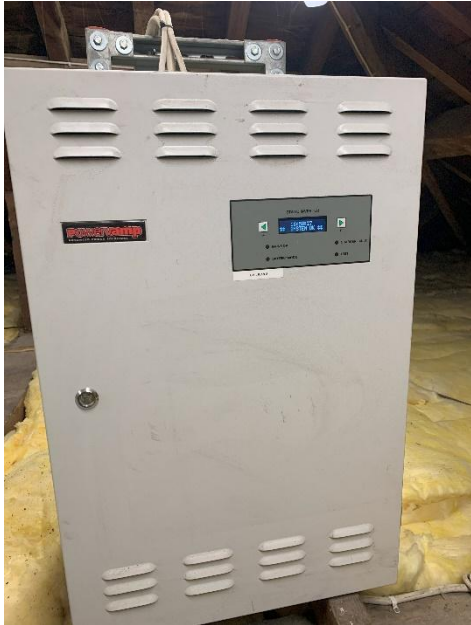
Mixture of integrated and standalone emergency fittings. Static inverter located in roof void. Unclear which areas are served by the static inverter.

Figure 5-18 Static inverter located in roof void

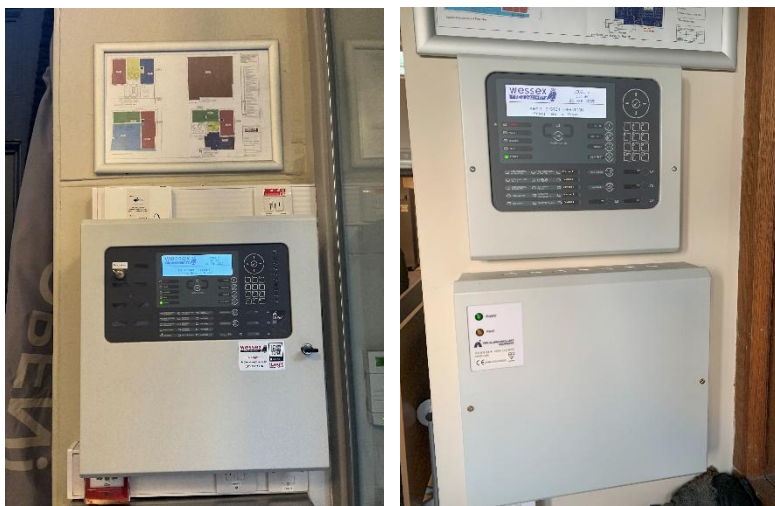
Figure 5-19 Left: Main fire alarm panel adjacent to main entrance. Right repeater panel located by the entrance from the car park to the rear of the building.

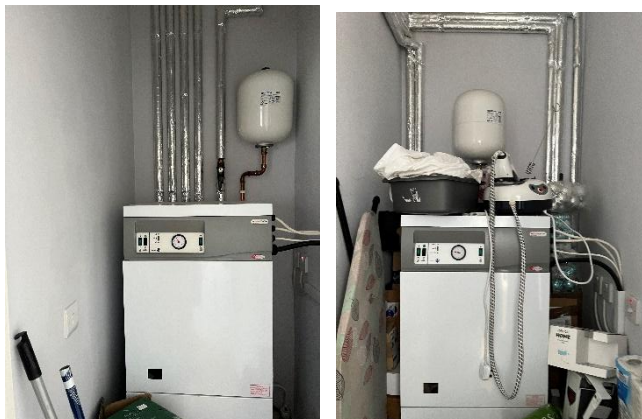
Figure 6-1 Electric boilers to flats

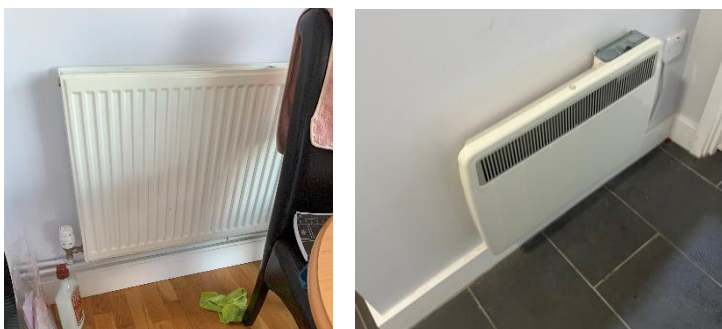
Figure 6-2 Left: LTHW panel radiator to flat. Right: Electric radiator to communal hallway

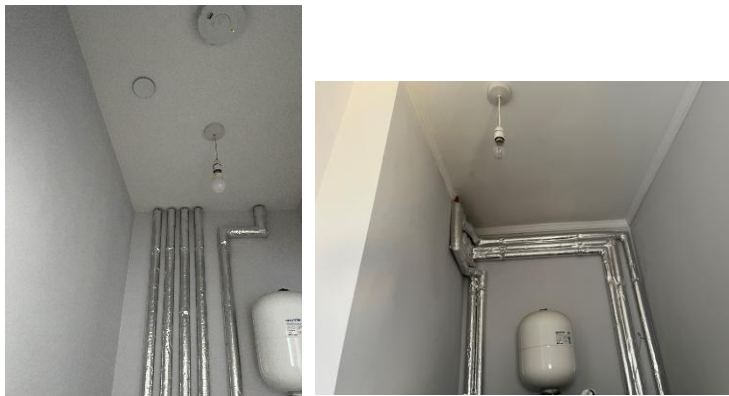
Figure 6-3 Insulated pipework to flats

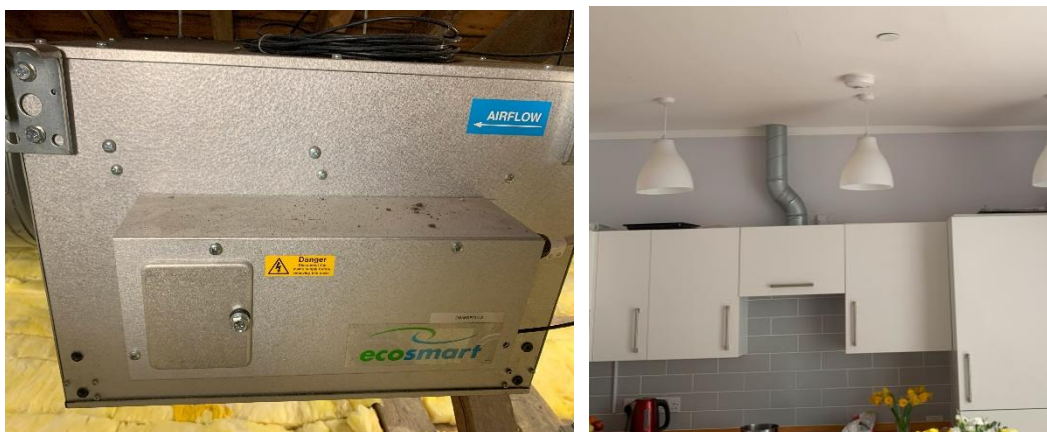
A Nuaire extract fan is located in the roof void above the flats is assumed to serve the flats. However, the ductwork routes were not traced. The fan does not appear to function and no controls were located during the survey.

Figure 6-4 Right: Un-labelled extract fan in roof void. Left: Ventilation ductwork from kitchen cooker hood

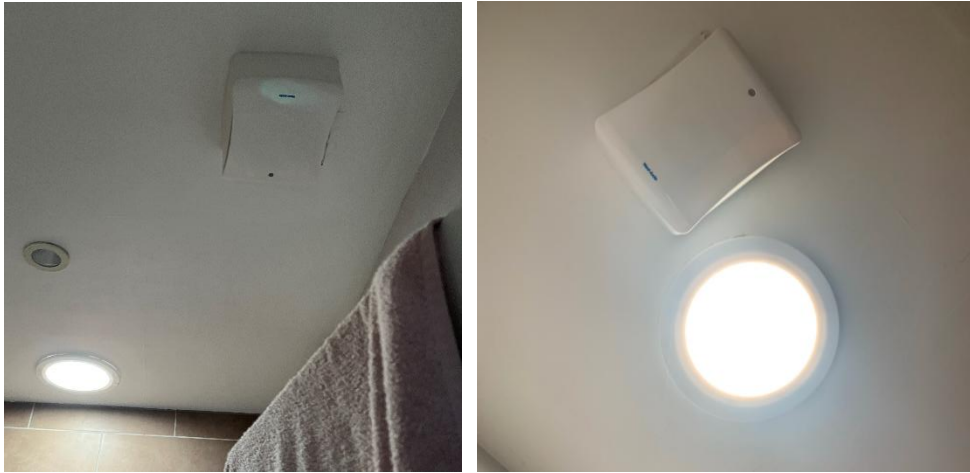
Ceiling mounted Vent-Axia extract fans are present in the bathrooms of both flats. The Shire Hall note that these were installed recently to combat moisture/mould issues in both flats.

Figure 6-5 Ceiling mounted Vent-Axia extract fans in flat bathrooms

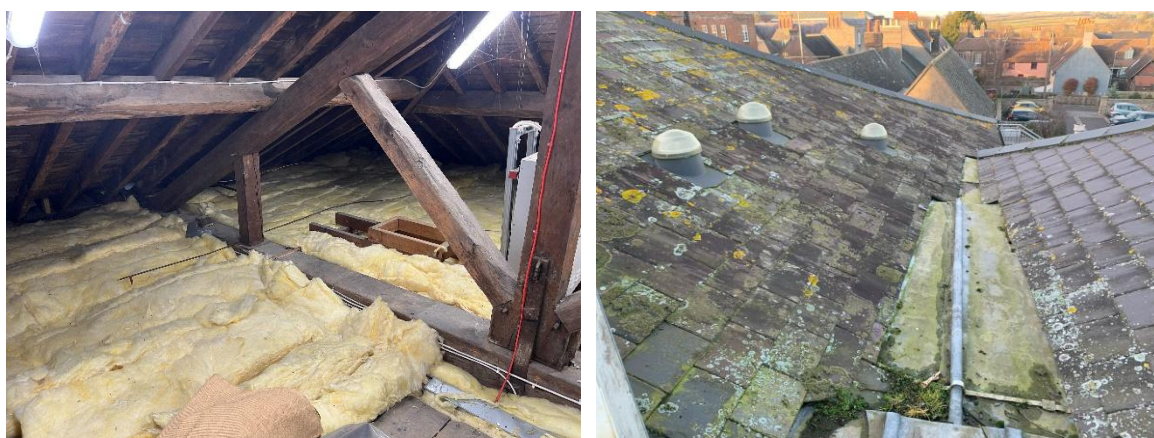
Figure 7-1 Left: Roof insulation. Right: Sun tubes penetrating pitched roof

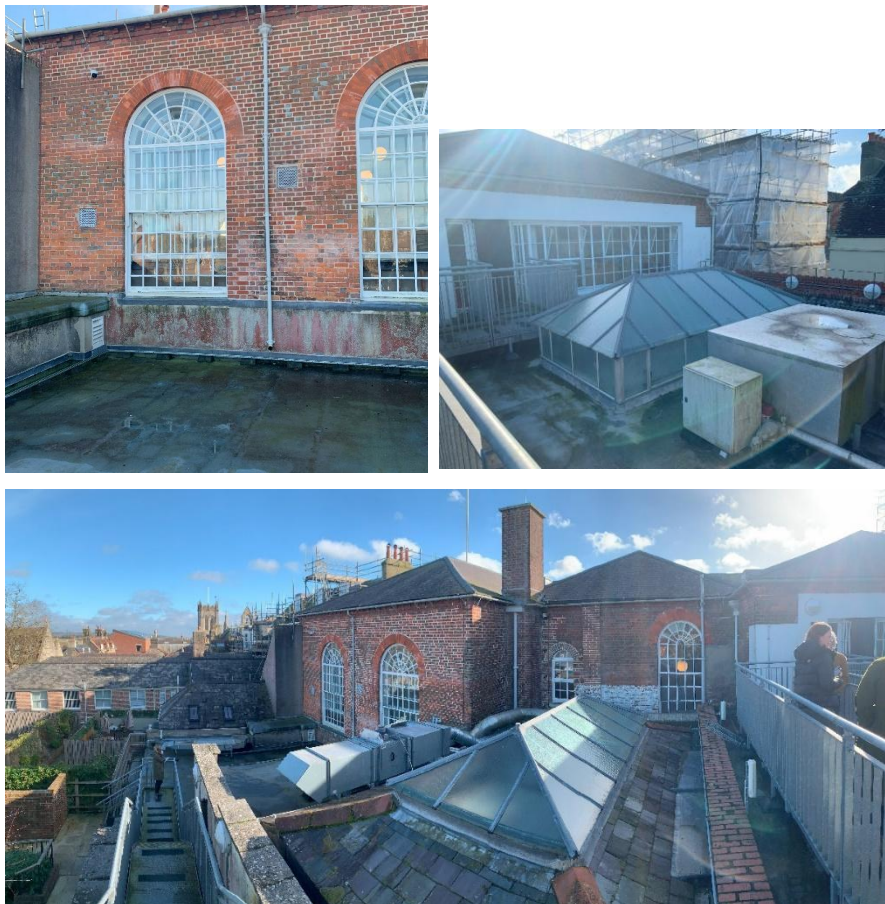
Figure 7-2 Images of flat roofs to the rear of the building showing the roof lanterns
