## Historic England Cultural Sector Decarbonisation

### Lit & Phil Library

### Condition Report

**Ref:** 241181/S Wilkinson

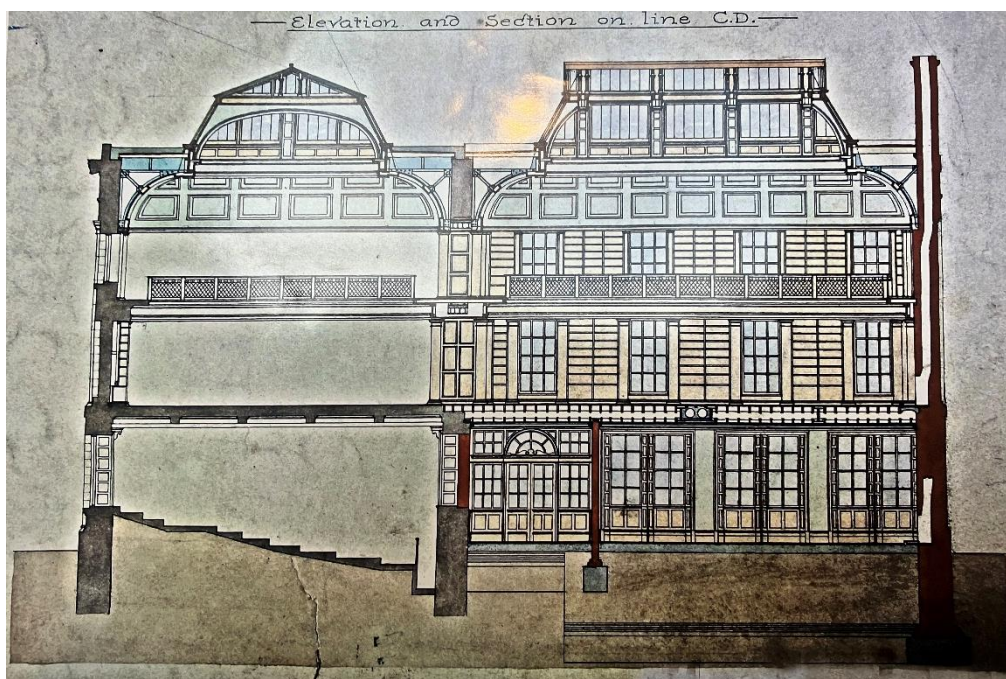
**Figure 1: Archive section cut E-W through the Main Library (short section) and Reading Room (long section)**

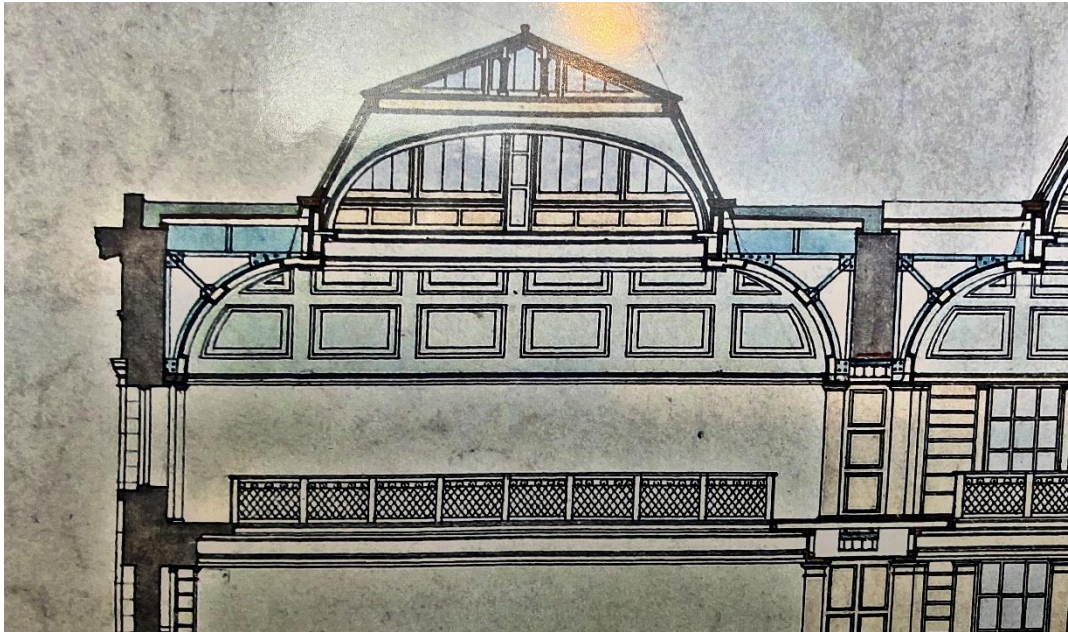
**Figure 2: Detail from archive section showing large primary steel beams running N-S and with shorter beams spanning E-W. Concrete slabs forming the flat roof deck are depicted to either side of the glasshouse.**

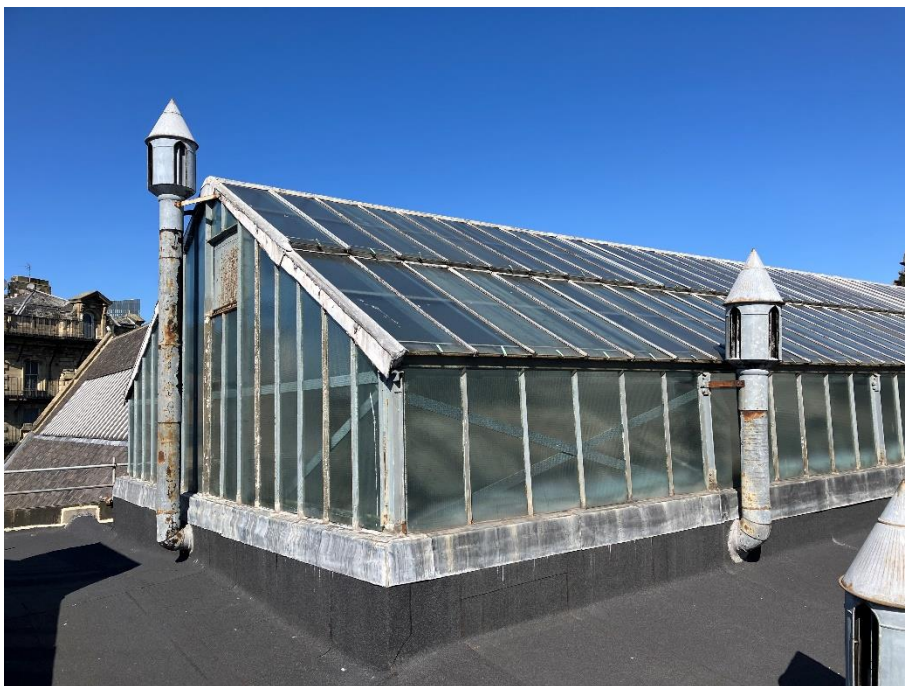
**Photograph 1: View of current steel glasshouse frame over roof light openings and felt roof coverings. No primary steel structure is visible.**

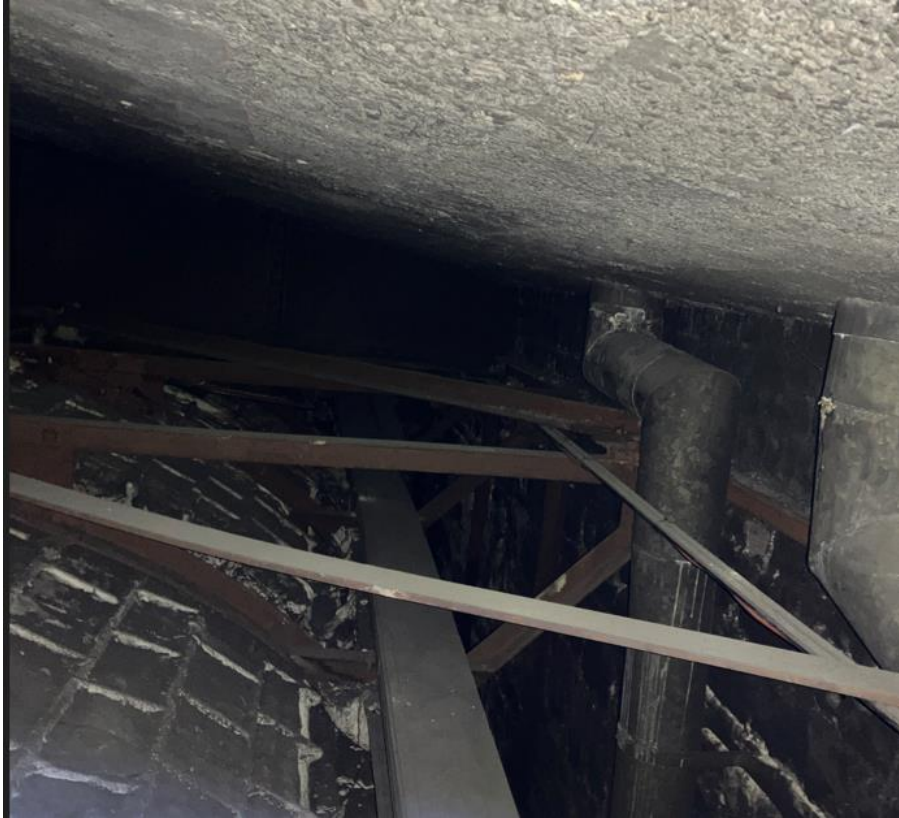
**Photograph 2: View within Main Library roof void showing steel framing supporting fibrous plaster coved ceiling and concrete slab roof deck over.**

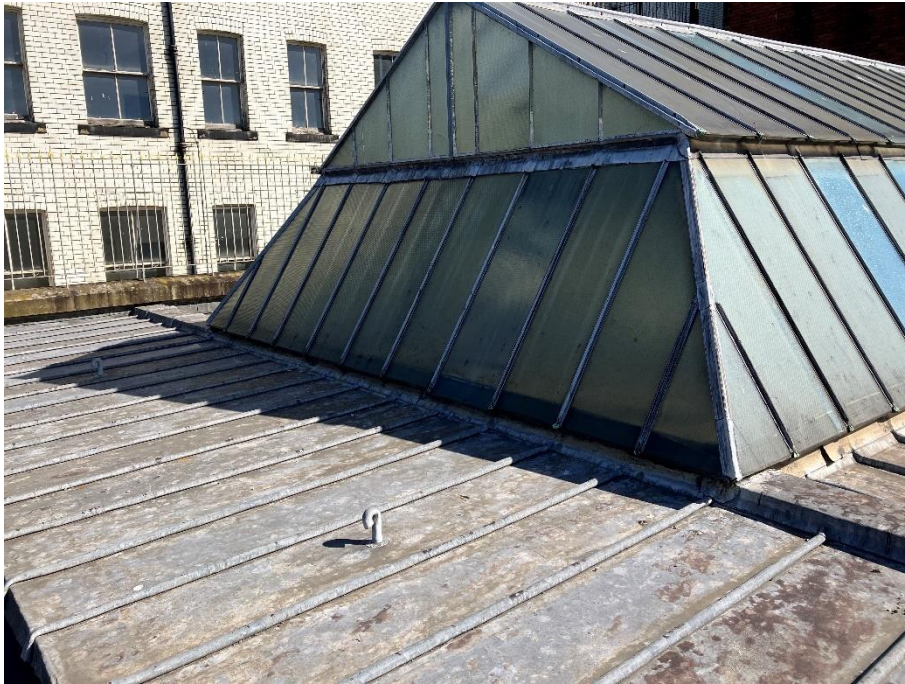
- 3.1.3 The Committee Room and Reading Room roofs, lanterns and glasshouses are of generally similar overall design however the flat roof decks in the Reading Room and Committee Room (assumed – not visually verified) are of timber joist construction

**Photograph 3: Reading Room 'glasshouse and leaded flat roof deck. A structural beam supporting the roof lights and glass house can be seen spanning N-S between the external walls and covered by the leaded upstand.**

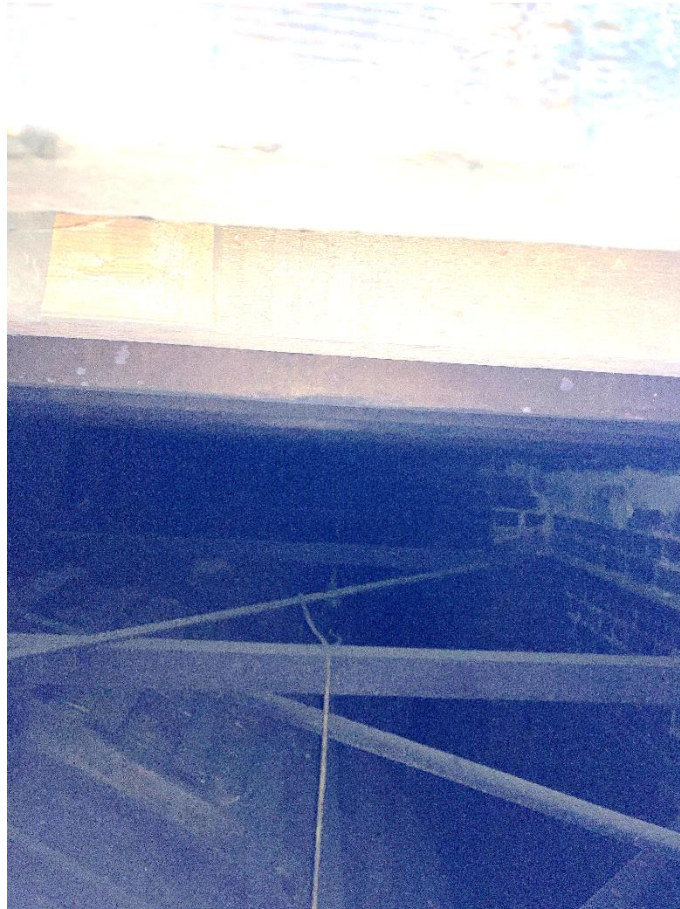
**Photograph 4: View within Reading Room roof void showing covered ceiling plaster, secondary steel structure and timber joist deck over.**

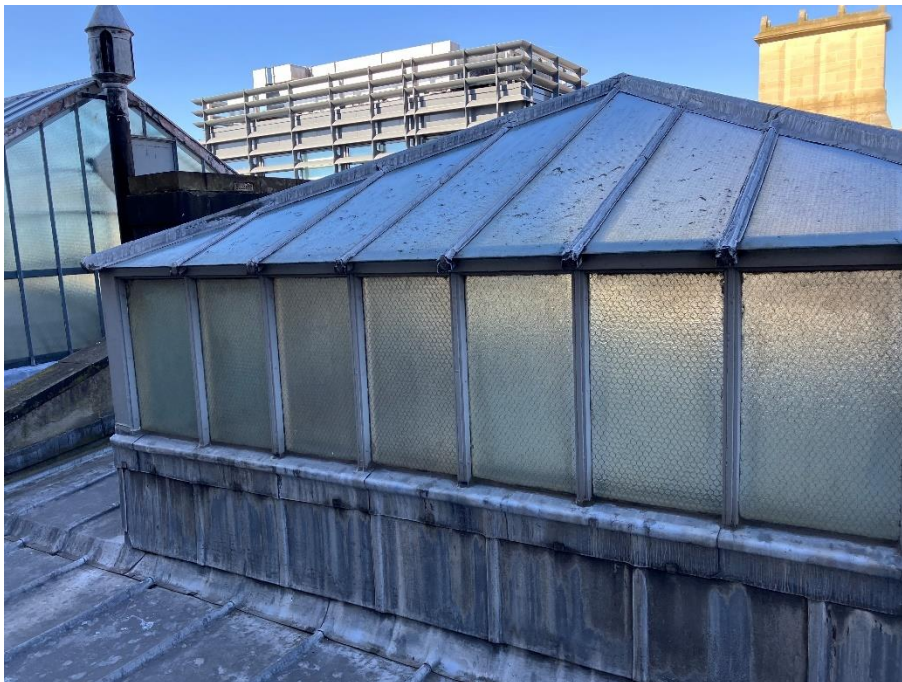
**Photograph 5: Committee Room 'glasshouse' viewed externally.**

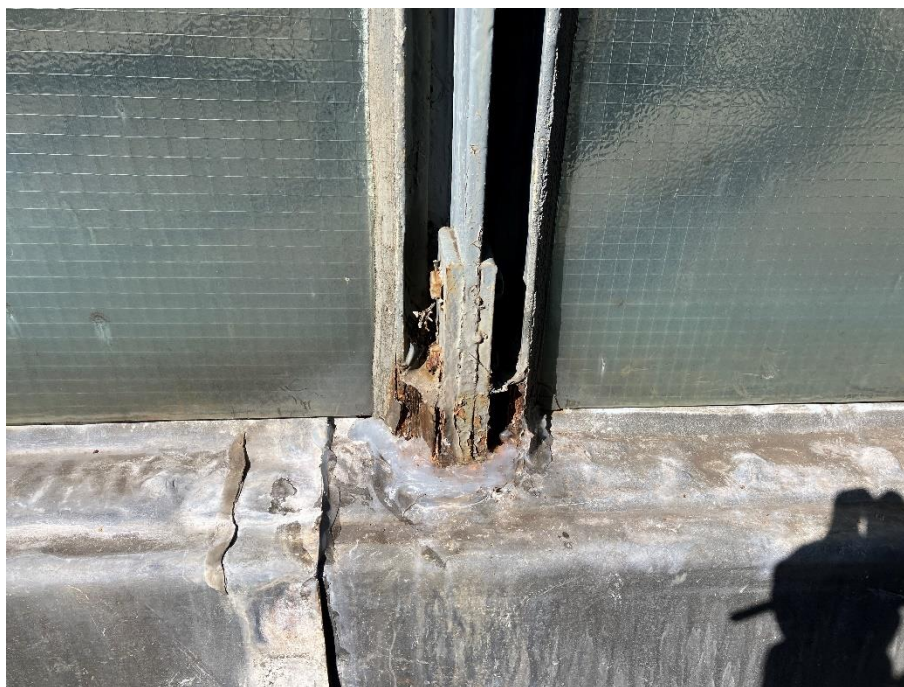
- 3.1.4 The glasshouse structure over the Main Library is in relatively poor overall condition with evidence of ongoing water ingress occurring into the room below. Many of the steel frame post bases are corroded (Photograph 6) and lead cappings, weatherings and flashings are in generally poor condition throughout. Several glazing panels are cracked and there is a likelihood that asbestos rope seals have been used at the glazing bars.

**Photograph 6: Typical example of corrosion to base of steel framing**

- 4.5 The glasshouses are in fairly poor condition. We assume that replacement of the existing Georgian wired glass with double-glazed units is being contemplated. Once deglazed, the steel frame will need to be exposed repairs undertaken where needed, particularly at the post bases. A comment has been made in reporting by others that the glazing bars may be undersized for the increased weight of double glazing. This will need to be reviewed and factored into costing.

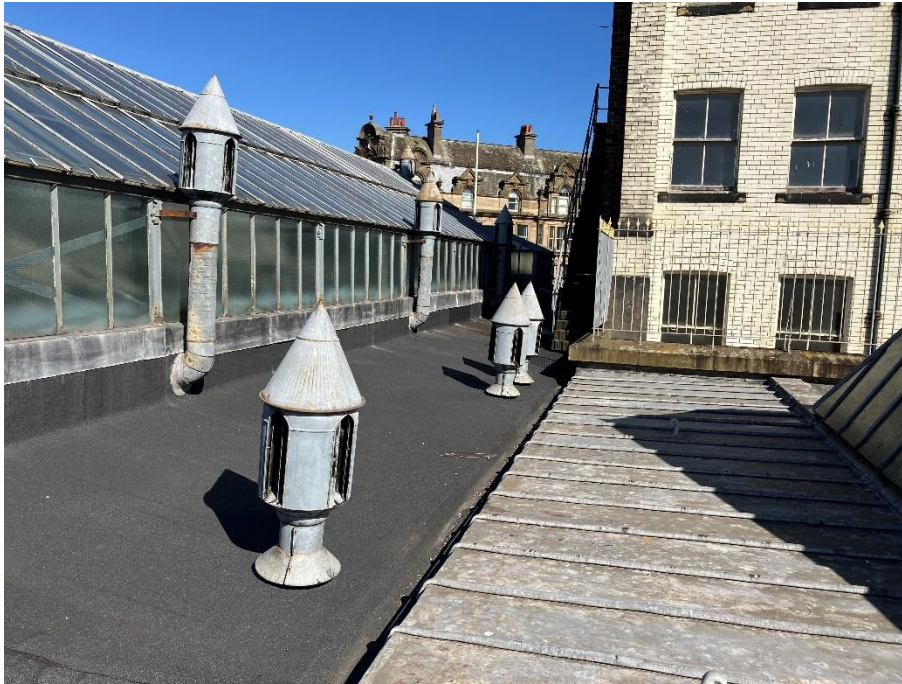
**Photograph 6: Junction and shallow drainage channel between lead and felt finishes.**

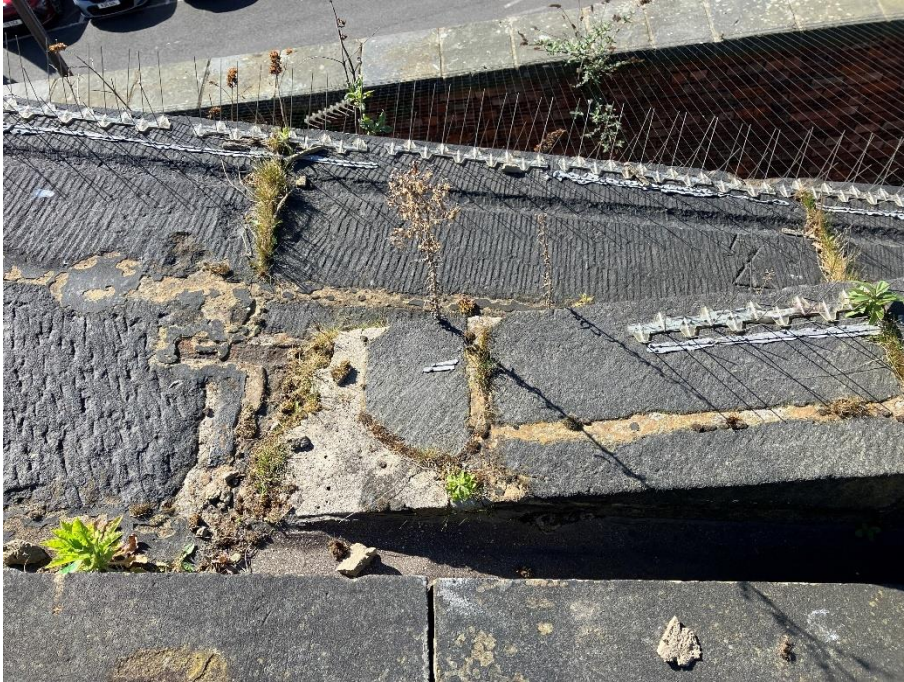
**Photograph 7: Typical example of roof level masonry showing open joints, vegetation growth and an exposed iron cramp.**

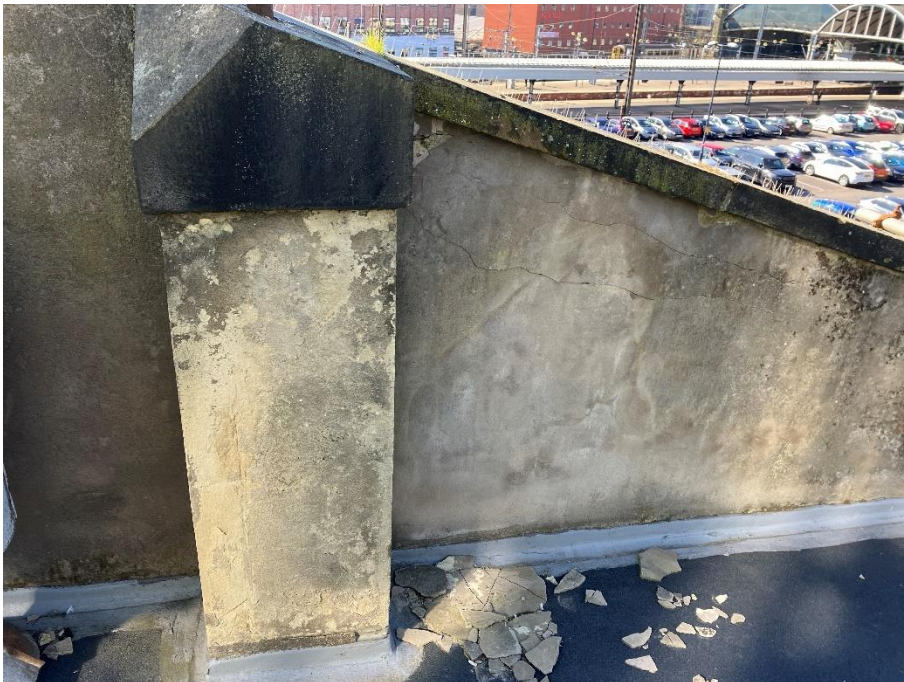
- 3.3.4 Render-finishes applied over masonry are in generally poor condition and have cracked and spalled (Photograph 8). These may have been originally applied to cover and shelter eroded stonework.

**Photograph 8: Typical example of failed render at roof level.**

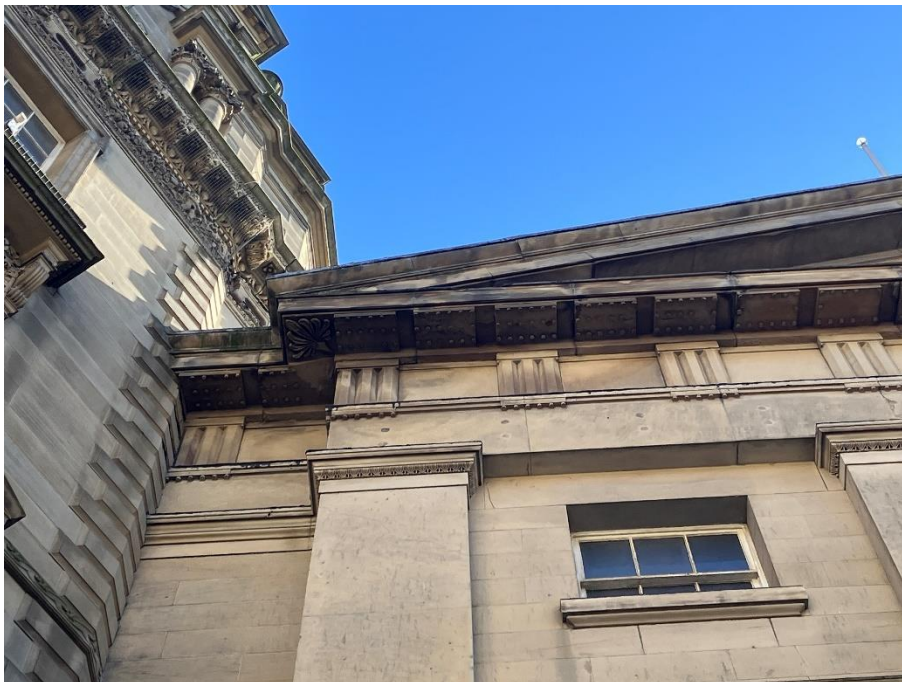
3.4.1 All elevations are assumed to be of solid brick and stone masonry. The front elevation comprises sandstone facework (we assume backed with brick rather than full thickness). It is in generally good condition with no sign of any structurally significant cracking or widespread deterioration of the stone facings. We do note that some of the stonework in the pediment area, particularly at the north-east corner is heavily stained in a manner that suggests surface water runs off the upper surfaces and down the block faces periodically (Photograph 9)

**Photograph 9: Front elevation - water staining at upper north-east corner.**

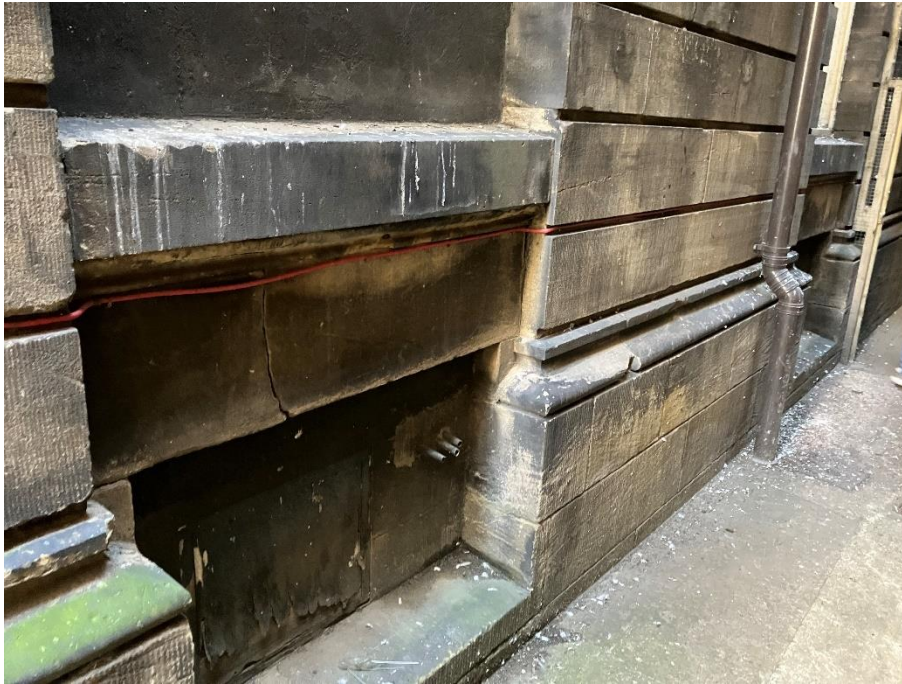
3.4.2 The west flank elevation is also sandstone-faced and remains in good overall condition where visible – inspection access is somewhat restricted by the narrow gap to the adjoining building. No structurally significant defects were observed. A cracked stone lintel was noted below a ground floor window, however this appears to be historic and to be supported by infilled masonry below (Photograph 10).

**Photograph 10: West flank elevation – cracked lintel.**

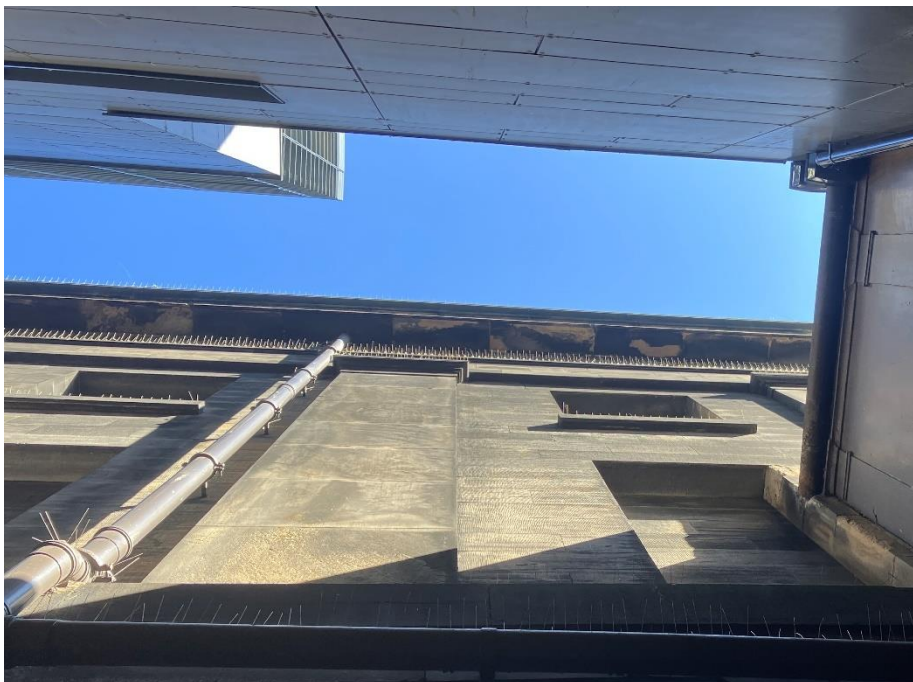
- 3.4.3 Similar staining is present to the underside of the cornice and it is assumed that water falling on the upper surfaces, runs over or percolates through open joints, especially where weatherings are absent (Photograph 11). This has resulted in at least one minor spall and others may be found with direct close inspection.

**Photograph 11: West flank elevation – water staining to cornice.**

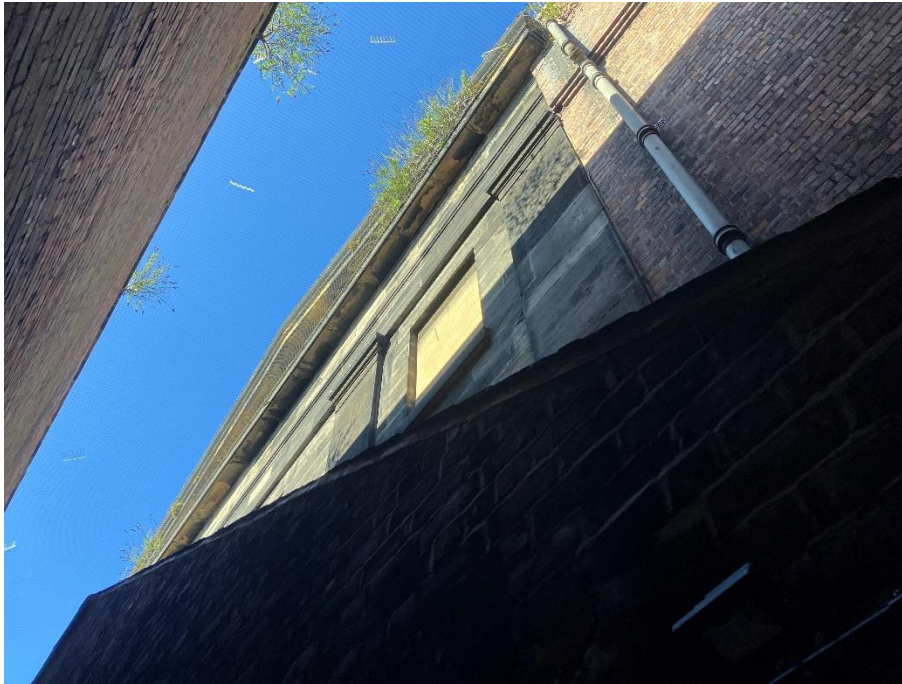
3.4.4 The rear (south) elevation is again difficult to view but comprises stonework on the original library building and brickwork on the Reading Room extension. Significant vegetation growth is occurring on the Main Library pediment (Photograph 12) and it is affected by similar high-level water ingress issues to the other stone elevations. No significant structural defects were visible but direct inspection by rope access or drone is warranted to confirm.

**Photograph 12: Rear (south) elevation - plant growth and water staining to pediment.**

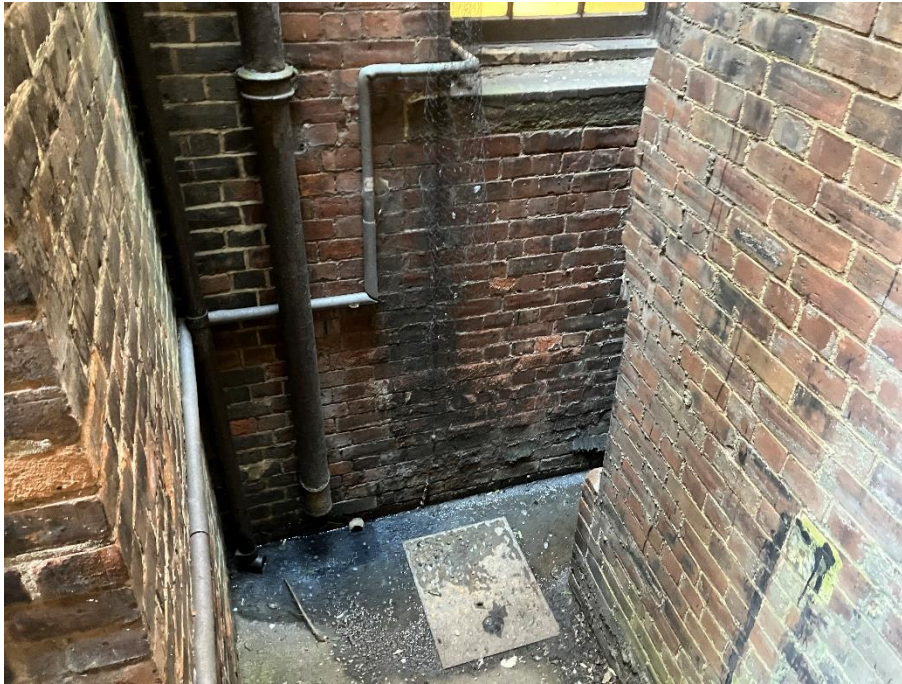
3.4.5 Surface water drainage arrangements at the base of the south elevation were noted to be poor with water discharging straight on to the ground (Photograph 13). This is an unsatisfactory arrangement and is saturating the adjacent wall in the WC's behind.

**Photograph 13: Rear (south) elevation – RWP discharging onto ground externally**

- Repaint external masonry in external lightwell
- CCTV survey of surface water drainage pipework and provisional allowance for repair/replacement.

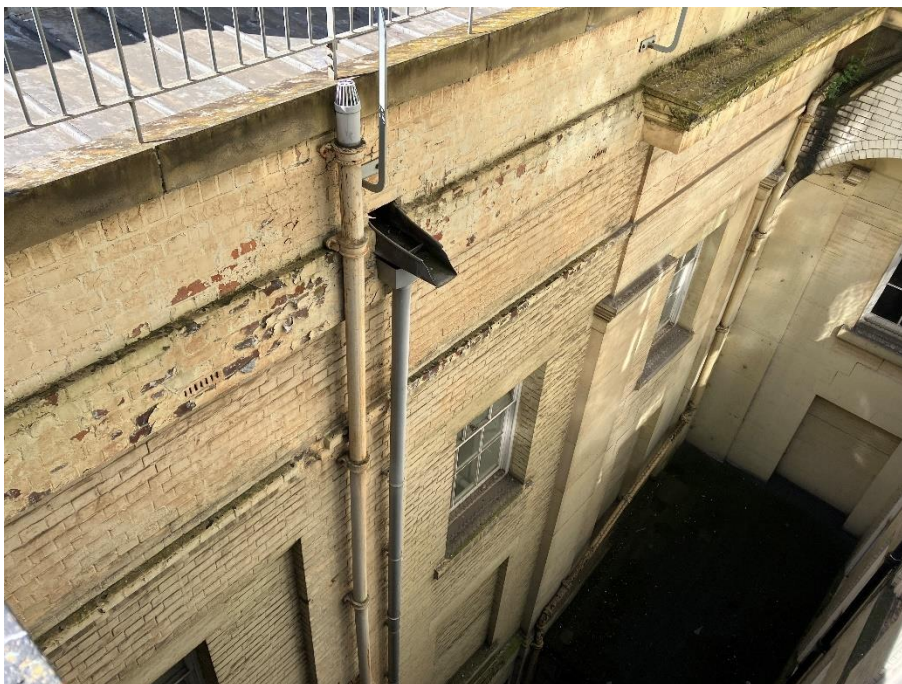
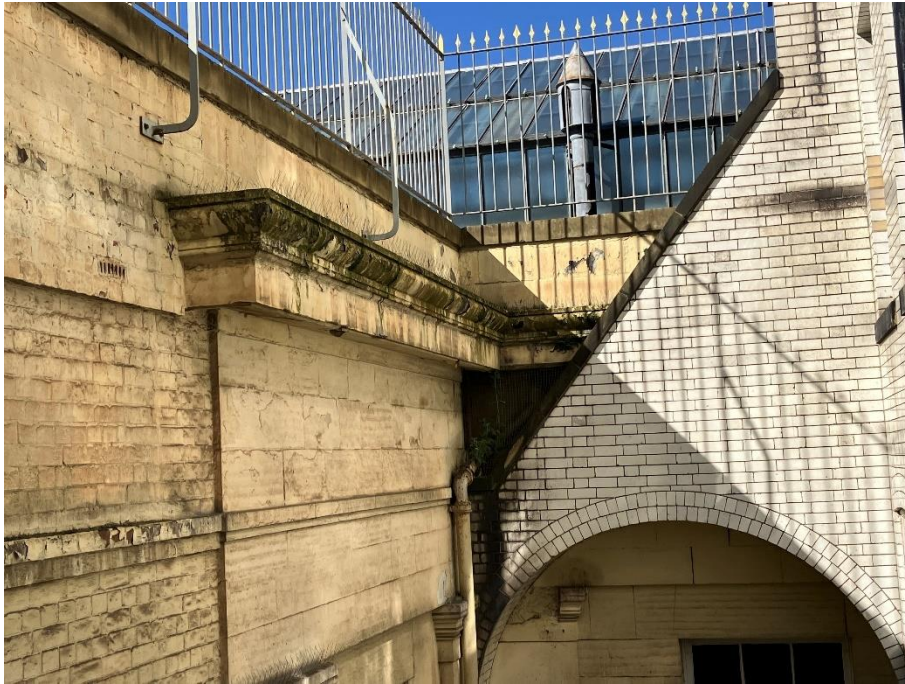
3.4.6 The courtyard/lightwell elevations to the north-east between the Lit & Phil and Bolbec Hall are in relatively poor condition. They mainly comprise painted brickwork with some more limited areas of stone masonry. Paint finishes are in universally poor condition and the brickwork and masonry substrates appear to be somewhat damp (Photographs 14 & 15) due water runoff and/or slow drying following rainfall.

**Photograph 14: Courtyard elevations – failed decorative finishes and dampness**

**Photograph 15: Courtyard elevations – failed decorative finishes and dampness**

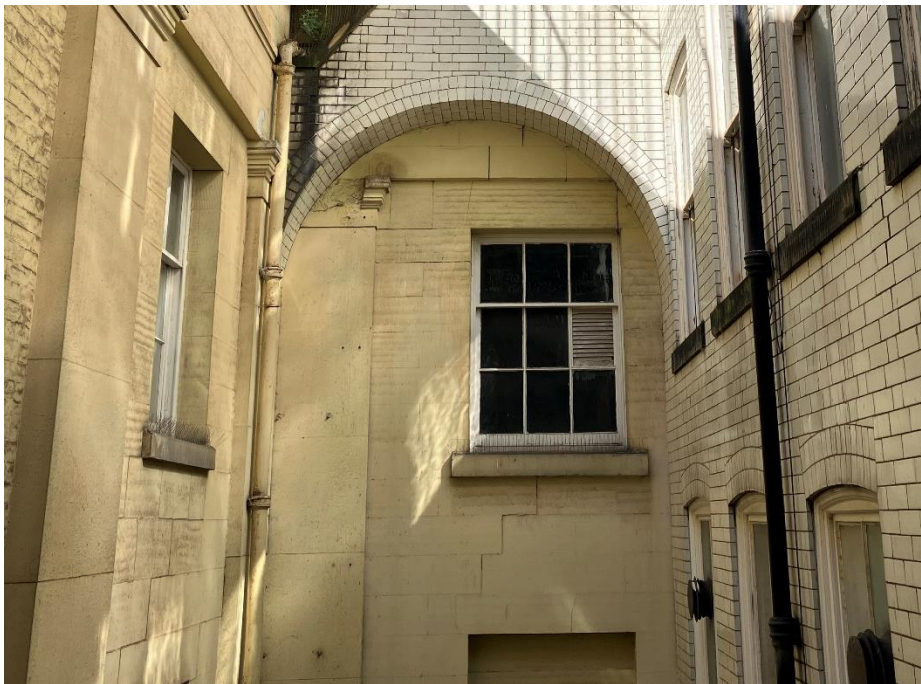
- 3.4.7 Some stepped cracking is also present on the short exposed flank of the main library (Photograph 16). This is not of any current structural concern and is likely to be a historic issue, but some close inspection and further investigation is recommended.

**Photograph 16: Stepped cracking to masonry in the courtyard.**

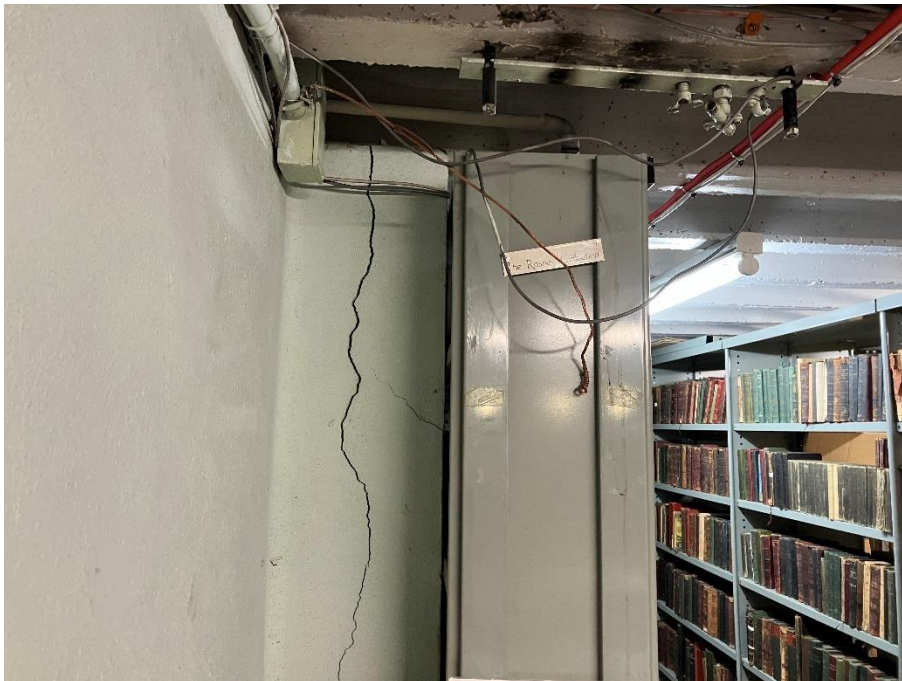
3.5.1 The basement is accessed via steps leading down from the entrance hall. The largest part is located under the Main Library area and is used for archive storage. It has been extensively reconstructed with a new concrete floor slab, rendered blockwork liner walls and a new pre-cast concrete plank roof/ground floor plate supported on brickwork walls and steel beams. The original basement walling is now almost fully concealed. No defects of immediate structural concern were observed in this area, although some cracking has occurred to the blockwork walling and should be investigated (Photograph 17). The rendered finishes have widespread fine cracking, however this is fairly normal and likely relates to shrinkage and minor differential movement.

**Photograph 17: Cracking to blockwork liner wall.**

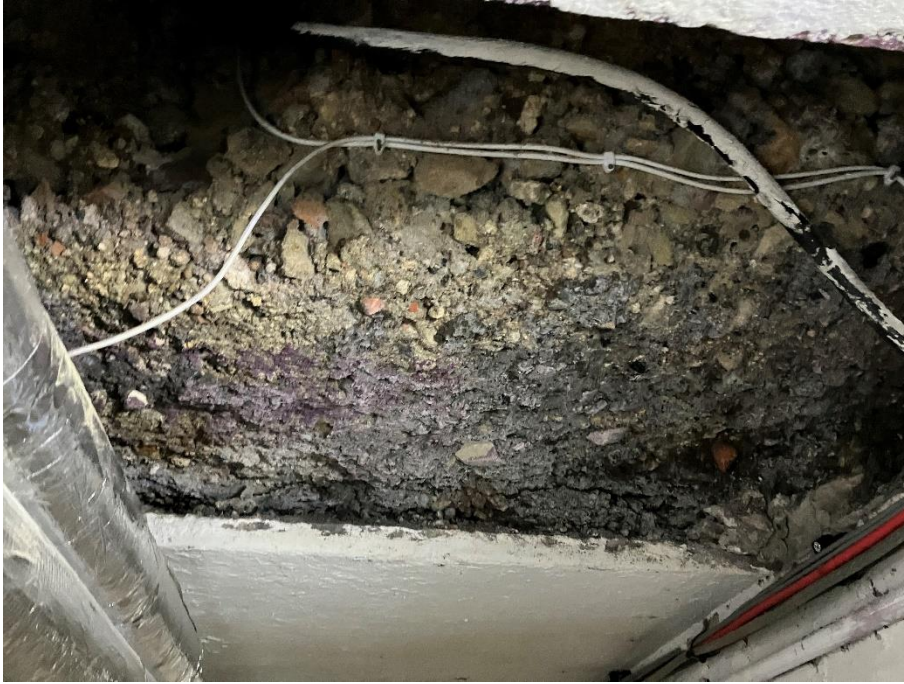
3.5.3 The boiler room is located under the Reading Room extension and is accessed via a narrow and low-ceiling tunnel. This is roofed with stone slabs spanning between the side walls and supporting poorly bound aggregate and rubble fill material, presumably below the ground floor slab above. One of these slabs has already collapsed (Photograph 18) and several others were noted to be cracked. This matter was highlighted to the building owners for urgent action following our inspection.

**Photograph 18: Basement – failed roof to boiler room access tunnel**

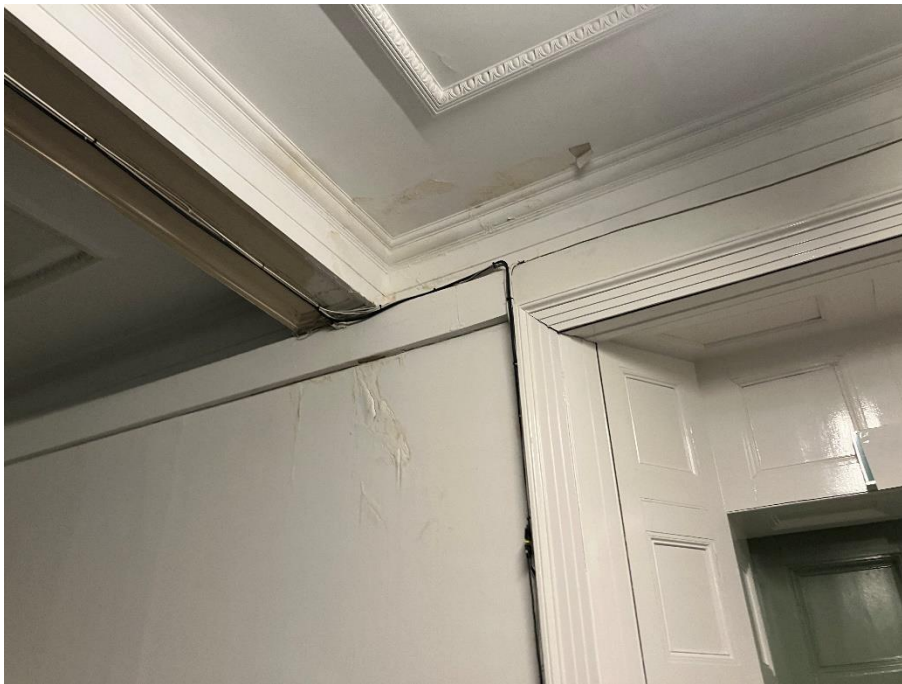
**Photograph 19: Ground Floor – Loftus Room, water damage around probable beam bearing**

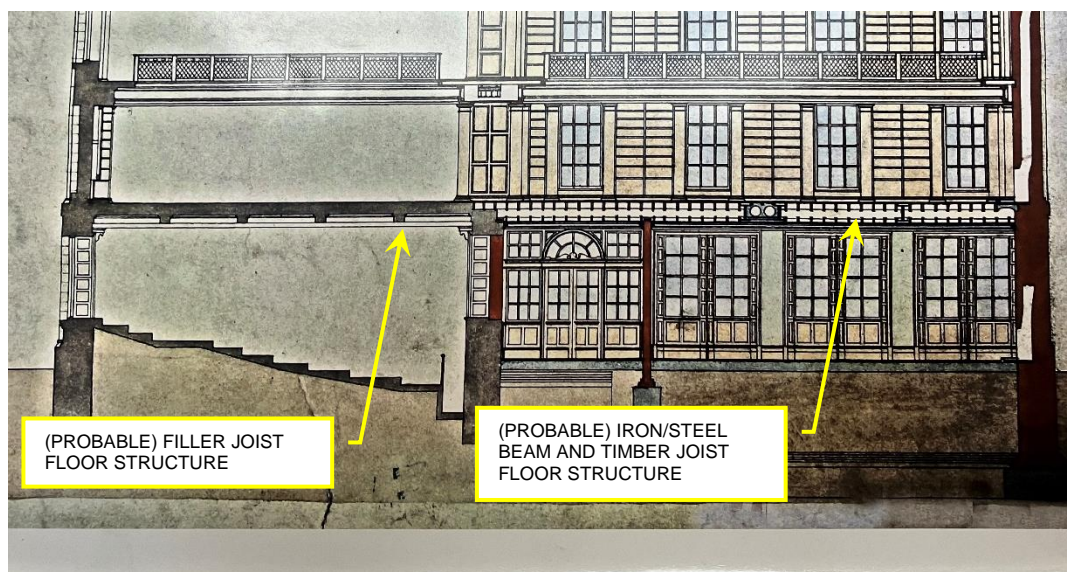
- 3.6.4 Archive drawing information suggests that the first floor structure is of filler joist concrete construction (Figure 3) with a false ceiling under. There is no direct indication that the damage is structurally significant, however we recommend that the damaged plaster at the bearing is opened up to view beam above. Similarly the cracked plaster should be assessed to confirm whether it is a defect restricted to the finishes.

**Figure 3: Part section through Main Library & Reading Room showing likely floor construction (not visually confirmed on site)**

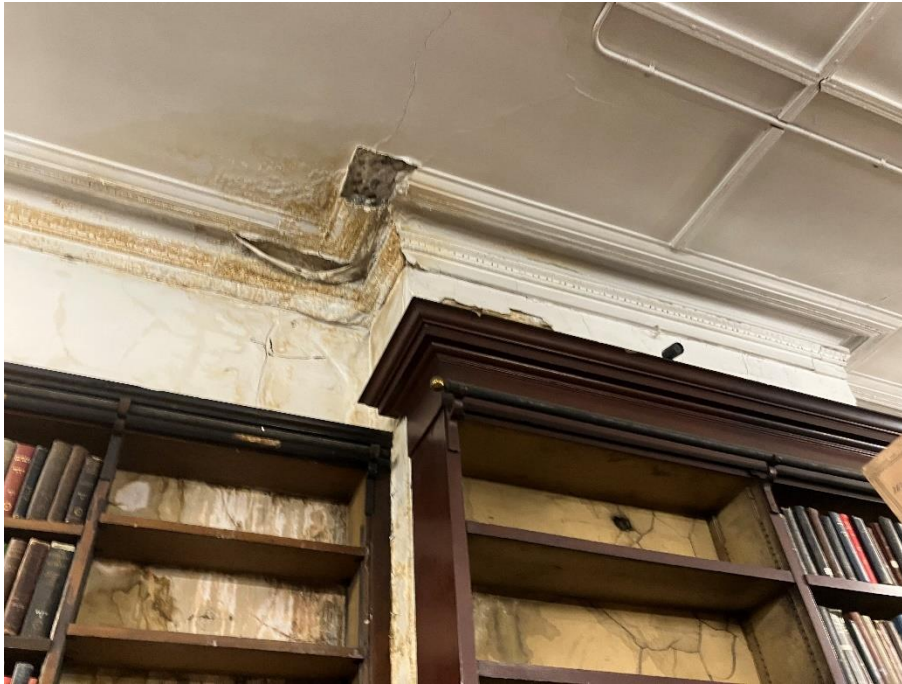
- 3.6.6 The Reference & Silence Room in the Reading Room extension is in poor overall condition. There has been extensive water ingress around the chimney breast at the east end of the room with associated visible damage to internal finishes (Photograph 20). The archive section drawing does not indicate an iron/steel beam in this location and the timbers joist appear to span north-south rather than taking bearings into the east elevation. A hearth structure is indicated on the section and intrusive investigations are recommended to confirm the condition of trimmer beams supporting the hearth masonry. The area was noted to be dry at the time of inspection and we presume that the leakage at higher level has been resolved.

**Photograph 20: Ground Floor – Reading & Silence Room, water damage at eastern end**

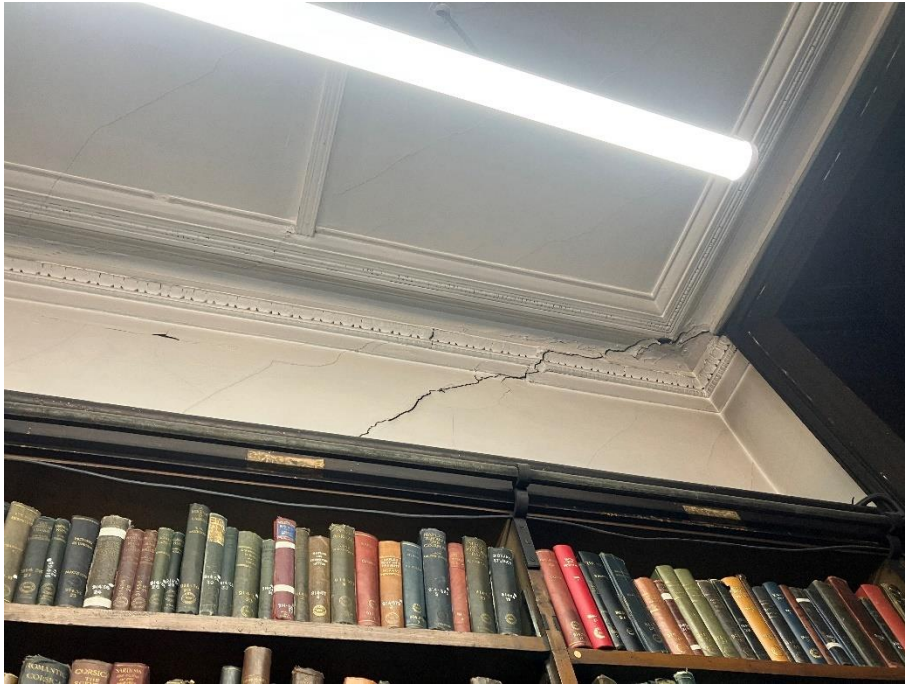
- 3.6.7 Further water damage has occurred to the central part of the ceiling but was reportedly associated with a heating services leak that has now been fixed.
- 3.6.8 The plastered ceiling is in very poor condition throughout and will most likely need to be taken down in full and replaced.
- 3.6.9 A diagonal crack is present at the north-west corner of the room (Photograph 21). This does appear to extend through the plaster into the wall structure and also seems to be on a similar diagonal alignment to cracking noted externally in the lightwell (see Photograph 16). There is no current risk of structural failure but localised removal of plaster and monitoring is recommended.

**Photograph 21: Ground Floor – Reading & Silence Room, crack at north-west corner**

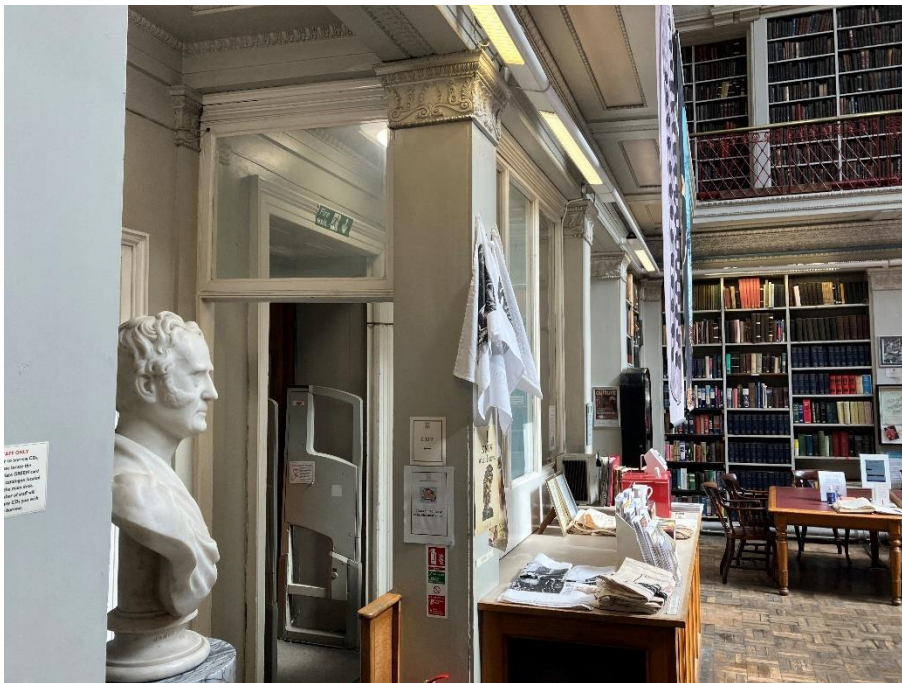
3.7.2 Some settlement appears to have occurred to the first floor plate just inside the entranceway from the Hallway to the Main Library. This is evidenced largely by apparent downward movement of columns supporting the gallery in this area (Photograph 22). There is no evidence of current structural distress in the floor finishes or ceiling finishes under, however intrusive investigations are recommended to confirm that there is no significant structure defect present in this area.

**Photograph 22: Main Library – apparent settlement of columns supporting the gallery**

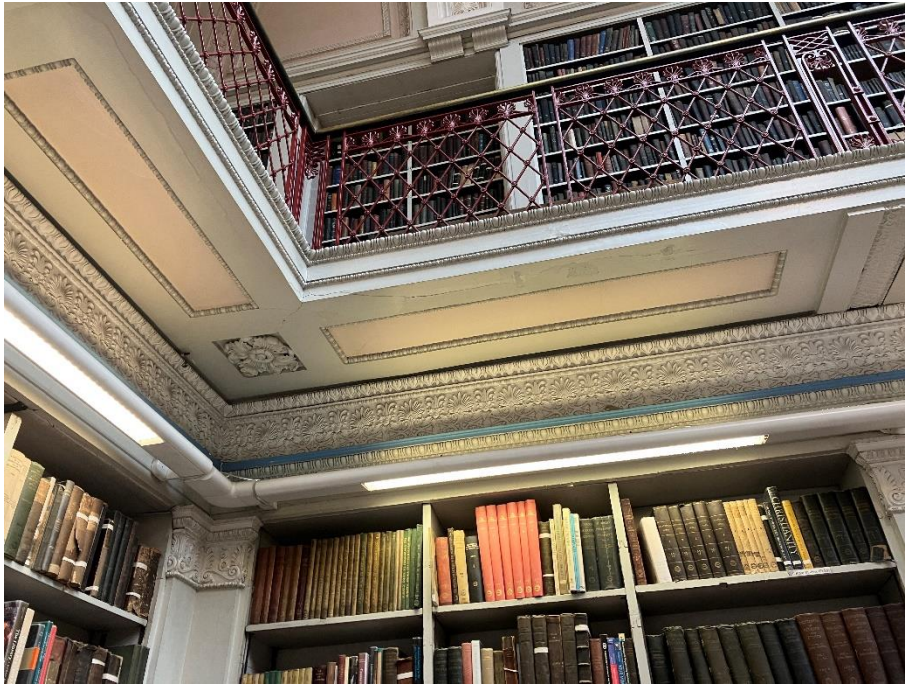
3.7.3 The plastered soffit and fascia of the galleries in the Main Library and Reading Room is extensively cracked (Photograph 23) likely due to flexion of the gallery structure itself. Site observations and archive drawings suggest that it comprises cantilevering timber beams, possibly supported by an iron/steel beam close to the wall. The gallery floor was noted to have rotated downwards to varying degrees, with visible and perceptible tilt in some areas, whilst there was no sign that the structure was excessively 'lively' under light foot traffic, further investigation is recommended and strengthening may ultimately be needed.

**Photograph 23: Typical example of plaster cracking to the fascia and soffit of the library galleries**

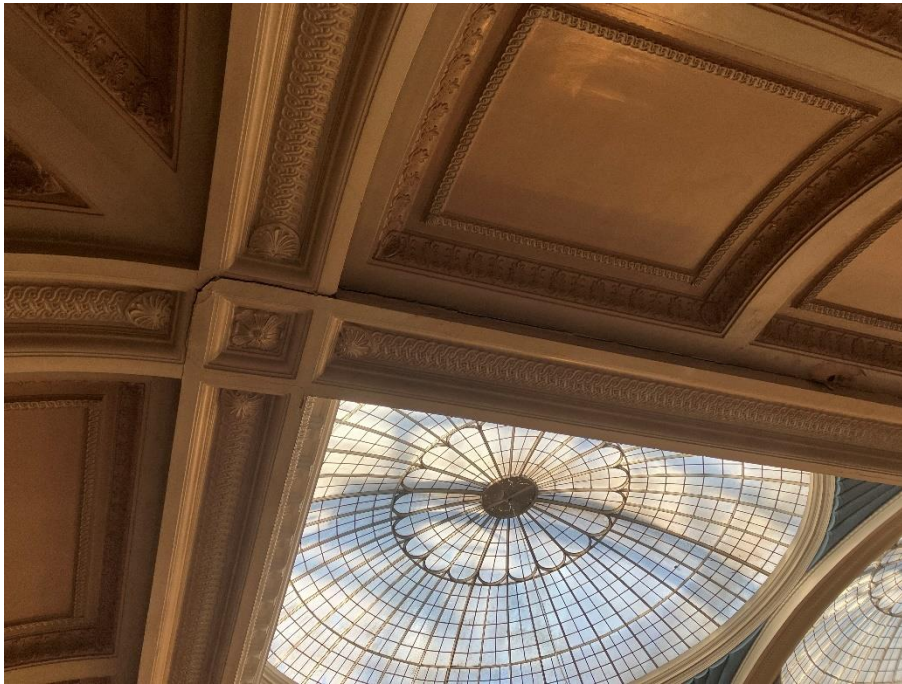
3.8.1 Significant water damage to ceiling plaster has occurred in the Main Library, mainly due to water ingress around the glasshouses at roof level above. This has resulted in plasterwork on some of the downstand ribs becoming detached and at risk of failure (Photograph 24). Various cracking is also present to ceiling finishes. Temporary repairs to re-fix detached plaster were recommended to the client and full inspection is required by a plaster specialist.

**Photograph 24: Main library – example of failed and detached ceiling plaster**

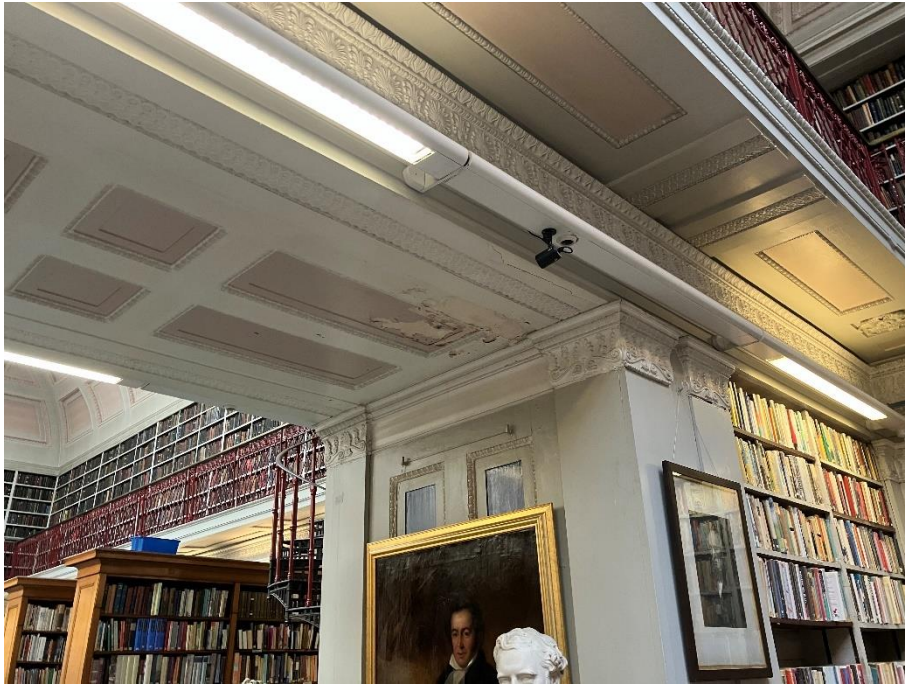
**Photograph 25: Water ingress between the Main Library and Reading Room**

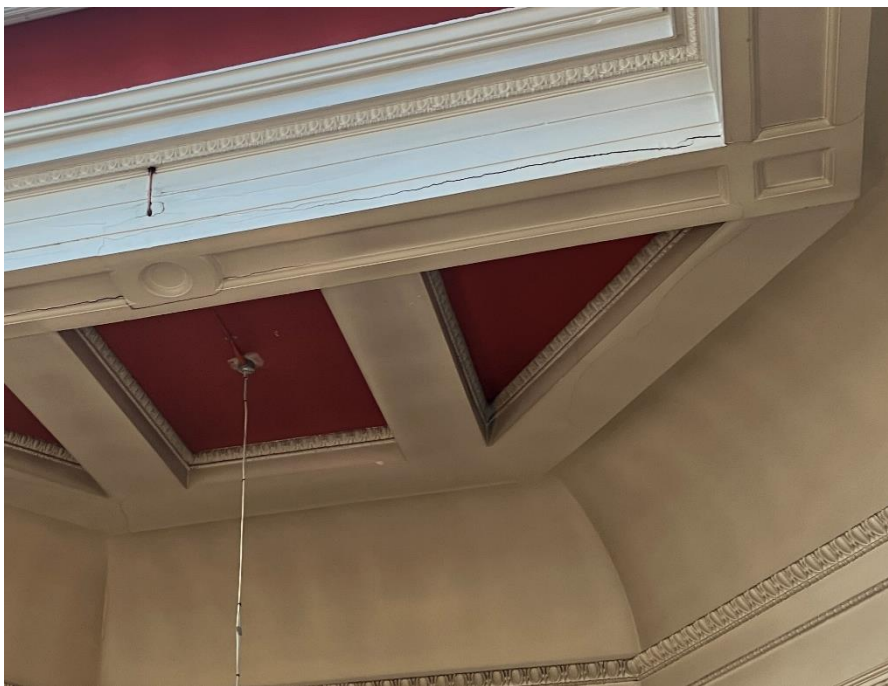
- 3.8.4 The Committee Room ceiling finish is also in poor condition with several cracked and partially detached plaster downstands. The structure above is not recorded on archive section drawings but seems likely to be of iron beams and timber. The defects seem likely to be limited to the plaster finishes but the opportunity should be taken to inspect the condition of the primary structure during repair works.

**Photograph 26: Committee Room – example of cracked plaster finishes**
