## Historic England Cultural Sector Decarbonisation

### Lit & Phil Library

### Condition Report

**Ref:** 241181/S Wilkinson

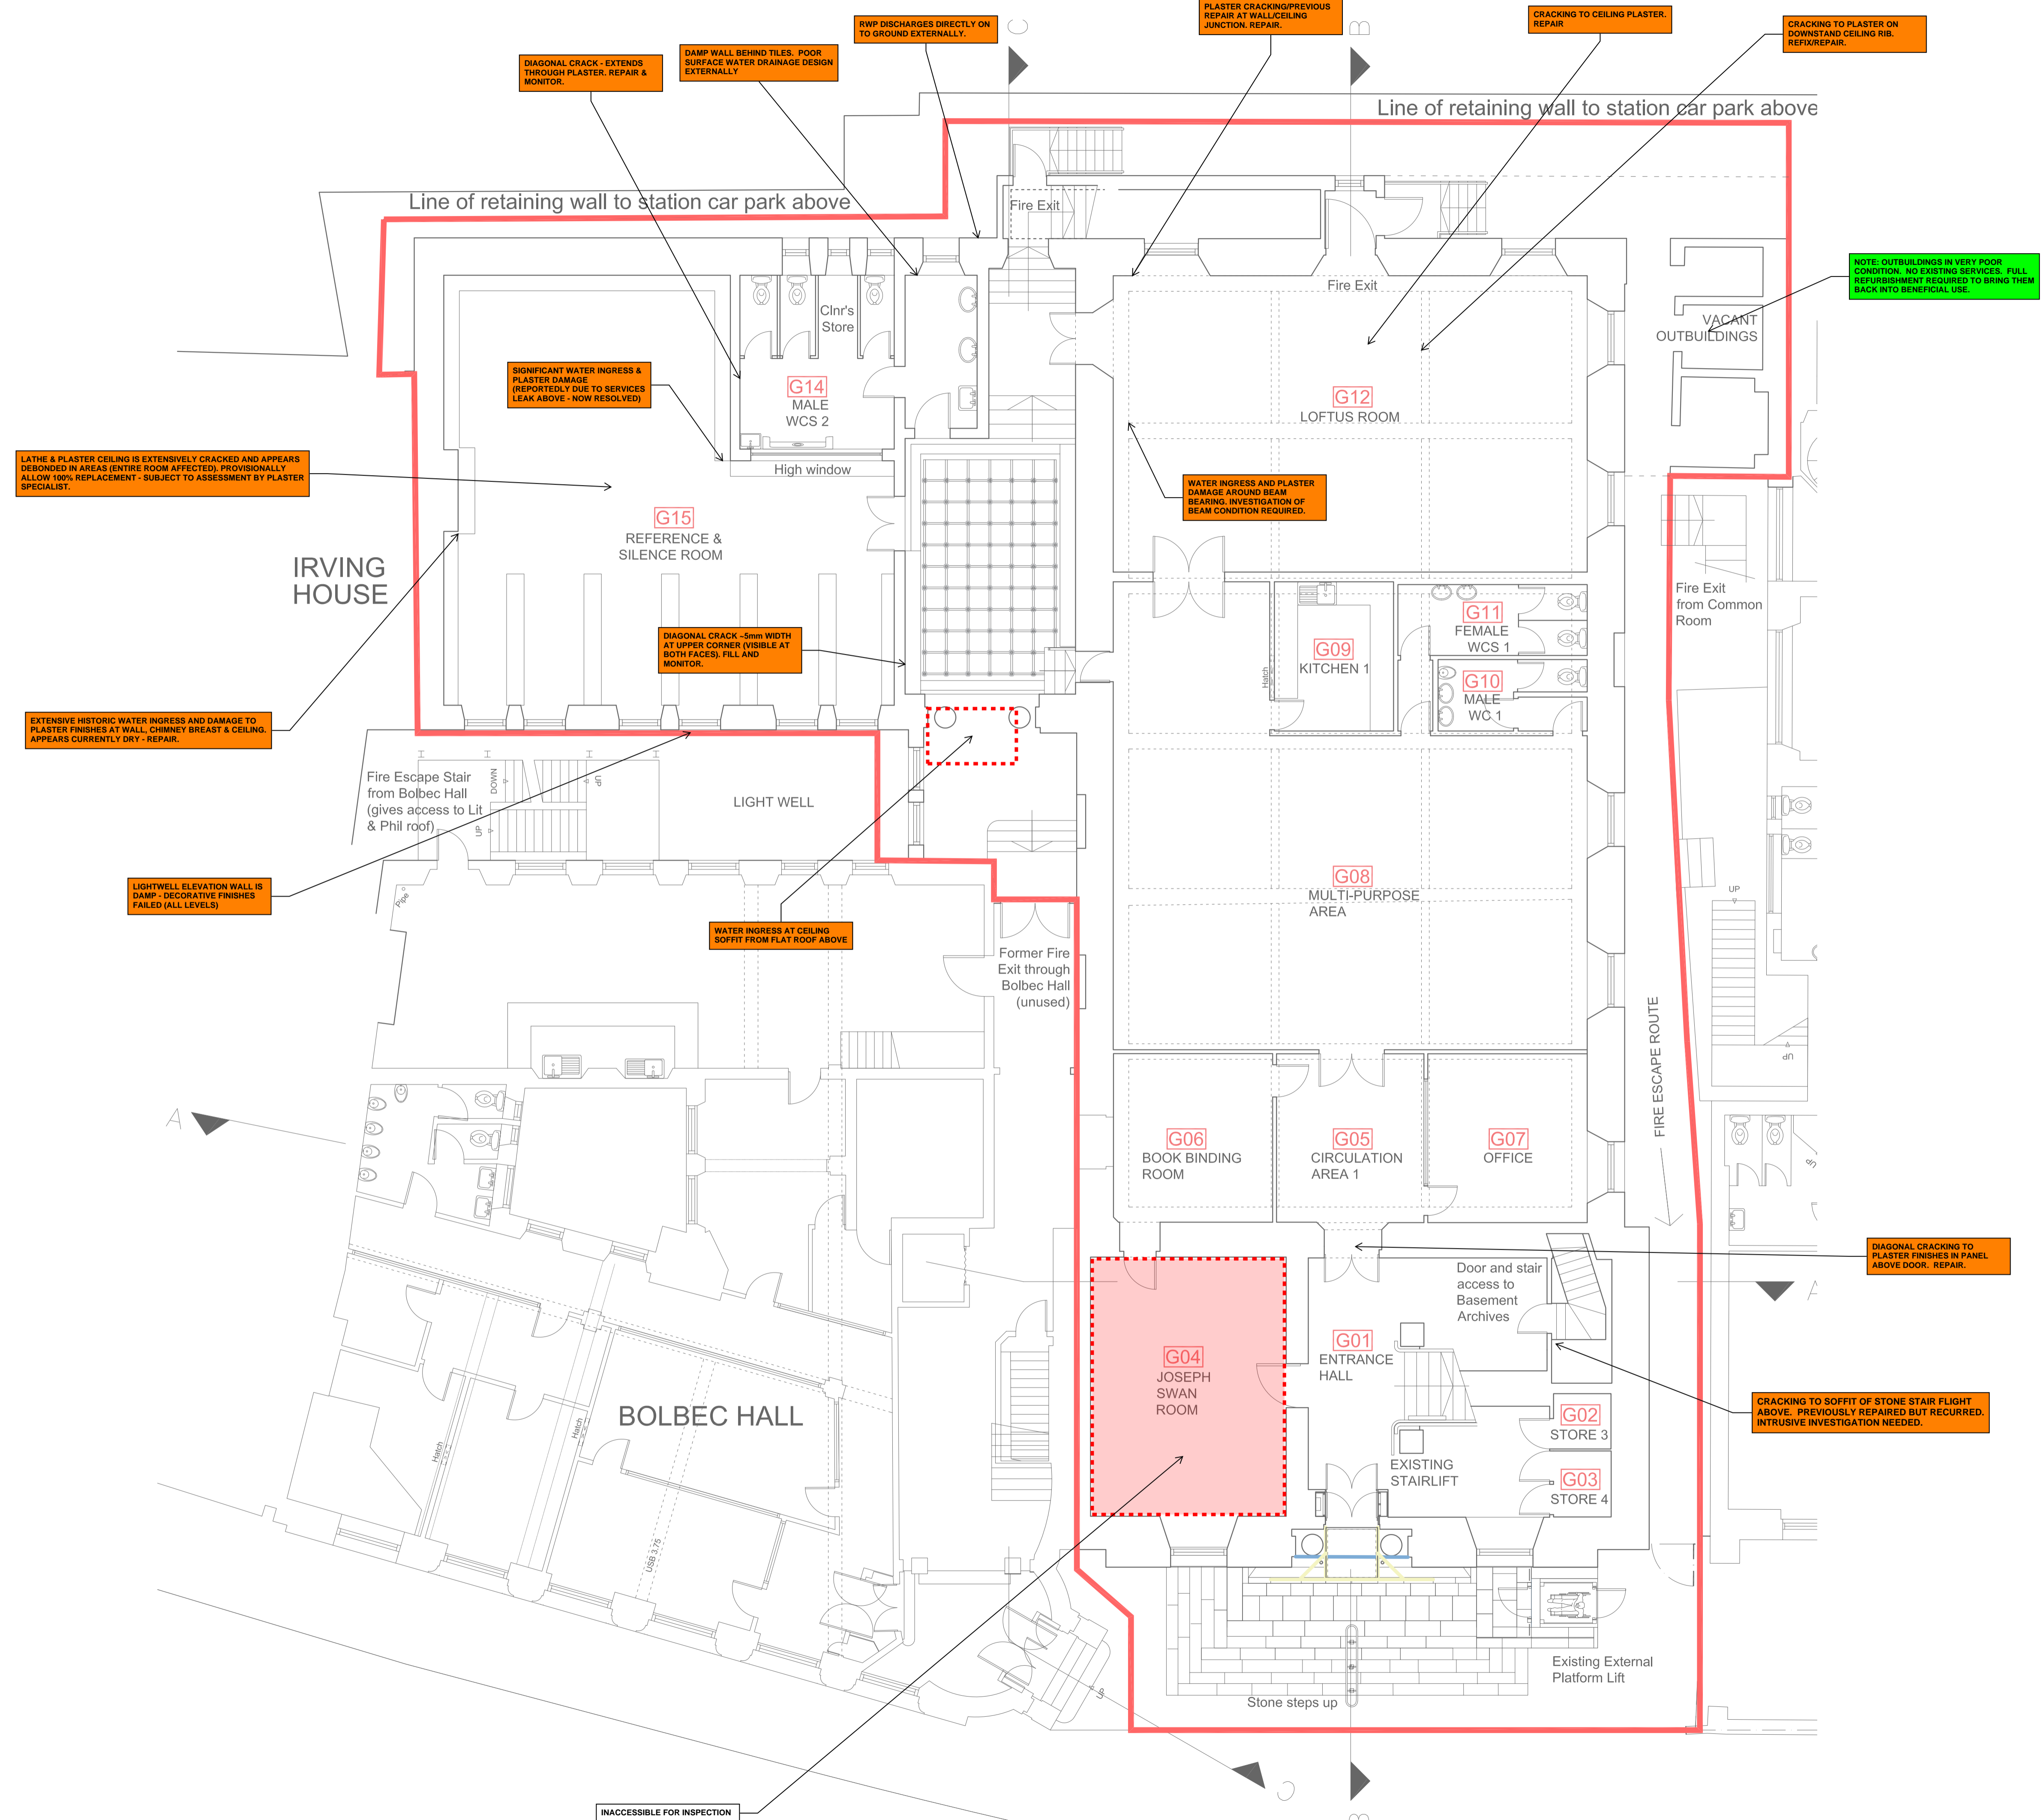
<b>Drawing Status</b>	
<b>FOR INFORMATION</b>	
Project	Date MAY 2025
HE CULTURAL SECTOR DECARBONISATION LIT & PHIL LIBRARY	Scale NTS
Title	Drawn SW
GROUND FLOOR PLAN DEFECTS	Engineer SW
Project No	241181
Drawing No	Revision
241181-CON-XX-00-SK-S-1001	P01

NOTE: OUTBUILDINGS IN VERY POOR CONDITION. NO EXISTING SERVICES. FULL REFURBISHMENT REQUIRED TO BRING THEM BACK INTO BENEFICIAL USE.

- Investigate recurrent cracking to underside of main stairs
- Repair damaged plaster above door between G01 and G05
- G12 (Loftus Room) - investigate water ingress around beam bearing
- G12 – investigate cracked ceiling plaster at downstands – repair plaster generally
- G14 – address external downpipe to redirect surface water into drain
- G14 – repair crack and monitor for further movement
- G15 – provisionally allow to fully replace plaster ceiling
- G15 - investigate condition of timber structure at water ingress locations
- G15 – repair water damaged wall plaster
- G15 – investigate and repair crack
- Hallway to Bolbec Hall – recover and insulate monopitch roof. Allow for timber repairs
