# Envelope Airtightness Test Results Shire Hall Museum (Whole Building), High West Street, Dorchester

Carried out for Historic England

Report CAT-HIS01-NA001-SHI01-010925-673166

1 September 2025

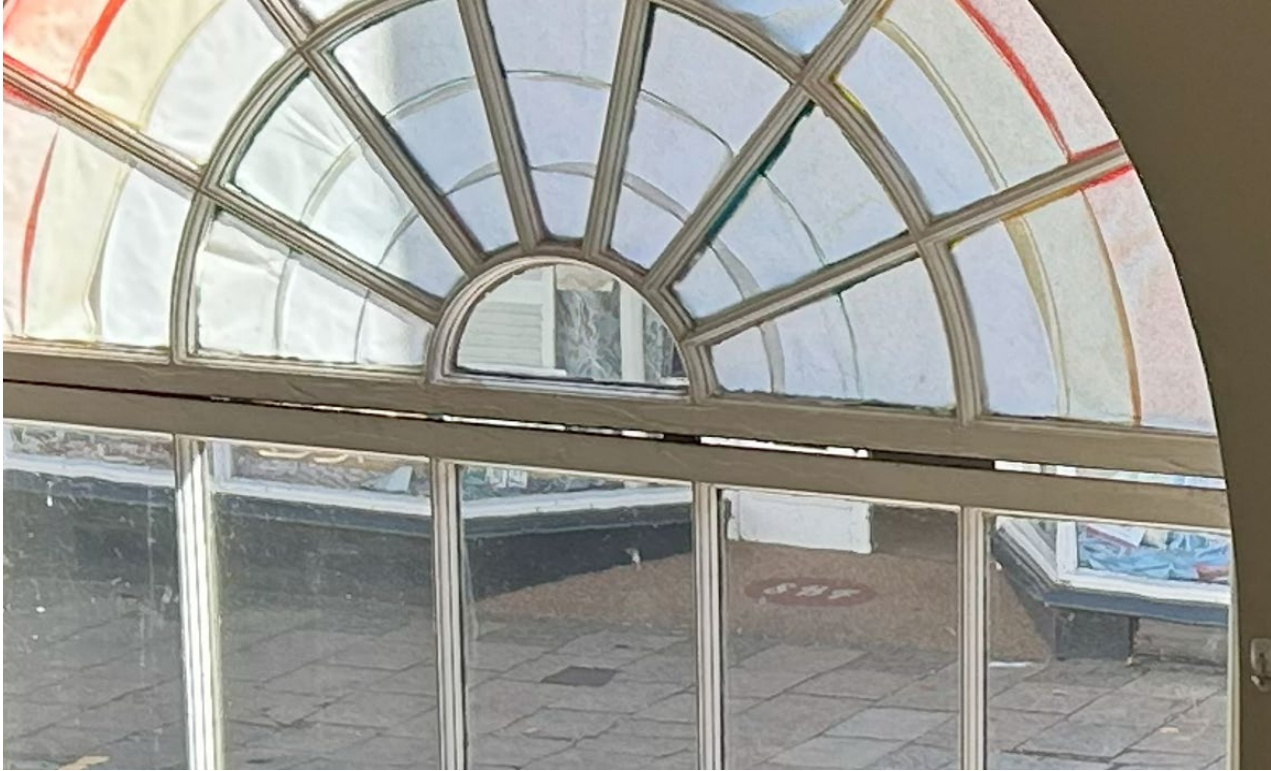
Figure A.1 Air leakage path

The upper window in the shop area was slightly twisted/open

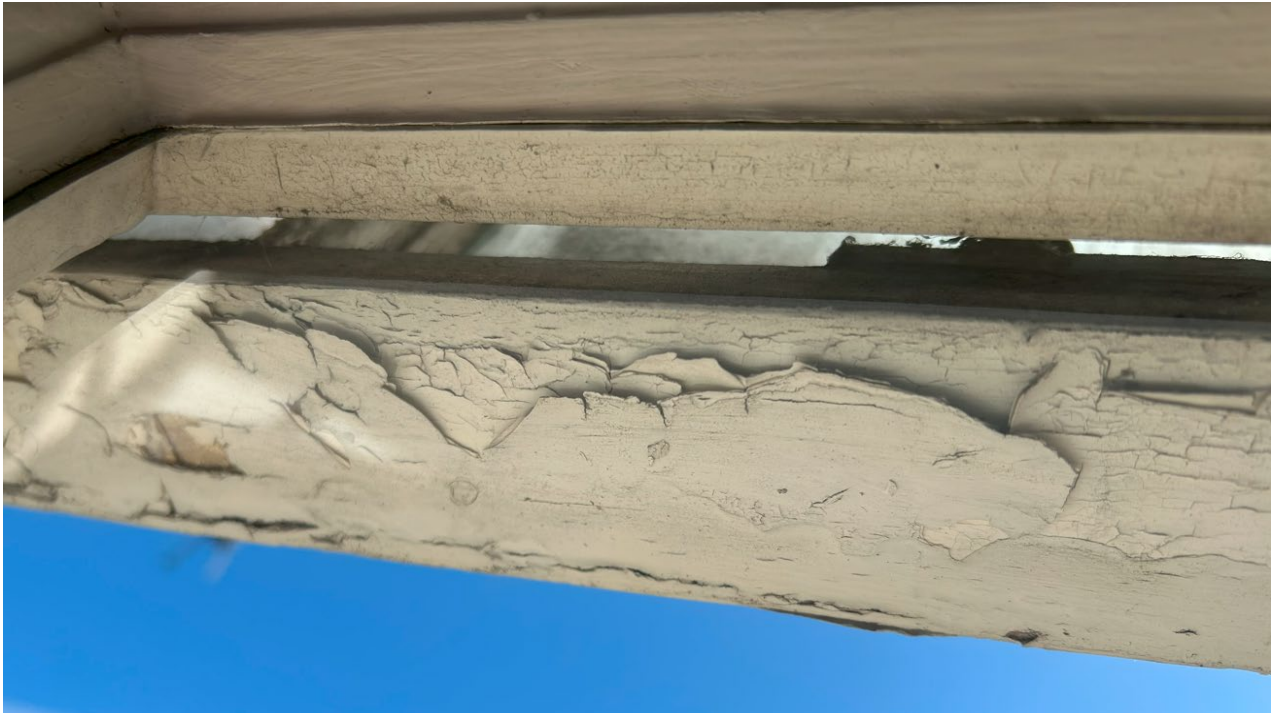
Figure A.2 Air leakage path

The window in staff area which had a gap at the meeting rail. The upper sash may have been slightly open. Not all windows were checked and there may be others in a similar state. Some windows had secondary glazing units fitted.

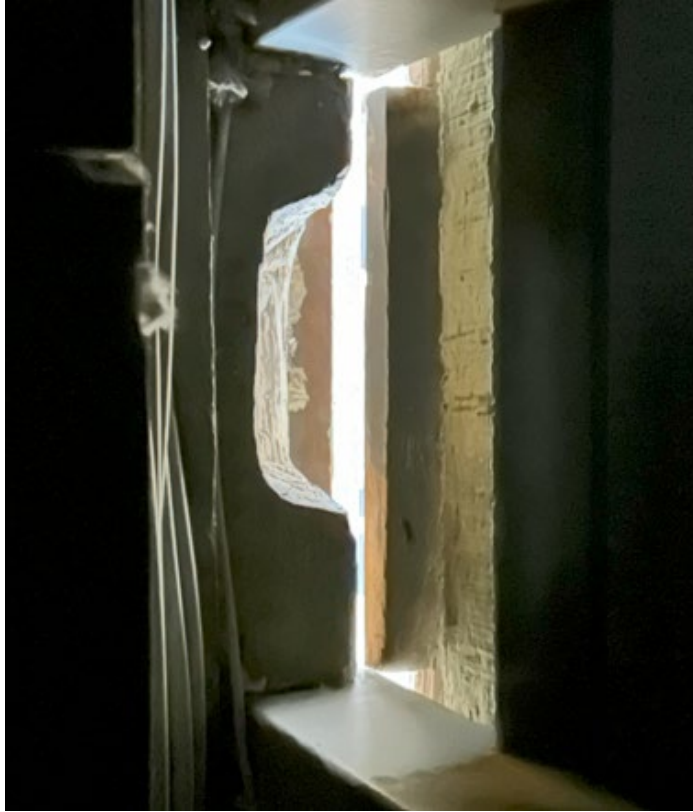
**Figure A.3** Air leakage path

Gap around loft hatch for ladder/handle.

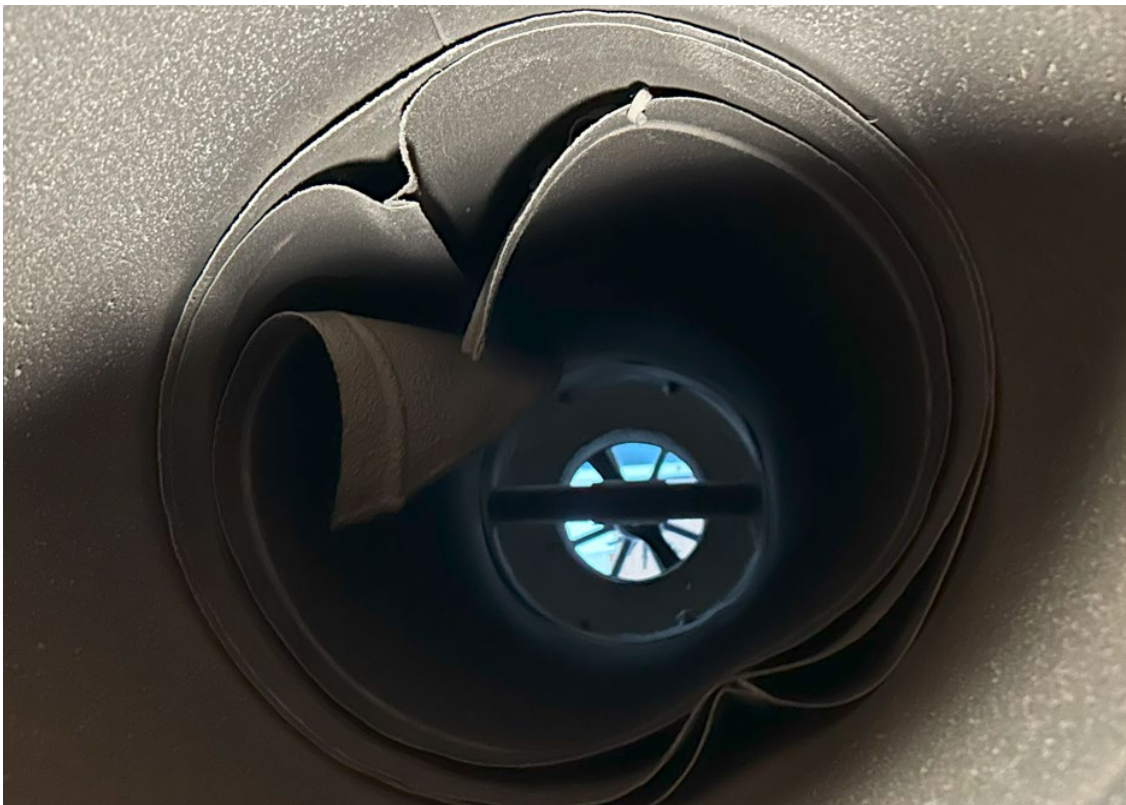
**Figure A.4** Air leakage path

The unducted ceiling vent to the court room was open to loft space. The other ceiling vents were ducted to small MVHR units but were not temporarily sealed for the test.
