## Thermal Imaging Survey Report

Historic England

1703 – Decarbonisation of Cultural Heritage Buildings : Shire Hall Museum

Revision 1.0 - 03.03.2025 - For Information

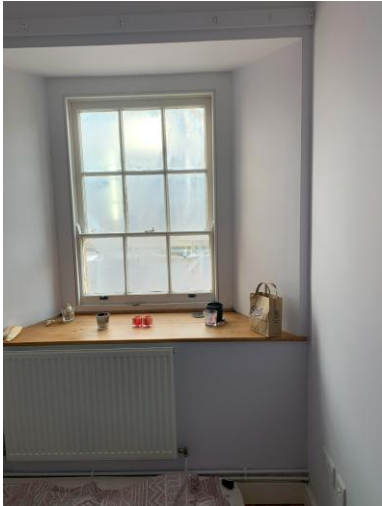
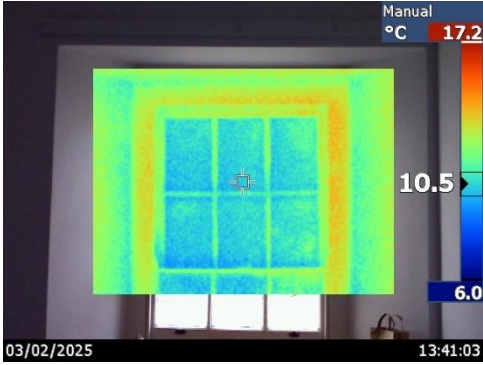
Location	Reference photo	Thermal image	Notes
Flat 1 bedroom

<p>03/02/2025 13:41:03</p>	<p>Thermal images showing heat loss through the single glazed sash window in the flat. Single glazing performing significantly worse than the solid walls.</p>
Entrance lobby

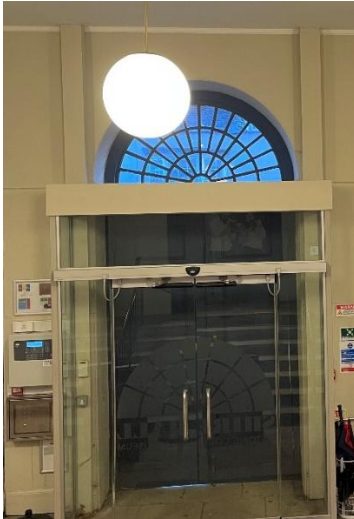
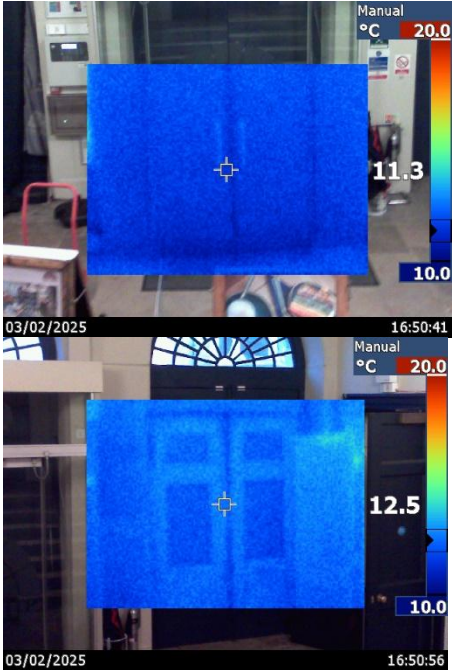
<p>03/02/2025 16:50:41</p> <p>03/02/2025 16:50:56</p>	<p>Unheated entrance lobby. Doorway is cold but likely owing to there being no heating</p>

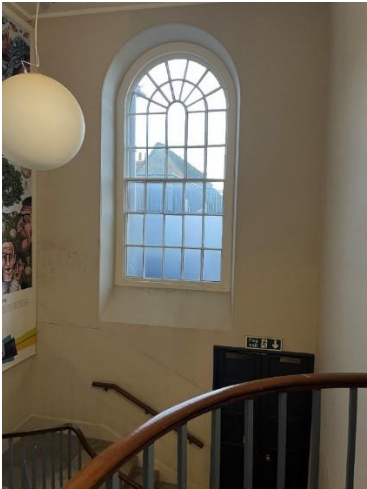
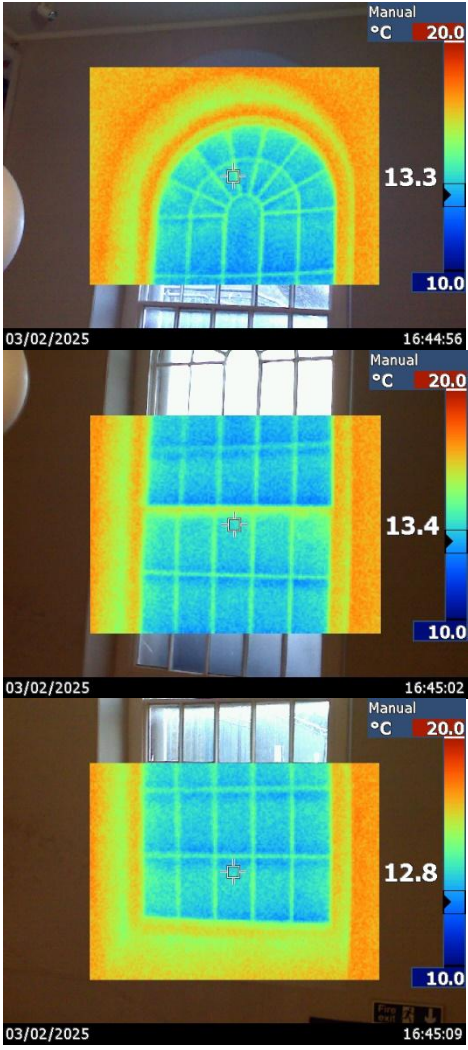
Location	Reference photo	Thermal image	Notes
<p>Top of central staircase</p>

<p>Thermal images showing heat loss through the single glazed sash window in the central stair. Single glazing performing significantly worse than the solid walls.</p>
<p>Crown court South</p>

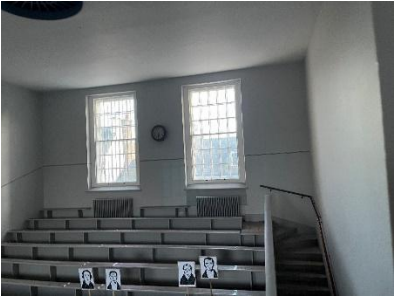
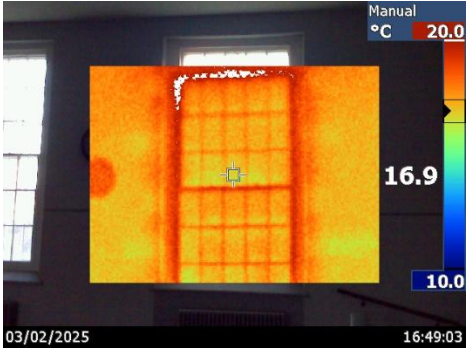
<p>Thermal imaging showing secondary glazing to the south façade of the crown court performing fairly well thermally.</p>

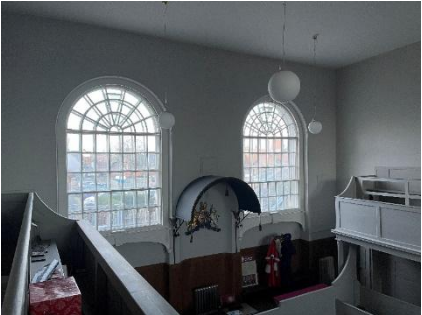
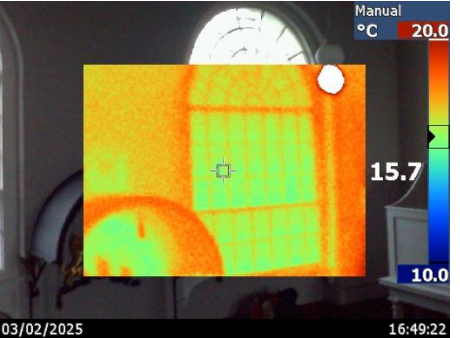
Location	Reference photo	Thermal image	Notes
Crown court North

<p>Thermal imaging showing secondary glazing to the north façade of the crown court. Secondary glazing to north façade performing slightly worse than that to the south façade.</p>
Staff office

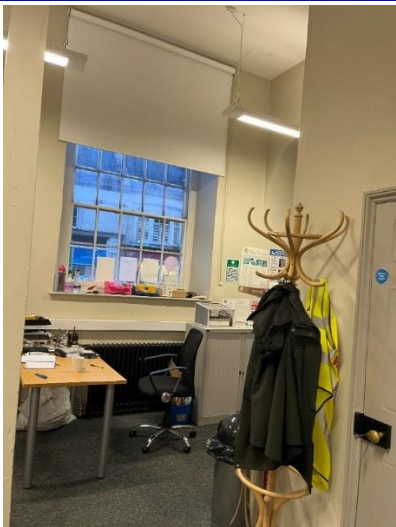
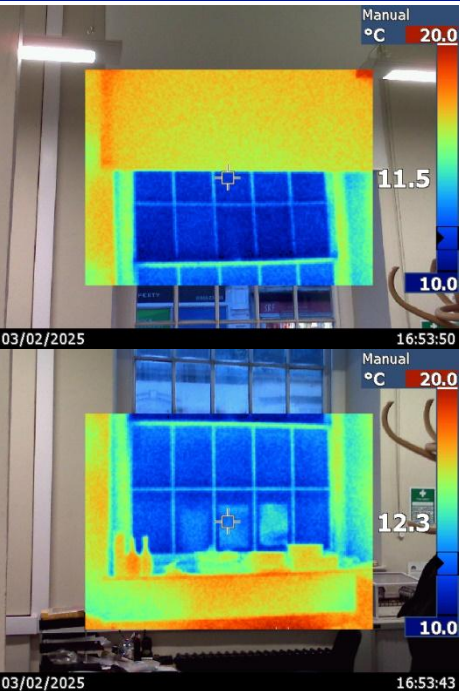
<p>Single glazing to the staff offices performing poorly thermally.</p>

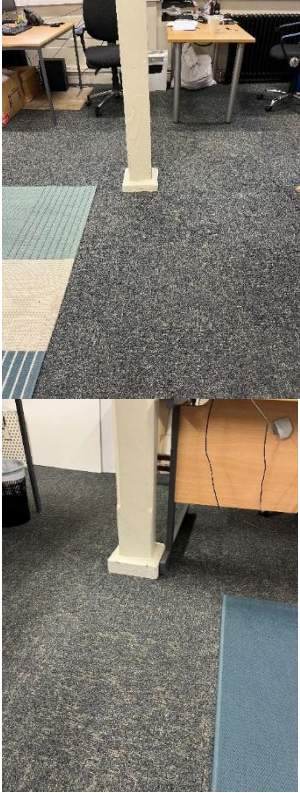
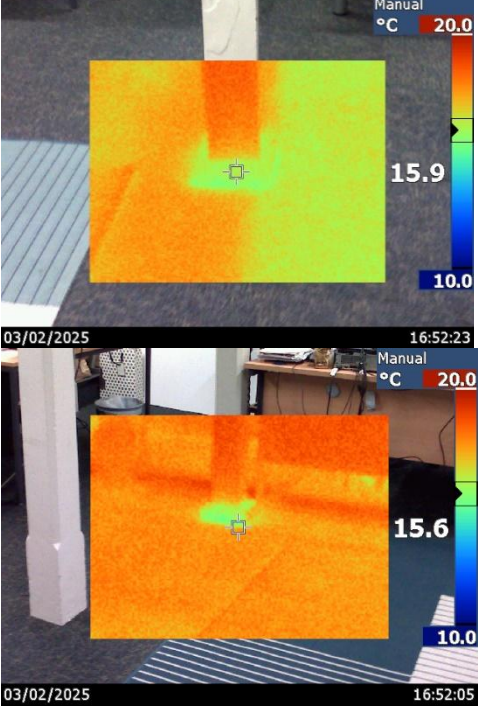
Location	Reference photo	Thermal image	Notes
Staff office

<p>Thermal imaging showing thermal bridging at the base of the columns supporting the crown court above. Areas of poorly performing building fabric at floor level between columns also evident.</p>
TIC continued

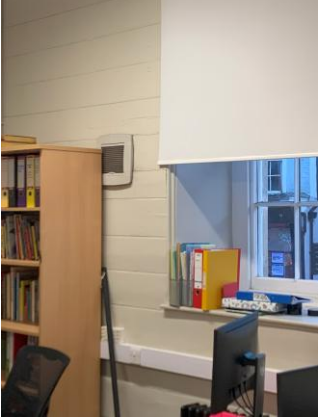
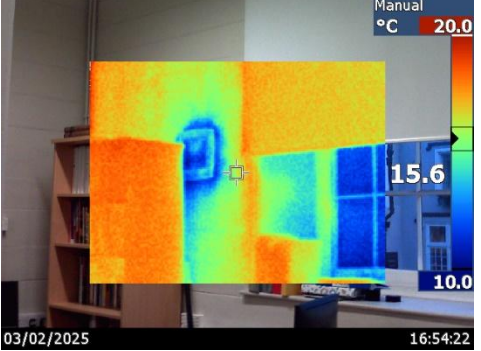
<p>Thermal imaging showing heat loss through a ventilation unit in the wall.</p>
Store room off introduction area

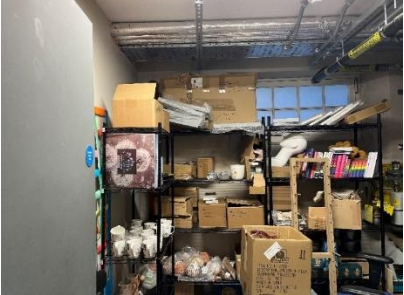
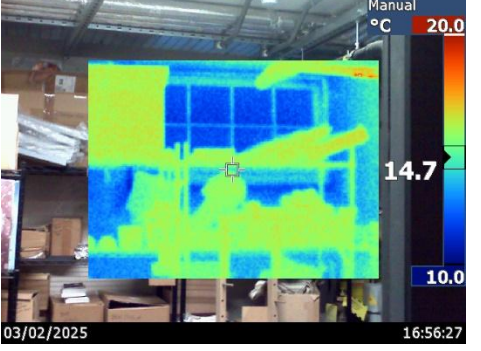
<p>Poorly performing single glazing in store room off introduction area. Note permanently open ventilation to</p>

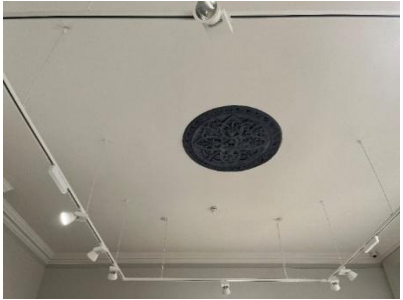
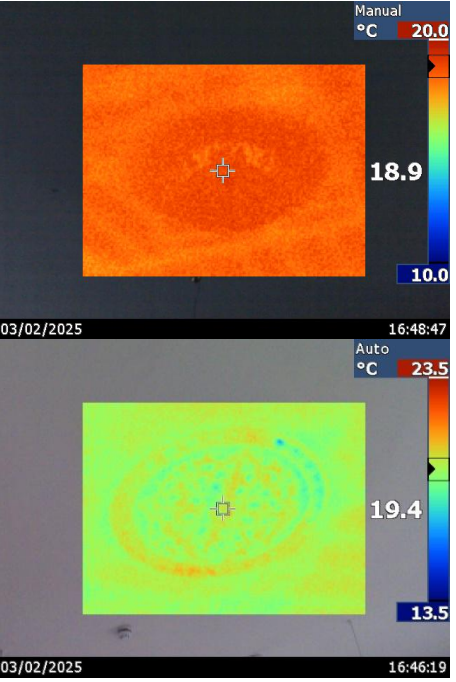
Location	Reference photo	Thermal image	Notes
Grand Jury room

<p>Historic ceiling grille in grand jury room. Grille &amp; ceiling performing well thermally.</p> <p>Automatic scale used in bottom image to highlight features.</p>
Grand Jury room

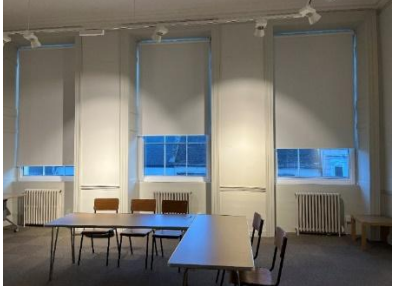
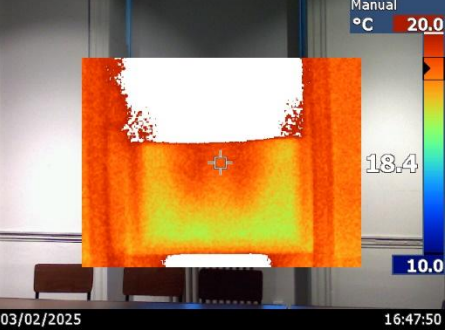
<p>Secondary glazing to Grand Jury room evident.</p>
Roof access hatch in store off Grand Jury room

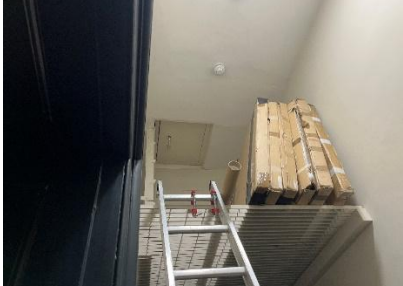
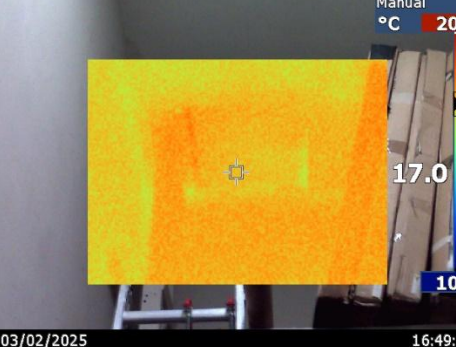
<p>Thermal imaging showing the access hatch into roof void. This was not found to be a weak point. Thermal imaging showing evidence that roof is insulated.</p>

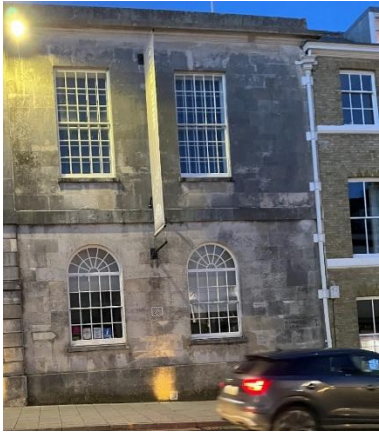
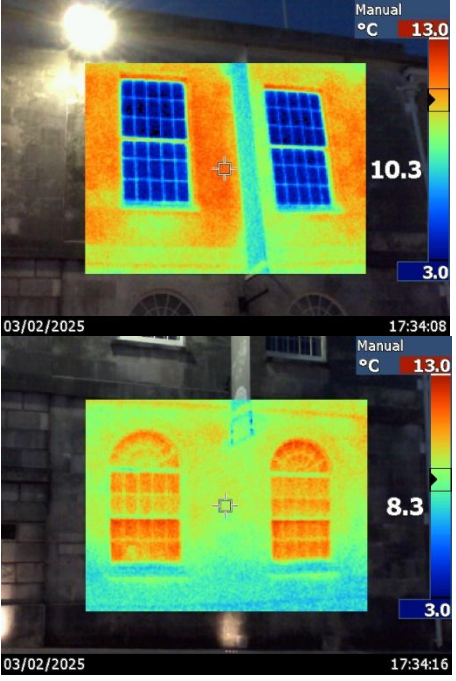
Location	Reference photo	Thermal image	Notes
Front façade (Right)

<p>Difference in performance of windows with and without secondary glazing evident from thermal imaging of façade.</p> <p>Top: Crown Court windows with secondary glazing.</p> <p>Bottom: Staff offices without secondary glazing</p>
Front façade (Centre)

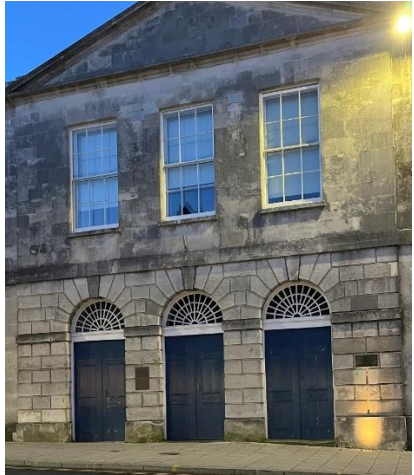
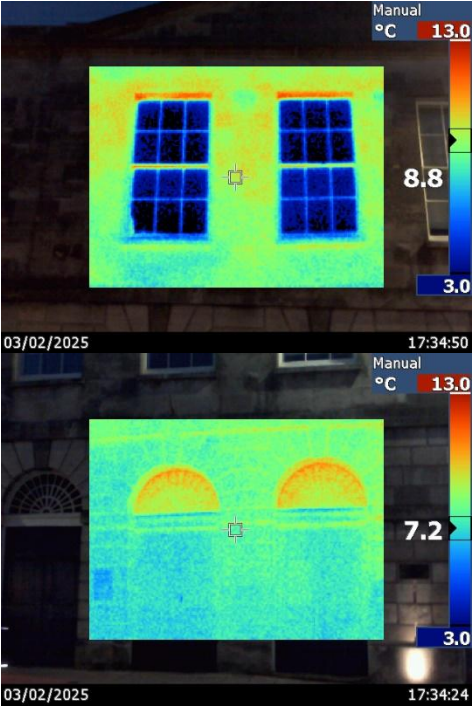
<p>Difference in performance of windows with and without secondary glazing evident from thermal imaging of façade.</p> <p>Top: Grand Jury room windows with secondary glazing.</p> <p>Bottom: Entrance hall without secondary glazing</p>

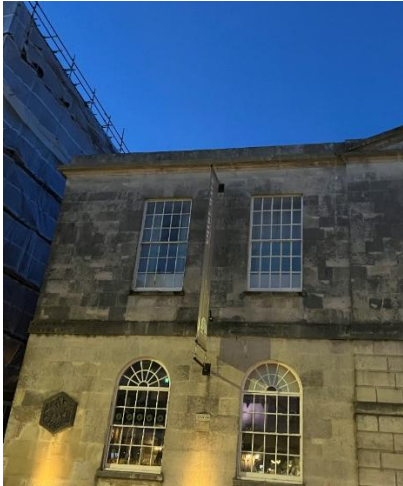
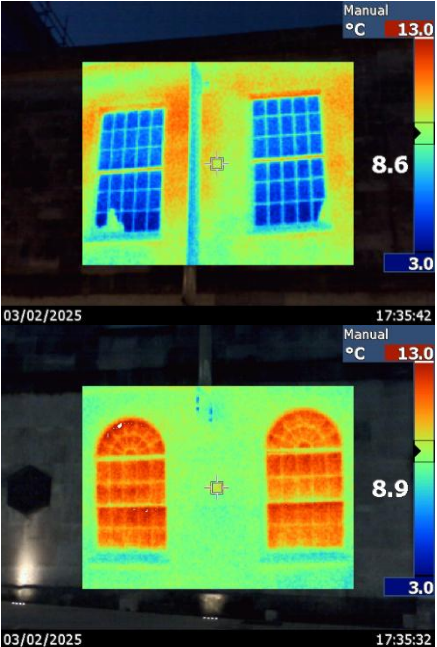
Location	Reference photo	Thermal image	Notes
Front façade (Left)

<p>Difference in performance of windows with and without secondary glazing evident from thermal imaging of façade.</p>

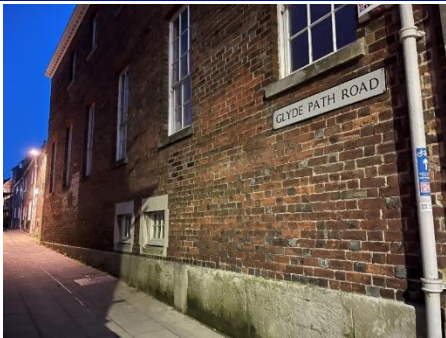
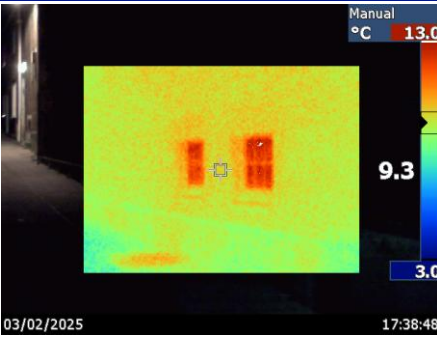
<p>Poorly performing single glazed windows to West façade.</p>

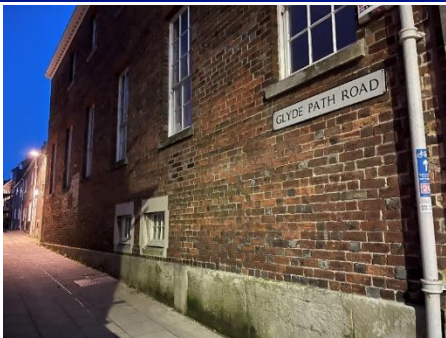
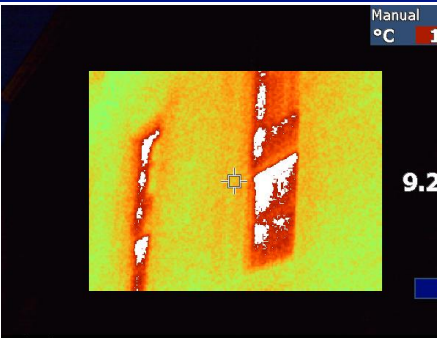
<p>Poorly performing single glazed windows to West façade.</p>

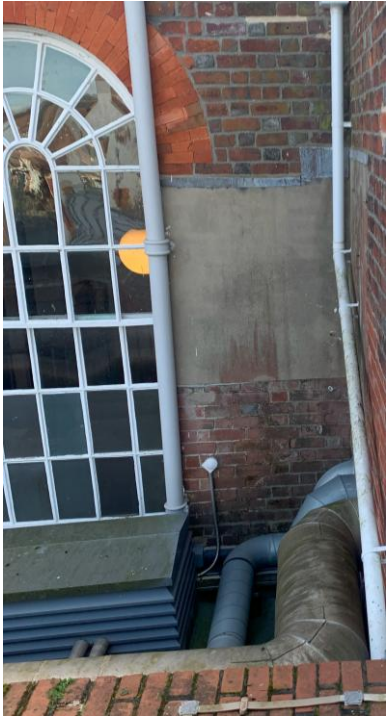
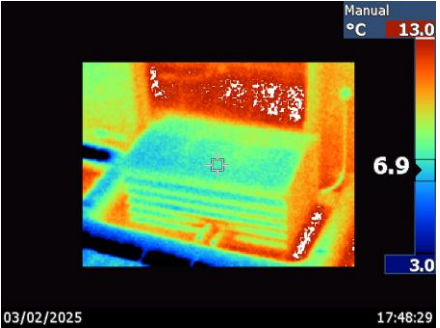
Location	Reference photo	Thermal image	Notes
<p>Rear roof – roof cowl over ventilation opening into basement plant room</p>

<p>Thermal imaging showing heat loss through roof cowl over ventilation opening into basement plant room</p>
<p>Rear roof</p>

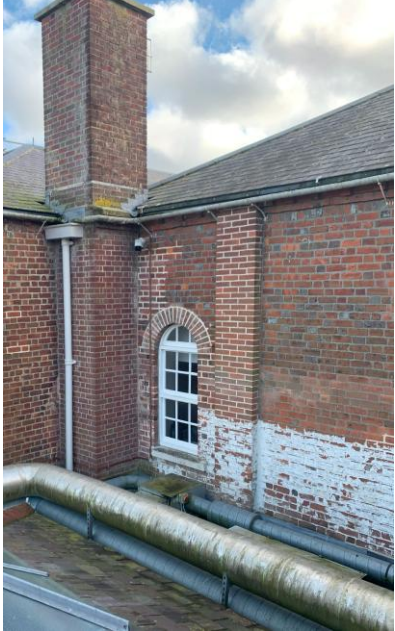
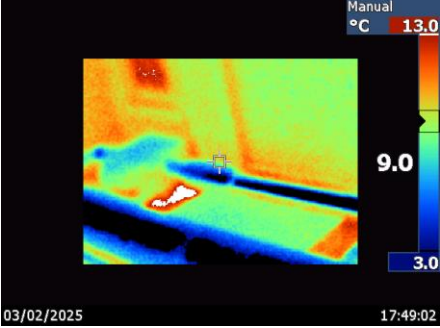
<p>Thermal imaging showing poorly performing roof to the rear of the building, including heat loss around services.</p>
