# Shire Hall Museum: Decarbonisation Plan

Cultural & Heritage Sector Decarbonisation Pilot Study

January 2026

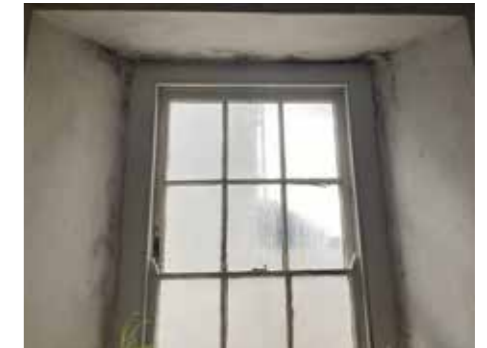
Flat 1 window is in disrepair, this is to be repaired by the council imminently.

Mould around flat window

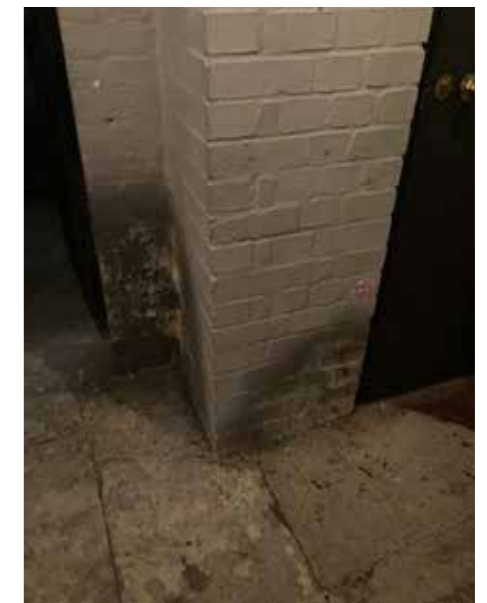
Damp in basement

The basement experiences damp conditions and some basement timber beams were found to be rotten and friable.

The Lower Ground floor/basement has been finished with a number of cementitious materials. The removal of non-breathable wall coverings, to the damp affected areas of basement, is recommended to allow the walls to breathe. The mechanical ventilation should also be repaired or replaced.

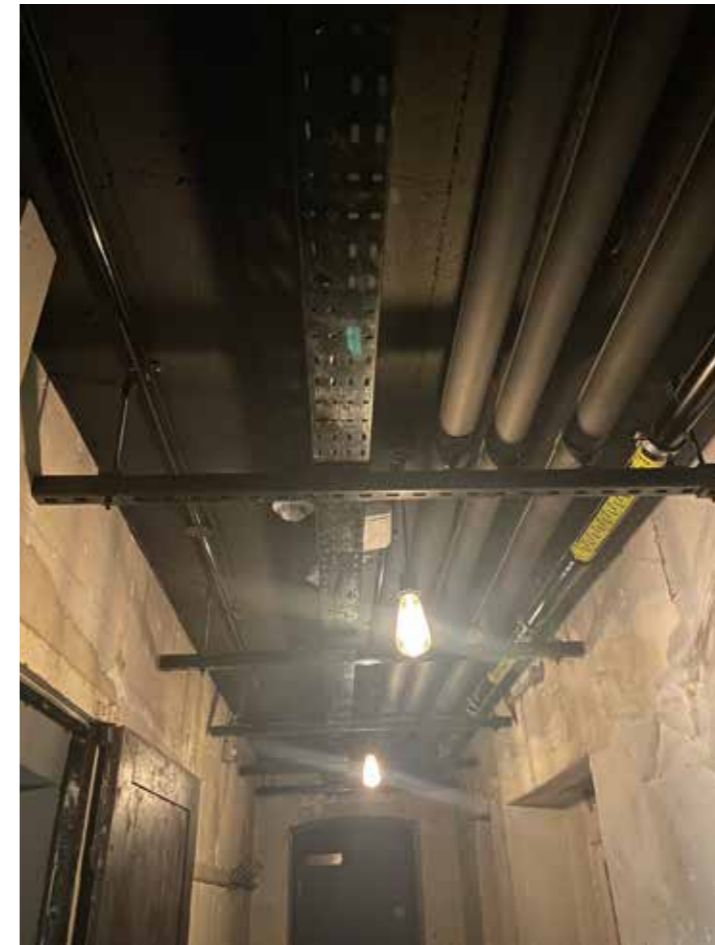
Services routes through the basement

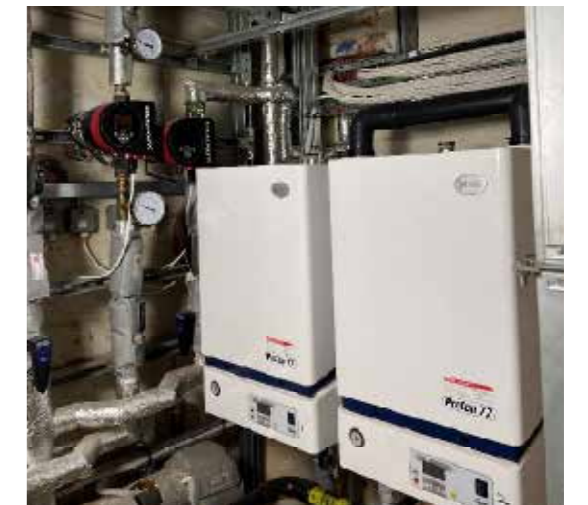
Figure 3-3: Basement plant room housing 2no condensing gas boilers

2no condensing gas boilers

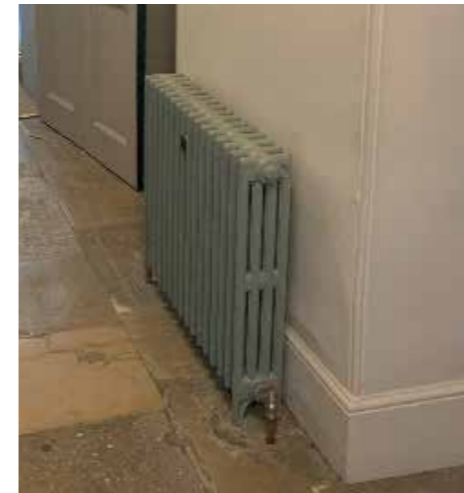
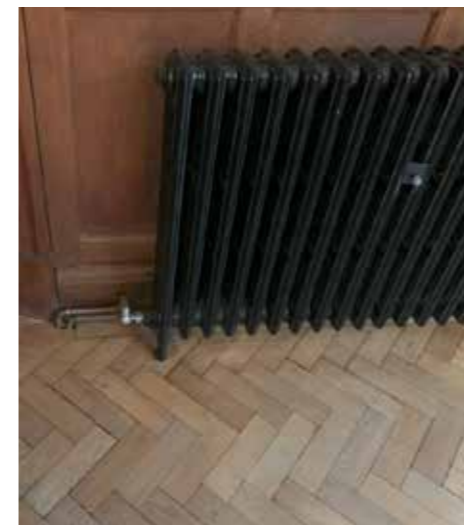
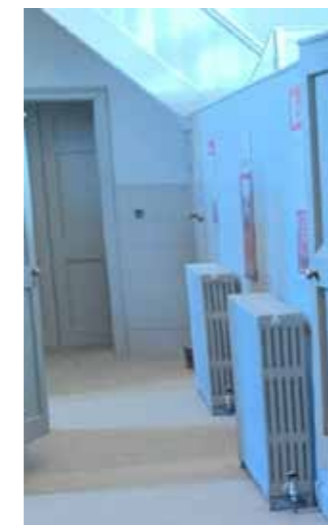
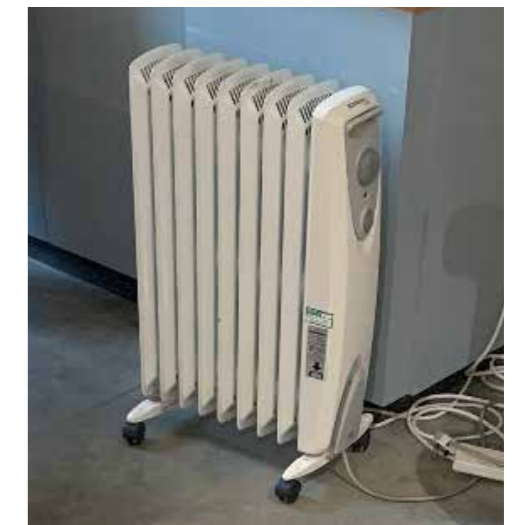
An electric radiator is used in the reception due to the space not being well heated by the heating underfloor heating system.

Cast iron radiators to Learning space, Crown court, & circulation space.

Electric oil radiator in the reception

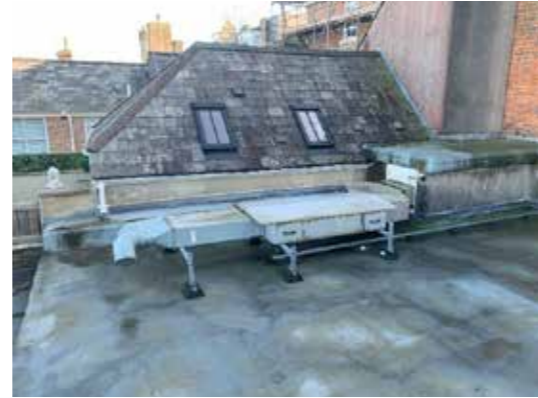
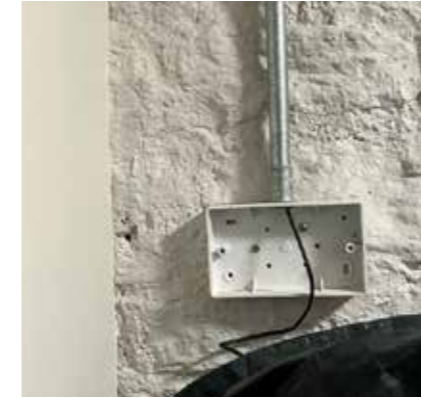
Left: MVHR unit located on low rear roof assumed to serve basement museum areas. Access up to unit not possible. Right: assumed system controller location in store at basement level.

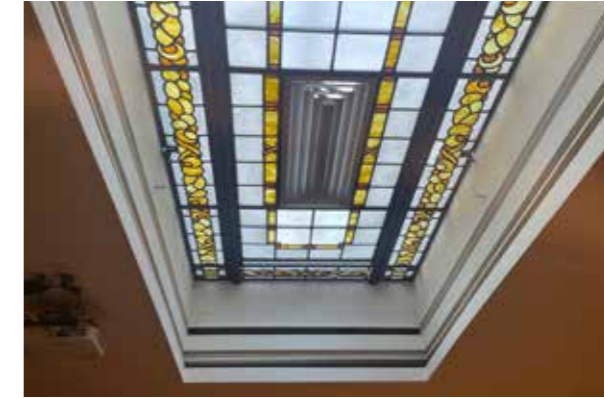
Open ventilation grille in centre of rooflight to learning space. Glazed lantern at roof level above rooflight.

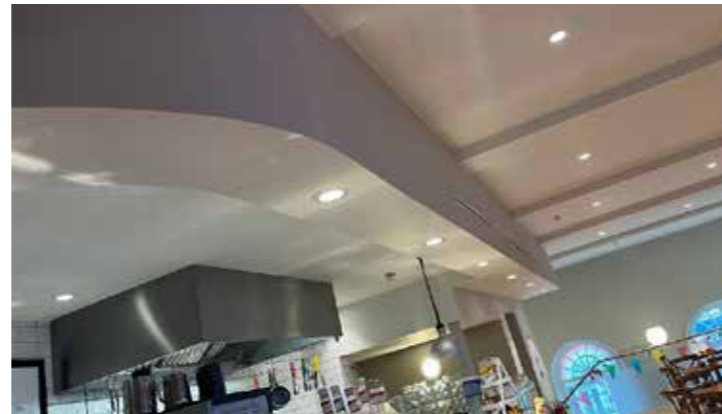
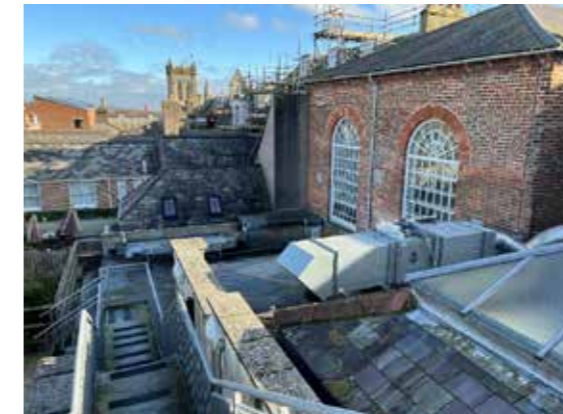
- Café supply ventilation with heater battery, supply to café through slot diffuser on face of bulkhead above cafe counter.
- Manual enabling and override of fan speed possible from controller.
- System name: Café supply air SF1
- Fan controller on wall adjacent to café servery
- System set to manual controls
- Heater in fault during site visit
- Fan location: assumed to be located on lower roof to rear of building.

Cafe supply & extract ventilation

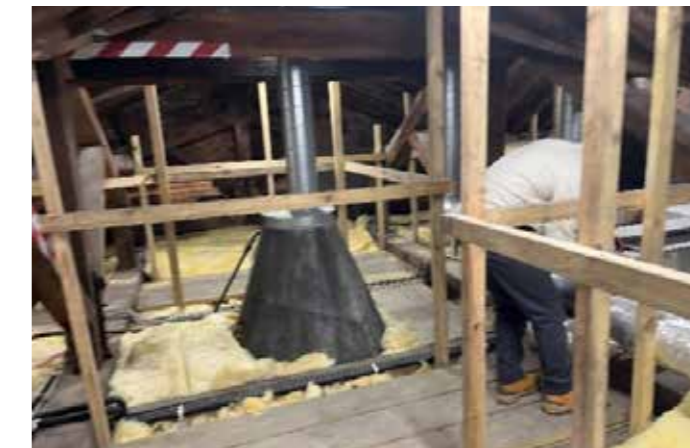
MVHR unit in roof void assumed to serve grand Jury room

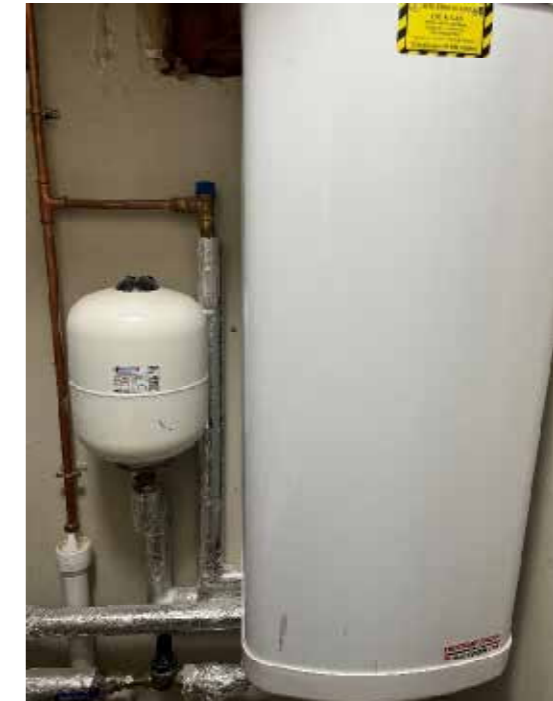
Cafe store cupboard housing an electric water heater

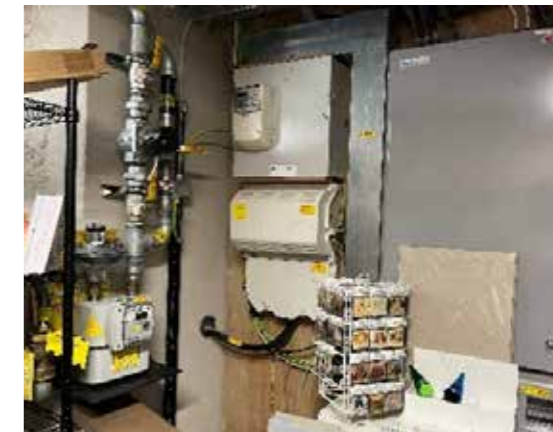
The main panel board feeds distribution boards throughout the building. The main panel board and distribution boards were installed during the 2017 works and appear to be in good condition. Cables are generally installed on cable trays.

Incoming supply and adjacent switch panel

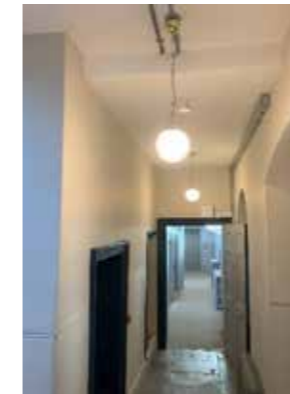
Pendant fittings in circulation areas

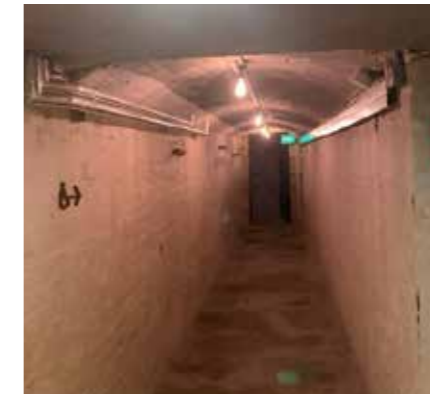
Fluorescent fittings within basement corridor

Lighting is already largely LED although some fluorescent fittings can be found. Lighting is manually controlled within most areas, though PIR sensors are present in some WCs and storerooms.

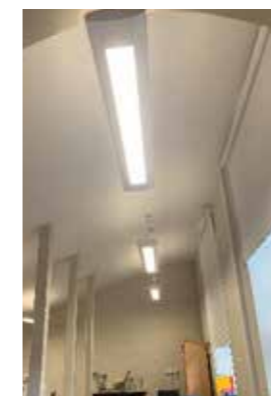
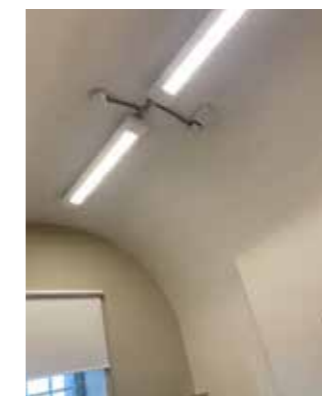
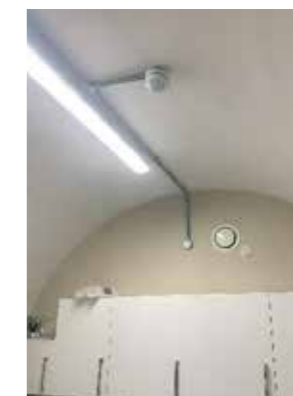
Suspended/surface mounted linear fittings in second floor meeting room, volunteer kitchen, and basement corridor

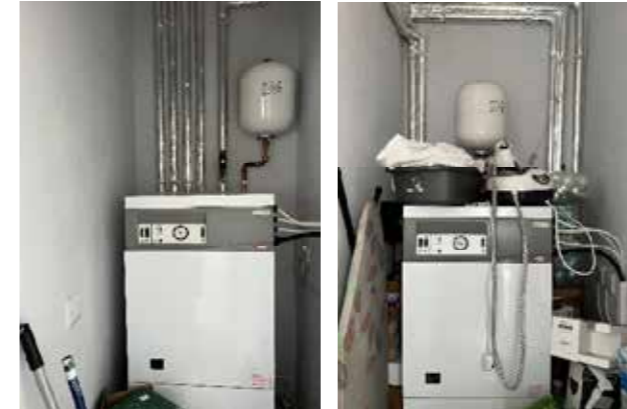
Boiler installation:  
a Heatrae Sadia Electromax Combined electric flow boiler and direct unvented hot water cylinder is located in the utility cupboard in each of the two flats.

Electric boilers to flats

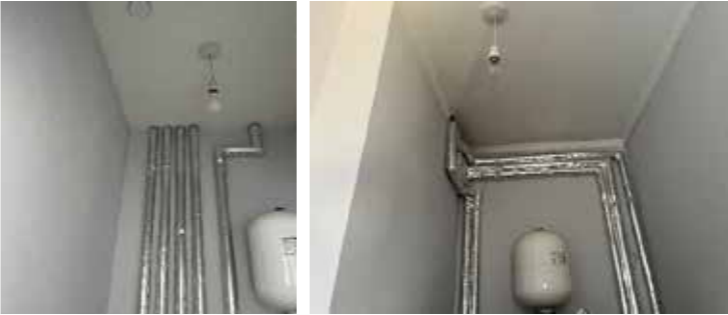
Insulated pipework to flats

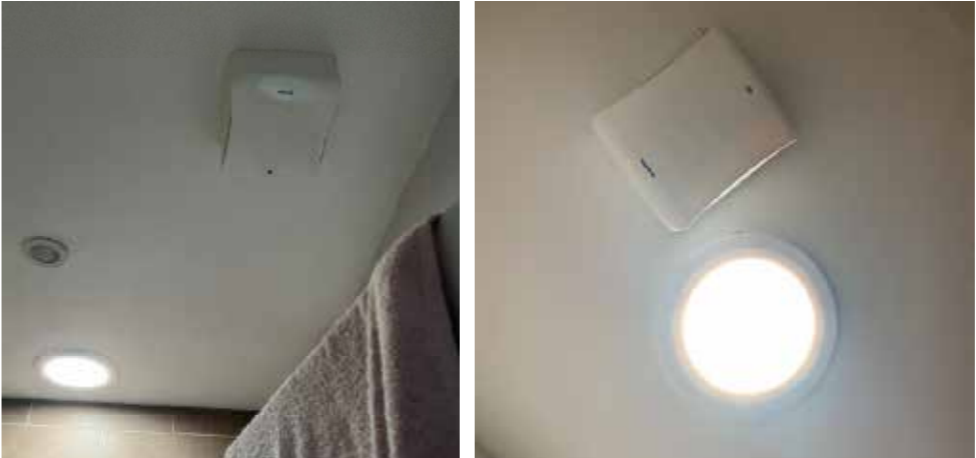
Ceiling mounted Vent-Axia extract fans in flat bathrooms

Ceiling mounted Vent-Axia extract fans are present in the bathrooms of both flats. The Shire Hall note that these were installed recently to combat moisture/mould issues in both flats.

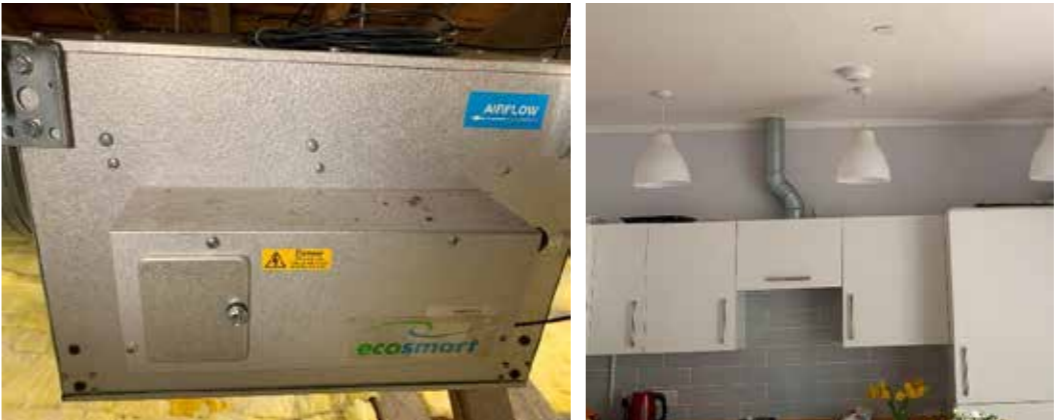
Right: Un-labelled extract fan in roof void. Left: Ventilation ductwork from kitchen cooker hood

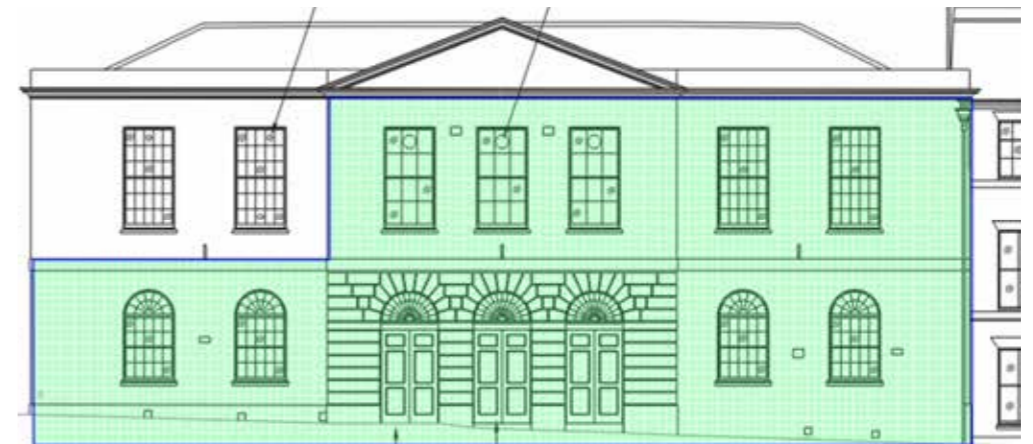
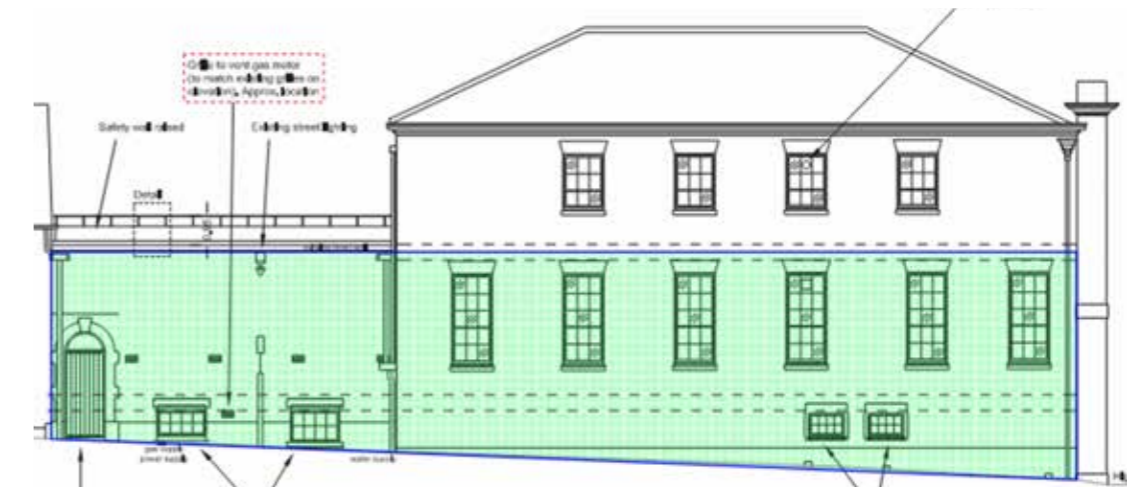
South, west and north elevations showing areas considered with heat loss, highlighted per wall construction

Difference in highlighted colour indicates a separate wall or roof construction.

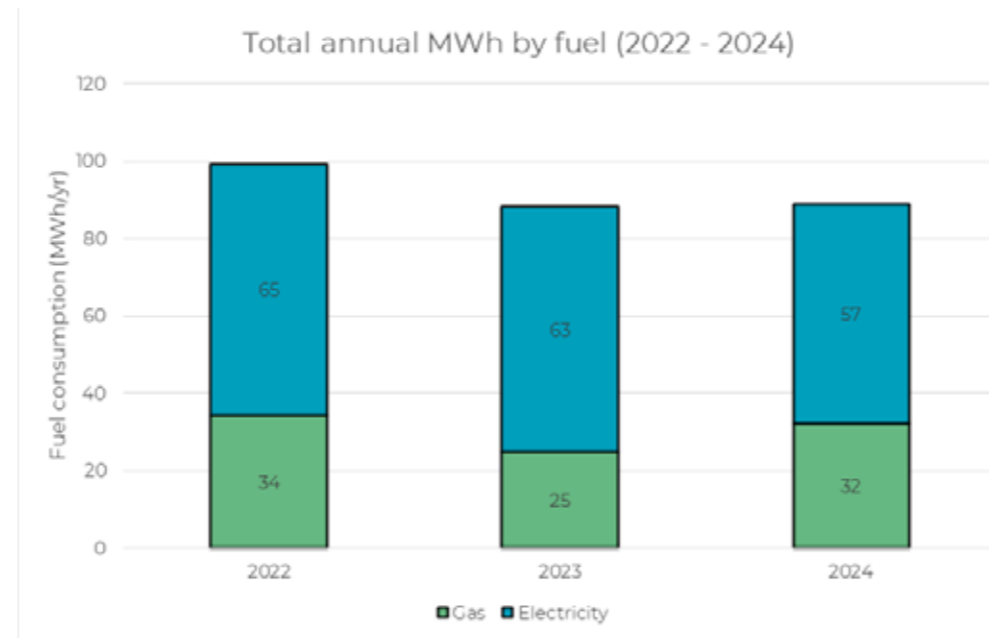
Total annual energy consumption by fuel in MWh based on 2022-2024 meter readings

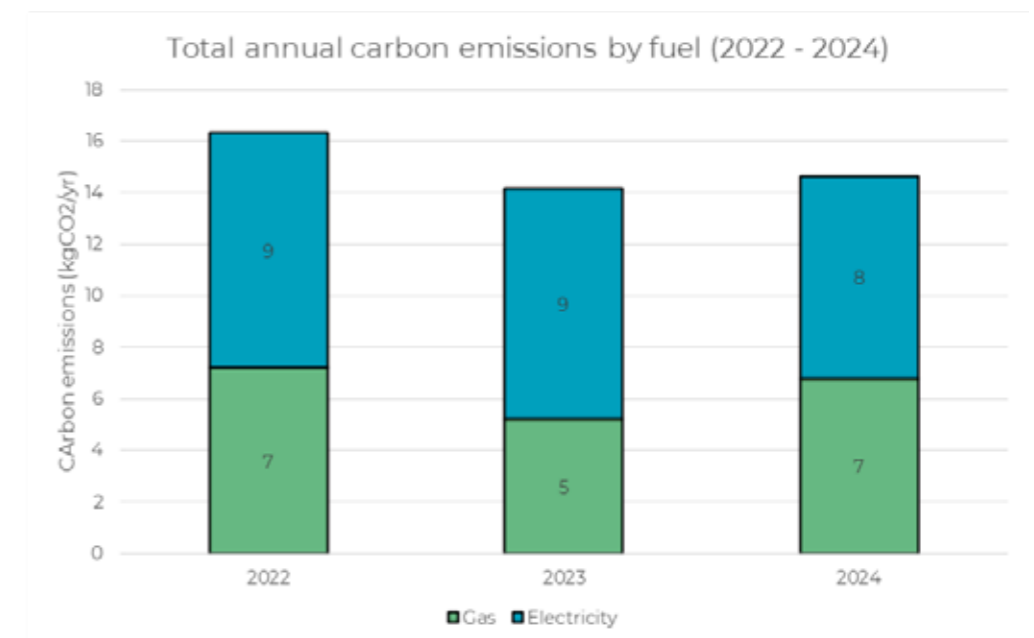
Total annual carbon emissions by fuel in tCO<sub>2</sub> based on meter readings from 2022-2024

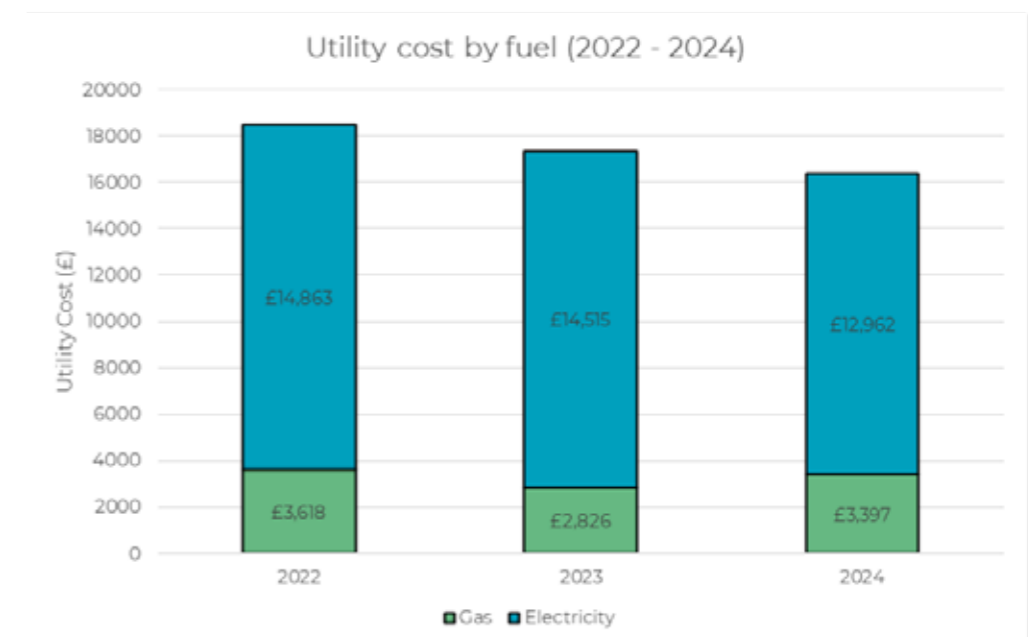
Total annual cost by fuel in £ based on current energy rates excluding standing charges

- Total annual cost has decreased consistently for the past three years
- 2023 had the lowest gas cost out of all the collected data.

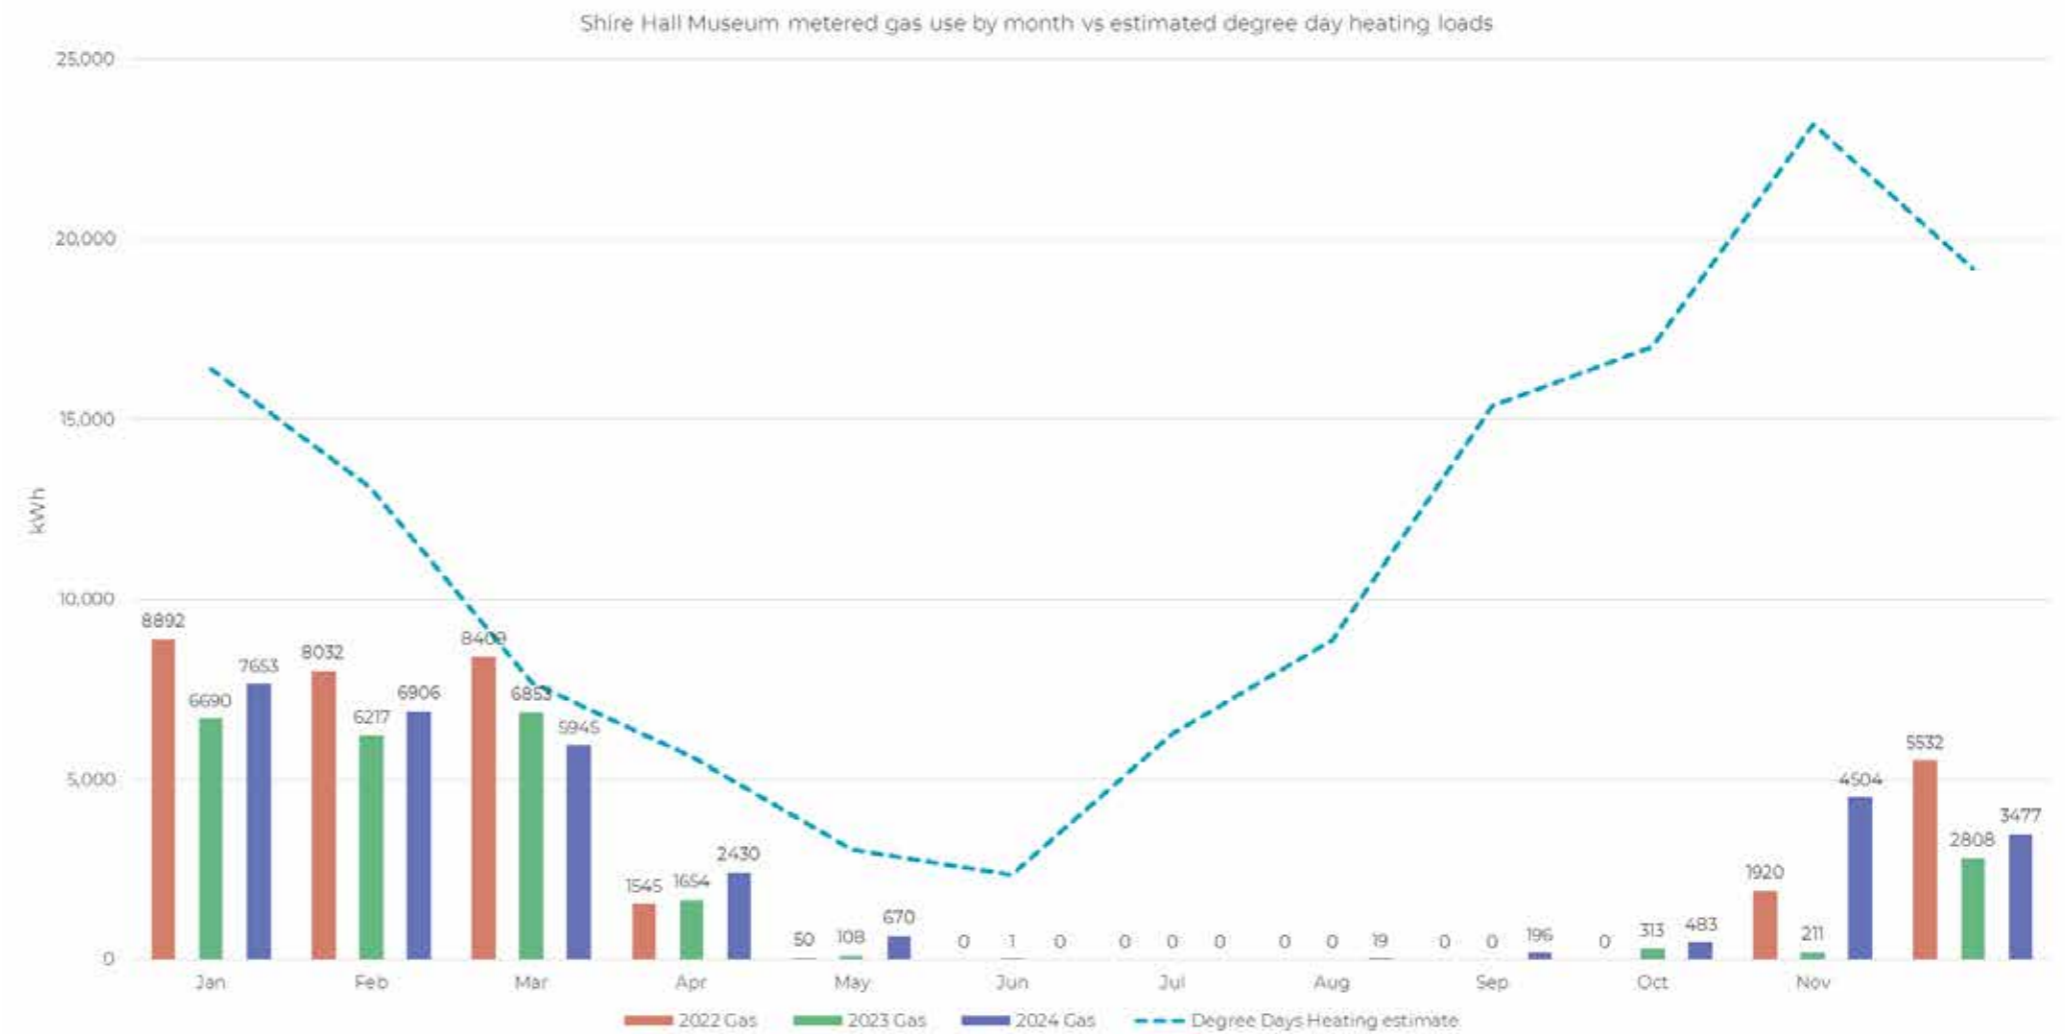
Shire Hall Museum metered gas use per month (kWh) in the period Jan 2022-Dec 2024 with comparison between 2022, 2023 and 2024. Plotted against the estimated monthly heating loads based on Heating Degree Days for Bournemouth with a base temperature of 17.5°C.

- The monthly heating usage is greatly below the estimated requirement to keep spaces comfortable. This is likely due to the building not being heated up to the standard comfort temperatures as have been used in the calculations.
- The monthly gas consumption appears to follow a seasonal profile tracking the shape of the heating degree days estimates, albeit significantly reduced.
- January through to March has the highest monthly consumption each year
- The consumption was 0 across June - September for most years showing the heating was off for these summer months.

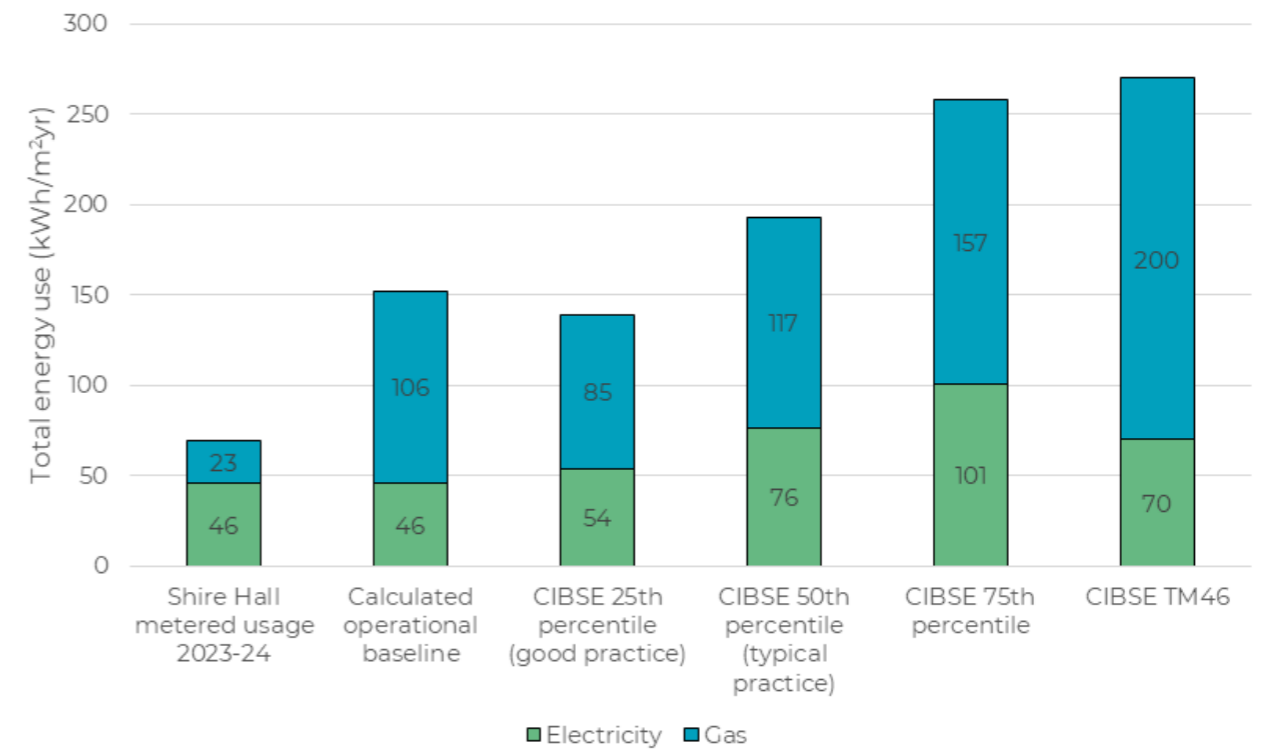
Annual energy use intensities (kWh/m<sup>2</sup>yr) comparison between the Shire Hall Museum metered usage 2022-24, the calculated operational baseline, CIBSE museum benchmarks by percentile, and CIBSE TM46 benchmark.

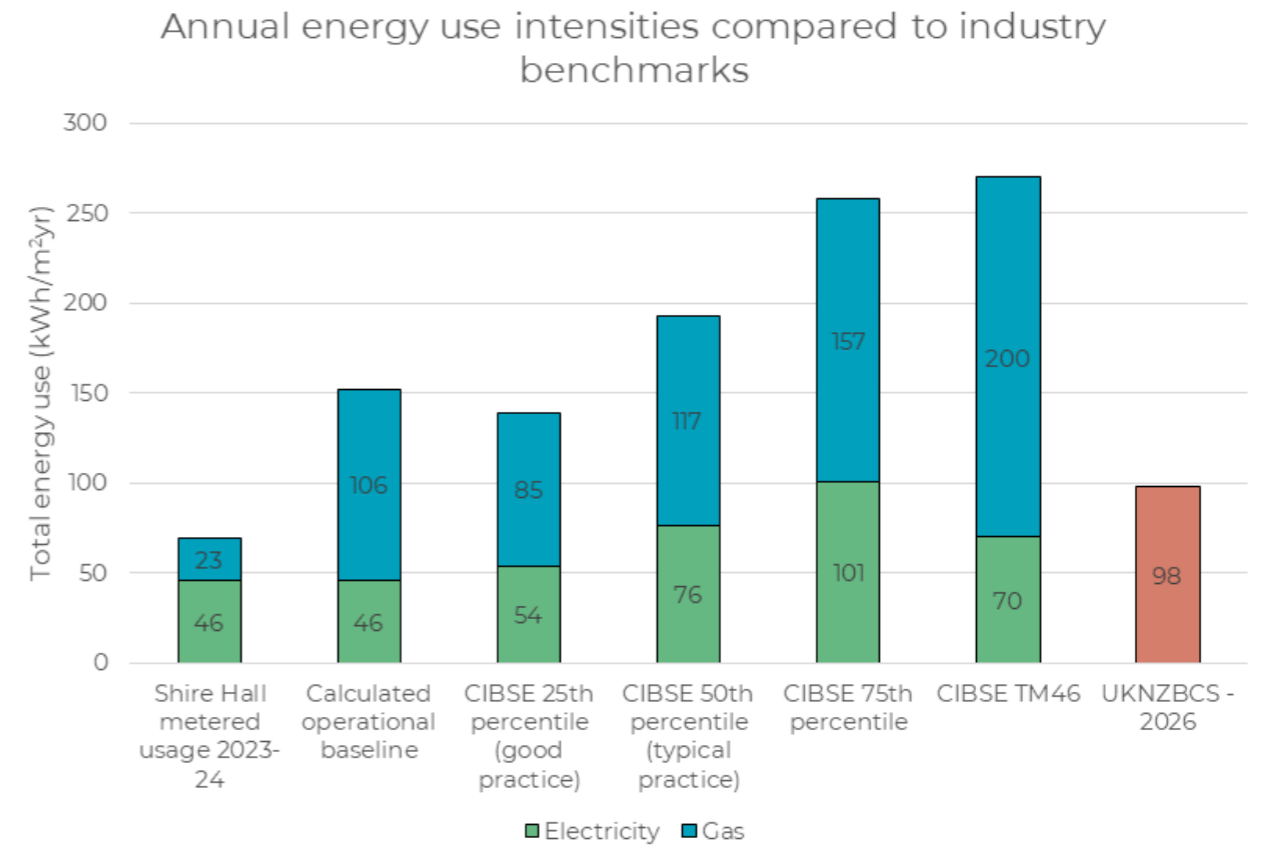
Annual energy use intensities (kWh/m<sup>2</sup>yr) comparison between Shire Hall metered usage 2022-24, the calculated operational baseline, CIBSE benchmarks and the UKNZCBS

- The metered data is already significantly below the target for total energy usage.
- Changing the heating system to an electric system, ideally a heat pump, and ensuring all electricity is purchased through a renewable only tariff, the building could meet the net zero definitions. However, this would likely go up if typical comfort conditions were met, as discussed above.
- The calculated operational baseline requires a 36% overall energy reduction to align with the UKNZCBS target. Again, changing to a heat pump would provide this.
- The gas consumption makes up for the largest proportion of the estimated emissions. Reducing heat load and changing to a heat pump would be areas to focus on.

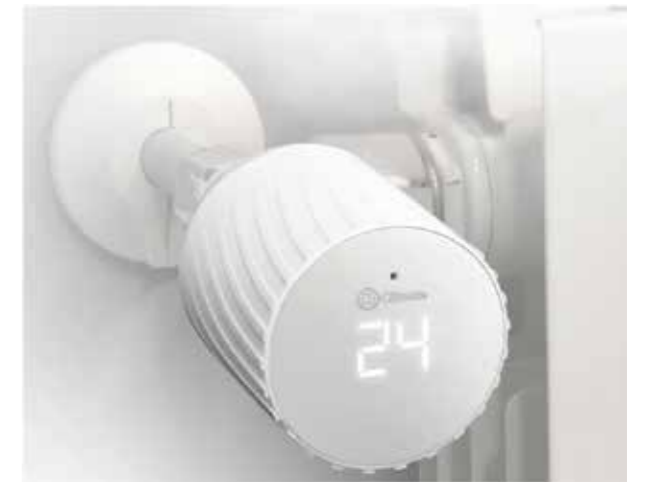
MClimate Vicki LoraWAN TRV

The use of LoRaWAN smart radiator valves would be a potential way to improve the control on individual radiators and allow for a centralised programmable system. This could allow the museum to begin using occupancy-based heating or limit heating overnight whilst ensuring the building is appropriately heated before opening. This avoids the need for changes to the pipework.

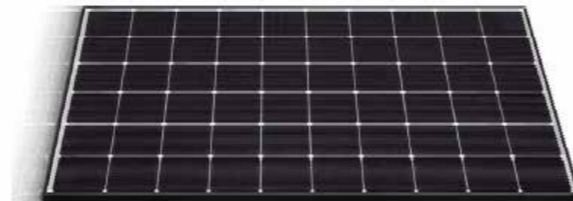
SunPower Maxeon 3 solar panel

A PV installation of 54 panels as such would generate 21 MWhs annually – over 1/3 of Shire Hall’s annual electricity usage. This would reduce the museum’s carbon emissions by 2.7 tCO<sub>2</sub> per year.

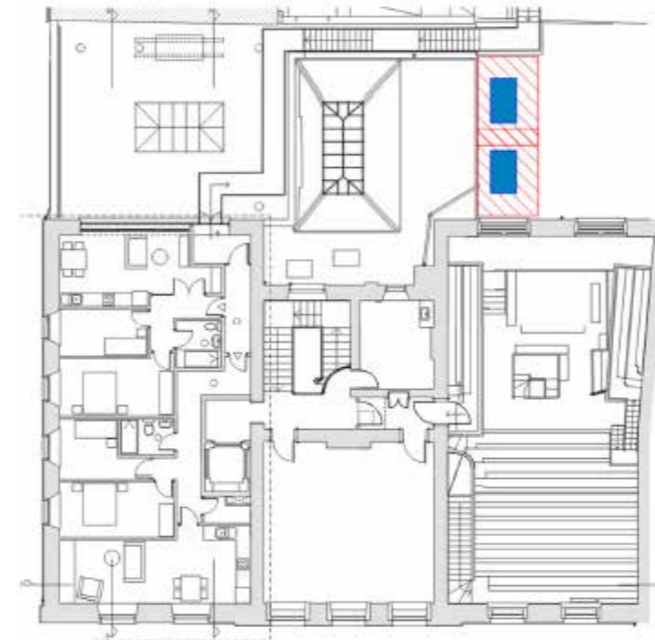
Indicative location of 2No. Clade ACER 65/50 Low Noise ASHPs

- 2No. ASHPs would result in additional electrical load of approximately 40kW, which may increase site loading beyond existing electrical capacity. Electrical infrastructure upgrades may be required and would be reviewed if this option were proposed.
- Noise to sensitive areas would need to be checked.
- Heat emitter outputs to be checked – heat emitters may require upgrade
- Heritage implications of external heat pumps
- Structural implications of heat pumps on roof
- Large buffer vessels required

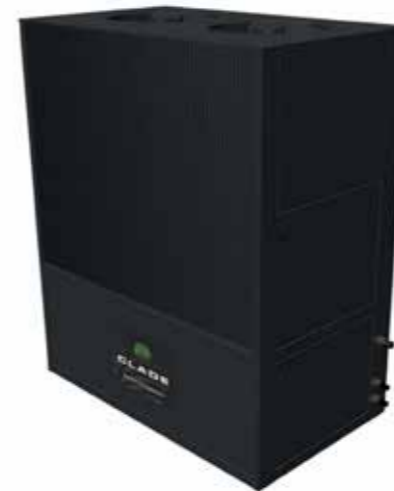
Clade ACER 65/50 Low Noise

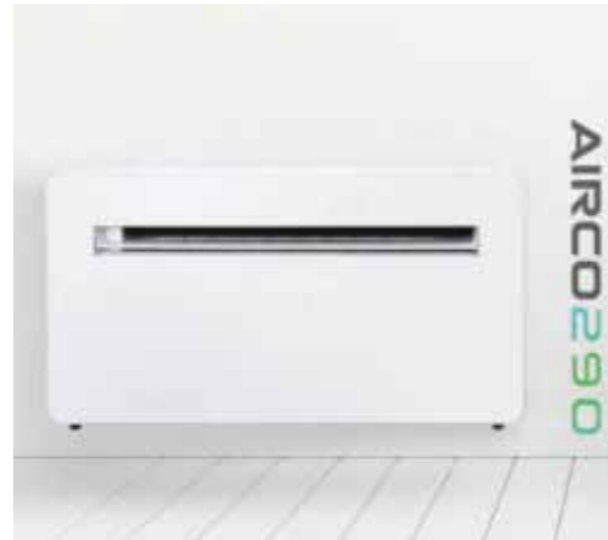
Powmatic AIRCO290 packaged wall-mounted twin duct heat pump

This technology could be a good method of reducing the buildings carbon emissions however alternative strategies will be required for other spaces of the museum.

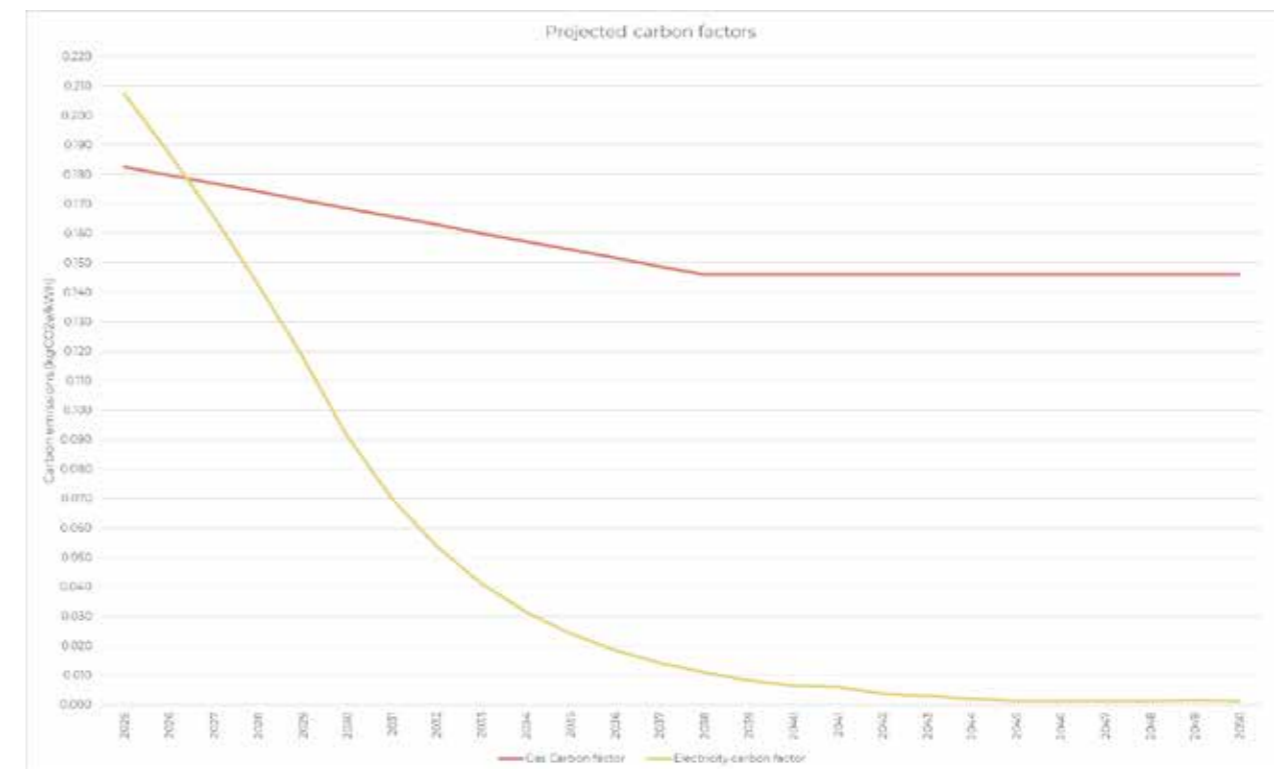
Graph showing predicted future carbon factors for gas and electricity
