## Thermal Imaging Survey Report

1703 – Decarbonisation of Cultural Heritage Buildings : Royal Theatre, Northampton

Revision 1.0 - 07.03.2025 - For Information

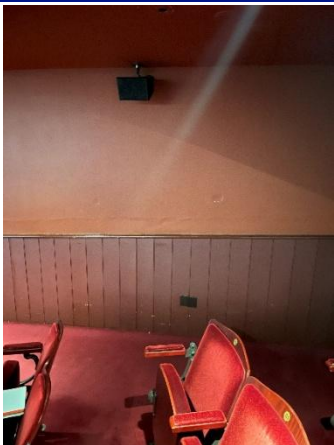
| Location | Reference photo | Thermal image | Notes |
|---|---|---|---|
| Royal –<br>auditorium<br>stalls right | | | The interior wall appears to be uniformly relatively warm indicating limited heat loss (owing to buffer space on the other side) |

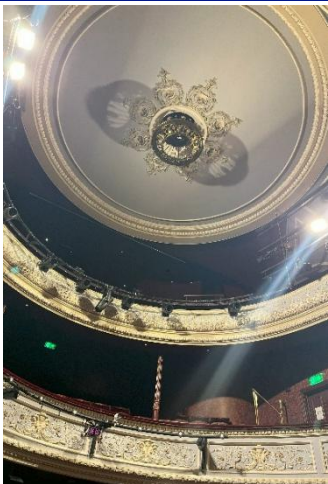
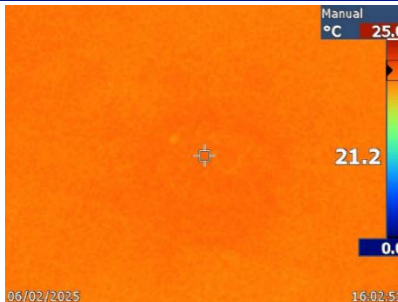
| Location | Reference photo | Thermal image | Notes |
|---|---|---|---|
| Royal –<br>auditorium<br>ceiling | | | The ceiling to be uniformly relatively warm indicating limited heat loss owing to understood presence of insulation in the void above |

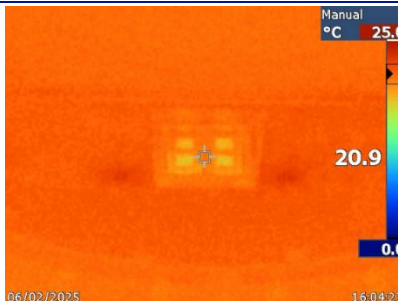
| Location | Reference photo | Thermal image | Notes |
|---|---|---|---|
| Royal –<br>auditorium<br>gallery rear | | | The rear wall is appears to be uniformly relatively warm owing to buffer spaces behind, although heat loss through the rear gallery vent is noted |

- Direct heat loss from the Royal auditorium area appears to be relatively low. This is mitigated by the surrounding lobbies, apparent insulation to the roof void and general limited glazing/vents. High heat loss is evident through the vent to the rear of the gallery and its associated housing.

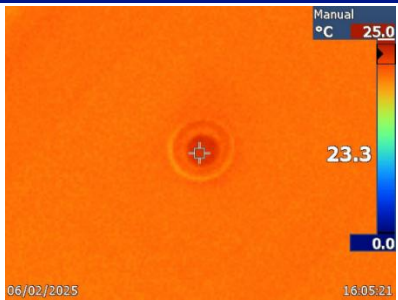
| Location | Reference photo | Thermal image | Notes |
|---|---|---|---|
| Royal – supply grille above stage | | <p>Thermal image showing a warm spot (23.3°C) at the supply grille above the stage. The ceiling is uniformly relatively warm. A color scale on the right indicates temperatures from 0.0 to 25.0°C. The date 06/02/2025 and time 16:05:21 are visible at the bottom.</p> | The ceiling to be uniformly relatively warm (as notes above). A warm spot of about 23-24oC is noted where supply air is entering the auditorium |

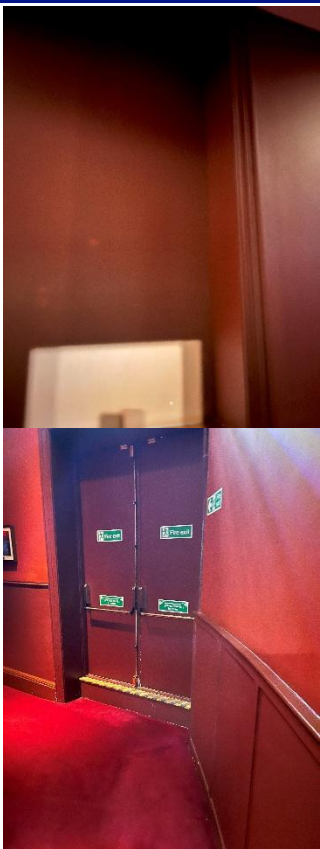
| Location | Reference photo | Thermal image | Notes |
|---|---|---|---|
| Royal – lobby outside auditorium circle right | | | Heat loss is noted through the door to the lobby, particularly around cracks |

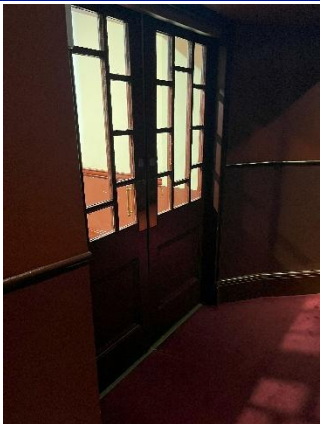
| Location | Reference photo | Thermal image | Notes |
|---|---|---|---|
| Royal – door to old main entrance foyer | | | Heat loss is noted through the door to the lobby, particularly around cracks |

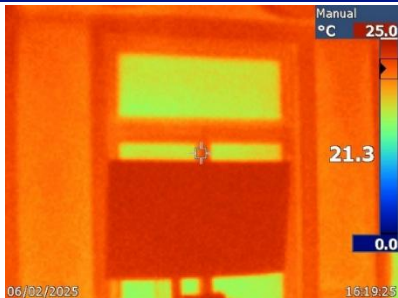
| Location | Reference photo | Thermal image | Notes |
|---|---|---|---|
| Crown Room (above old main entrance) | | | The wall is relatively warm and heat loss through the glazing (which appears to be double glazed) is relatively low |

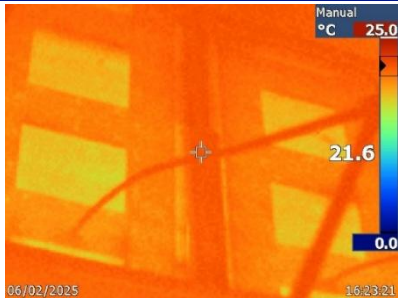
| Location | Reference photo | Thermal image | Notes |
|---|---|---|---|
| Royal –<br>auditorium<br>gallery rear<br>vent grille | | | Heat loss is apparent<br>through the rear vent<br>grille |

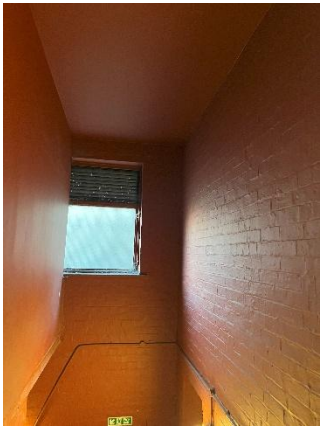
| Location | Reference photo | Thermal image | Notes |
|---|---|---|---|
| Royal –<br>auditorium<br>gallery right<br>rear stair (2) | | | Heat loss is apparent<br>through the single glazed<br>window and, to a lesser<br>extent, the external wall.<br>The wall adjoining the<br>foyer appears to be<br>warmer. |

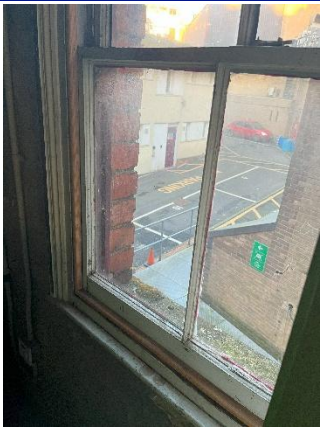
| Location | Reference photo | Thermal image | Notes |
|---|---|---|---|
| Royal – old box office | | | Heat loss is apparent through the single glazing and frame |

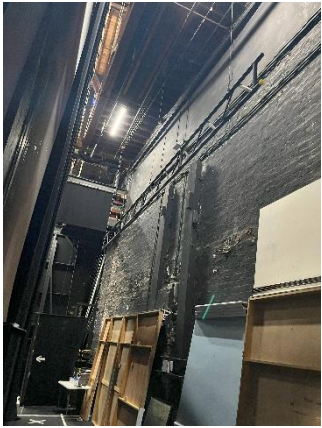
| Location | Reference photo | Thermal image | Notes |
|---|---|---|---|
| Royal – stage house rear wall | | | Similarly, overall the stagehouse appears to be warm although cold spots are apparent, particularly higher up |

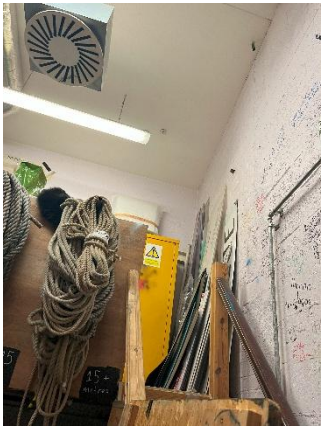
| Location | Reference photo | Thermal image | Notes |
|---|---|---|---|
| Prop store – rear and sides | | | The walls of the prop store are relatively cool and heat loss is apparent through glazed elements, although this space may generally be at a cooler temperature than occupied spaces. |

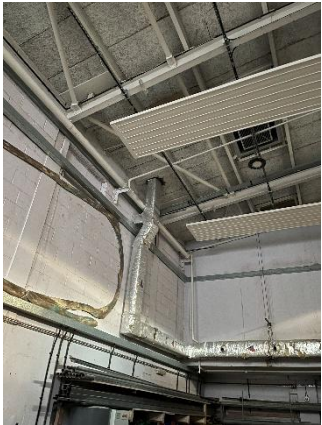
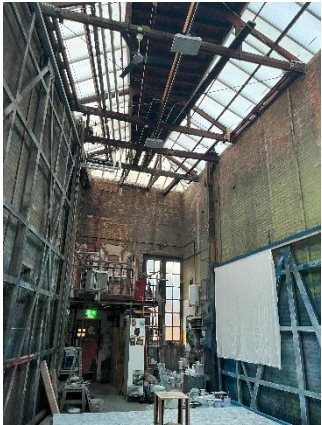
| Location | Reference photo | Thermal image | Notes |
|---|---|---|---|
| Paint spray frame room | <br> | <br> | Generally the walls and exposed structure were relatively warm, possibly owing to heating and solar heat gains during the day |

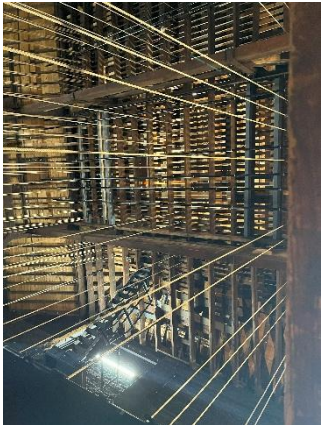
| Location | Reference photo | Thermal image | Notes |
|---|---|---|---|
| Royal – stagehouse fly gallery | | | As per image above, overall the stagehouse appears to be warm although some heat loss is apparent higher up towards the roof |

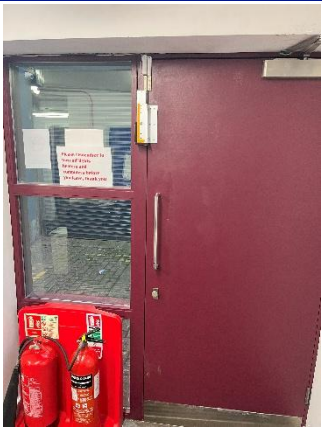
| Location | Reference photo | Thermal image | Notes |
|---|---|---|---|
| Royal – stage door | | | Heat loss is apparent around the edge of the door and the glazing. Overall heat loss through the door and glazing is relatively low |

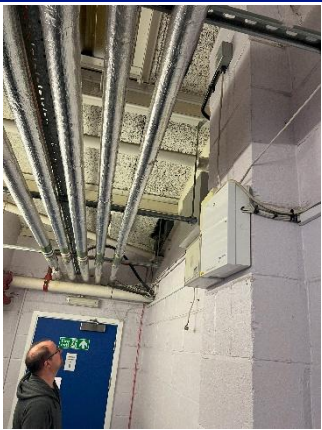
| Location | Reference photo | Thermal image | Notes |
|---|---|---|---|
| Back of house office corridor | | | Overall the roof is relatively cool indicating heat loss. Particularly high heat loss is apparent via the unsealed penetration |

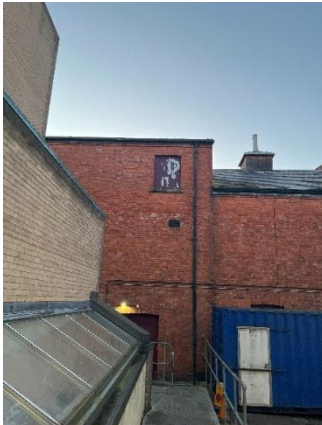
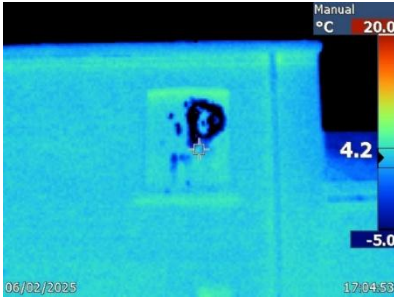
| Location | Reference photo | Thermal image | Notes |
|---|---|---|---|
| Royal – east façade (southern section) | | | The façade is slightly warm, indicating some heat loss, particularly around the existing window and roof junction (also noted on the internal gallery wall photo) |

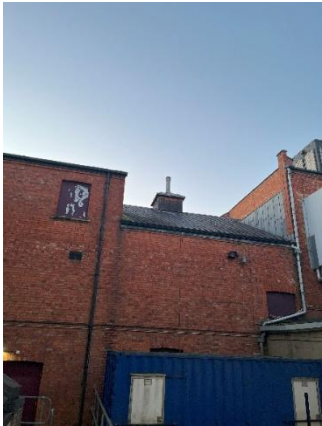
| Location | Reference photo | Thermal image | Notes |
|---|---|---|---|
| Royal – east façade (north section and auditorium roof cupola) | | | Overall the façade is slightly warm indicating some heat loss.<br><br>The cupola is also relatively warm, although not significantly so given its construction; this is likely assisted by insulation in the loft space |

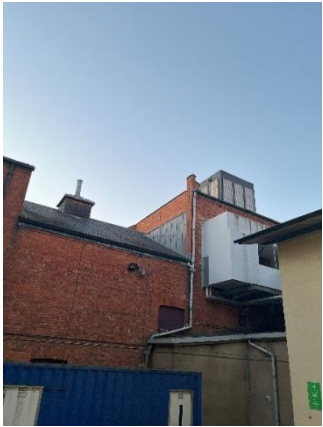
| Location | Reference photo | Thermal image | Notes |
|---|---|---|---|
| Royal - stagehouse | | <br>06/02/2025 17:07:04 | The wall at the top of the stage house appears relatively warm, possibly owing to heat accumulation at the top. This wall will likely have also been in sunshine during the day however |

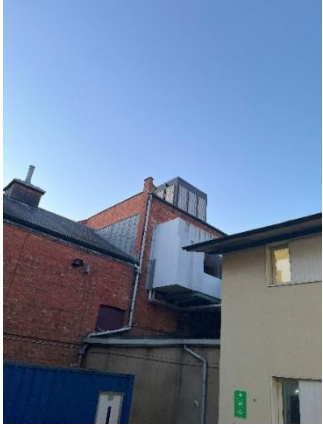
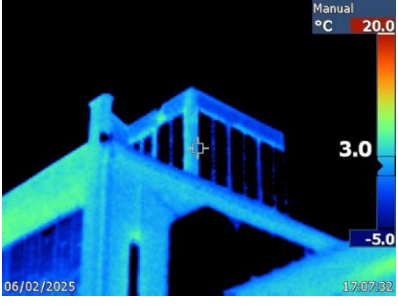
| Location | Reference photo | Thermal image | Notes |
|---|---|---|---|
| Royal - stagehouse | | <br>06/02/2025 17:07:32 | Observations for the stagehouse smoke vent are inconclusive as the metal louvre blades appear to be reflecting the (cool) sky |

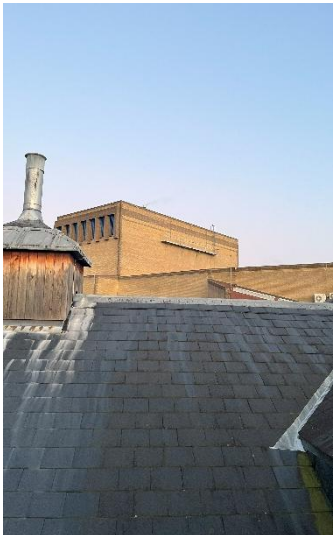
| Location | Reference photo | Thermal image | Notes |
|---|---|---|---|
| Derngate – stage house | | | Heat loss is apparent through the smoke vents on the side. This is particularly high for one vent, although this was understood to be owing to damage that was subsequently repaired.<br><br>The stagehouse south wall appears warm but this is likely owing to sunshine during the day |

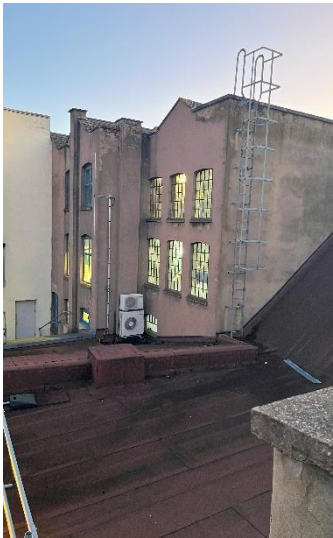
| Location | Reference photo | Thermal image | Notes |
|---|---|---|---|
| Admin building | | | Overall the façade is relatively cool although heat loss noted through the glazing |

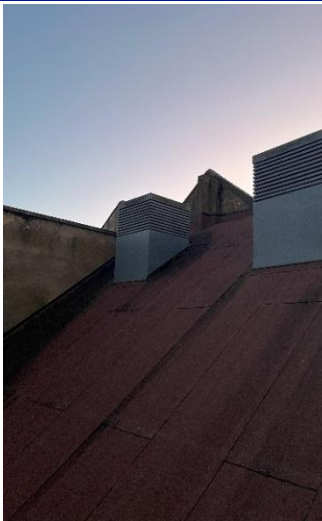
| Location | Reference photo | Thermal image | Notes |
|---|---|---|---|
| Rehearsal studio roof and vents | A photograph showing a dark, sloped roof with several white, rectangular ventilation units or vents protruding from it. The sky is a pale blue, suggesting dusk or dawn. | A thermal image of the same roof area. The roof surface is predominantly blue, indicating it is relatively cool. A color scale on the right shows a range from -5.0 to 20.0 °C, with a current reading of 1.2 °C. The date 06/02/2025 and time 17:19:44 are visible in the bottom left corner. | Overall the roof and vents appear to be relatively cool, although this could be an effect of sky reflection |
