Heat Pumps in Historic Buildings

Air Source Heat Pump Case Studies – Large Buildings

This report is a continuation of the previous study '[HEAG0316: Heat Pumps in Historic Buildings, Air Source Heat Pump Case Studies – Small-scale Buildings](#)', and focuses on five large historic buildings across 4 sites. In 2022, we commissioned environmental building services engineers, Max Fordham LLP to review the performance of ASHPs in larger historic buildings. The research aligns directly with Historic England's climate change and sustainability objectives.

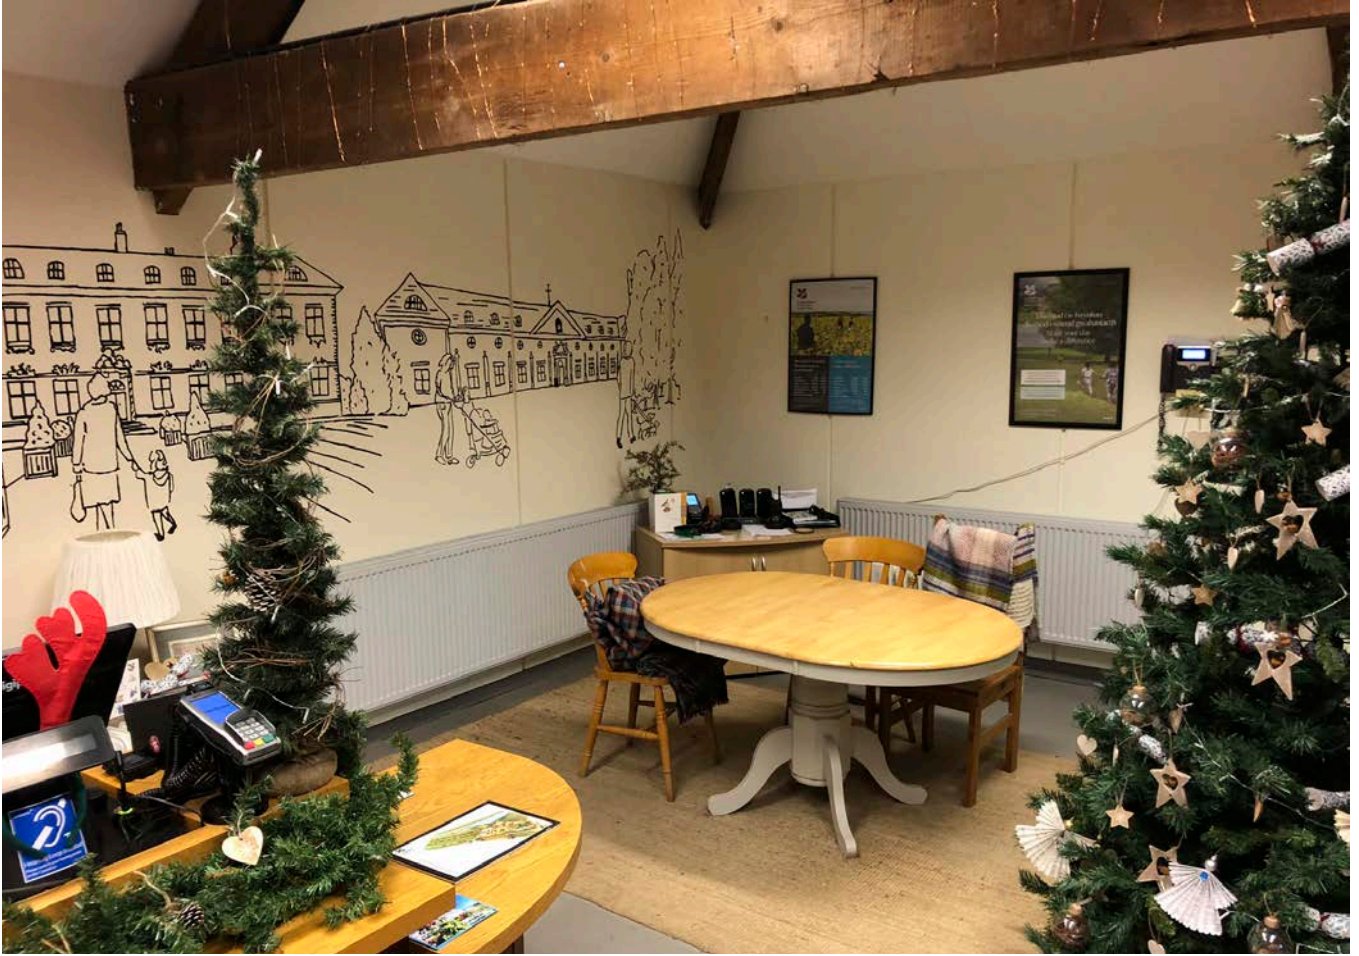
Figure 3: Reception interior.

- Doors are fully open during opening hours.
- The heating system comprises an ASHP, delivering heat via radiators. Radiators provide most of their heat by convection, meaning they warm the air in the space.
- Any warm air produced by the radiators is quickly lost to the outside, and so provides little comfort to the occupants.
- Staff use portable electric heaters to supplement the heating system.
- It is likely that a comfortable temperature for staff will only be achieved using this heating system if action is taken to reduce the high infiltration rate, for example by installing an automatic sliding door.

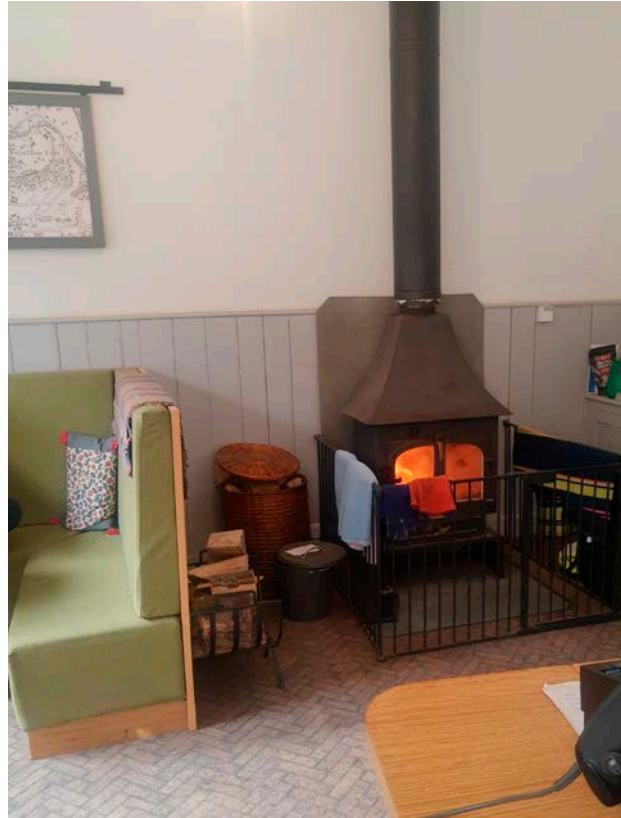
Figure 4: Reception interior.

- Entrance and exit doors to the reception area are automatic sliding doors. They provide easy access and keep out the cold when closed.
- An ASHP delivering heat via radiators was proposed for this space. However, the system was never installed. Concerns were raised that it would not provide enough warmth because of the high infiltration rate associated with a busy reception area.

- A radiant heat source in the form of a wood-burning stove provides thermal comfort to staff behind the reception desk. Such stoves emit most of their heat as infrared radiation, which allows the heat to be transferred directly from the stove to the person. Radiant heat sources are less susceptible to high infiltration rates because they are not attempting to heat the air directly.

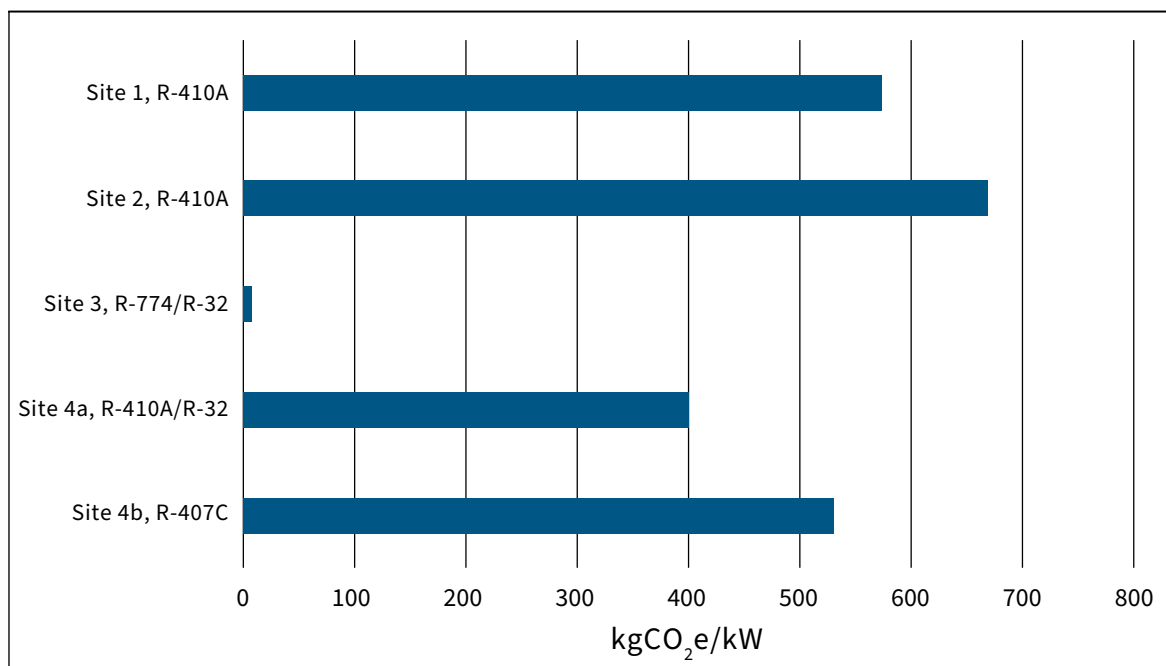
Figure 5: Total refrigerant leakage emissions per kW of installed system output.

Selecting an ASHP with a low GWP refrigerant is essential for minimising the system's emissions. Figure 5 shows the full leakage emissions and system output for each of the ASHPs in this report, based on the GWP of the system refrigerant. It does not account for the embodied carbon that is emitted during the manufacturing of the refrigerant.

Site 3 stands out because the full leakage emissions are extremely low, despite the system output being around 70 times greater than a typical domestic heating system. This is because the ASHP uses R-744, which is a CO₂ refrigerant with a low GWP of 1.

System designers should select a low GWP refrigerant ASHP to minimise the equivalent emissions in the event of a leak. Furthermore, a key goal of Fluorinated gas (F-gas) regulations is to phase down using refrigerants that have significant GWP when released into the atmosphere, such as R-410A. These high GWP refrigerants will, therefore, have a more constrained supply, meaning the price is likely to rise significantly. This is important because it means that the costs of repairing R-410A ASHPs will likely increase. R-32 has a much lower GWP than R-410A, and so is less likely to be limited in the short term. However, R-32 is likely to be a target of future F-gas phasedowns. Selecting a low GWP refrigerant will

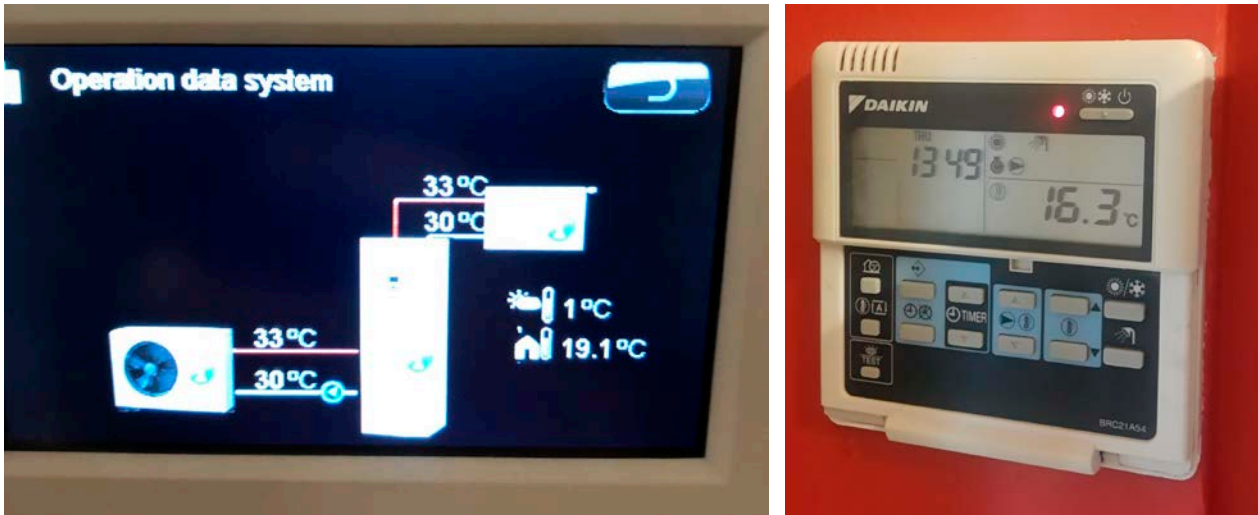
Figure 6 (left): Site 4b controller. Figure 7 (right): Site 1 controller.

Conversely, at Sites 4a and 4b, the users were enthusiastic about their ASHP systems and were eager to use the ASHPs correctly and get the most out of them. Particularly at Site 4b, the tenant showed a detailed understanding of the system controls and was able to improve efficiency by minimising flow temperatures (with weather compensation) and reducing cycling. The touchscreen controller at Site 4b (Figure 6) was far more intuitive than the older Daikin controller at Site 1 (Figure 7).

Clients should request that installers provide an in-person demonstration of the system's controls, including basic functions such as adjusting weather compensation and domestic hot water storage temperatures. Instructions should also be available in simple written form to ensure that knowledge of how to operate the system is not lost when the end user changes. Leaving the user with a pile of manuals is not sufficient. When the end user understands how the ASHP works and how to adjust basic settings, it creates a greater sense of ownership over the whole system. As a result, they are more likely to get optimal performance.

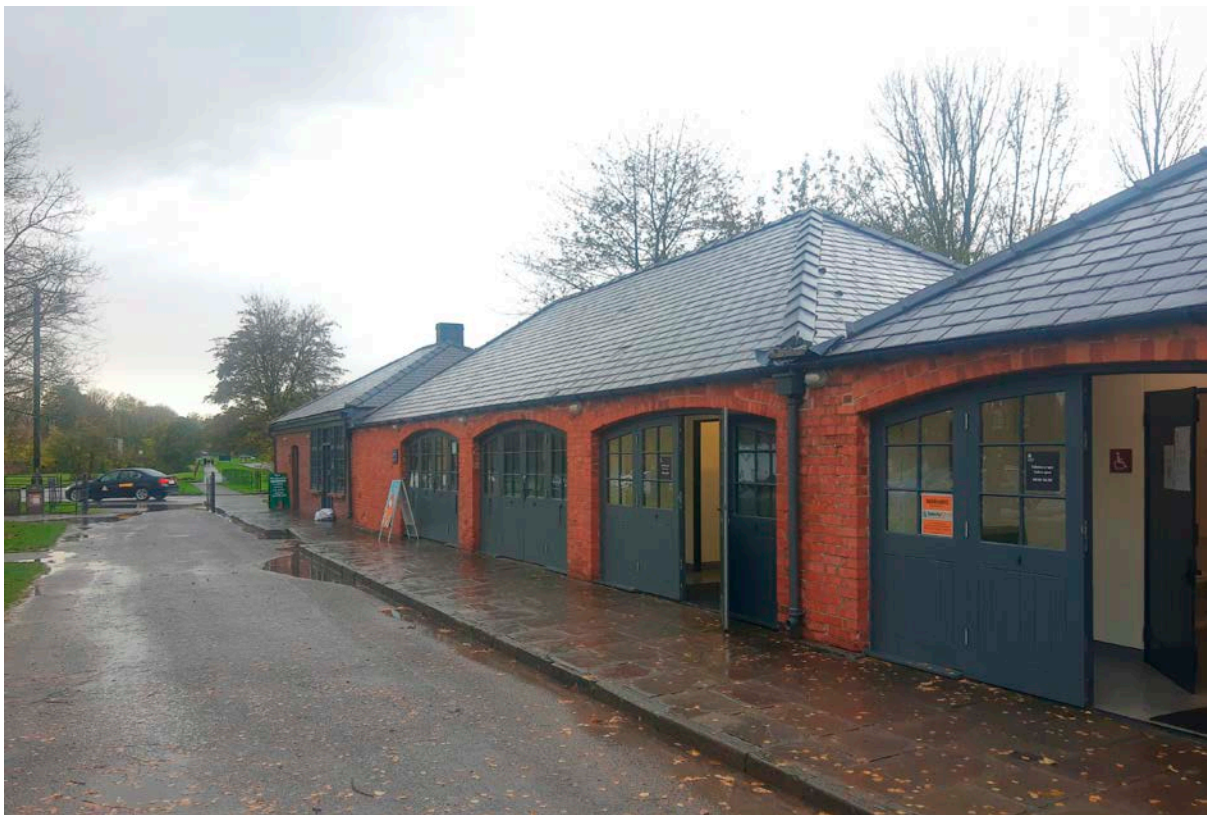
Figure 9: Site 1.

The workshops use two air-to-water ASHPs, consisting of separate pairs of outdoor and indoor units. The two ASHPs are isolated systems that serve different parts of the building. The installation also includes a 260-litre hot water cylinder. The ASHPs were installed as part of the renovation work to turn the agricultural buildings into a visitor centre and office space. As well as the ASHPs, additional insulation and a new radiator system were installed in the visitor centre.

The two ASHPs are used to heat the building and to provide domestic hot water to sinks in the bathroom and the office next to the plant room. Additional sinks elsewhere in the building have hot water provided by point of use heaters. The ASHPs and hot water cylinder are manufactured by Daikin.

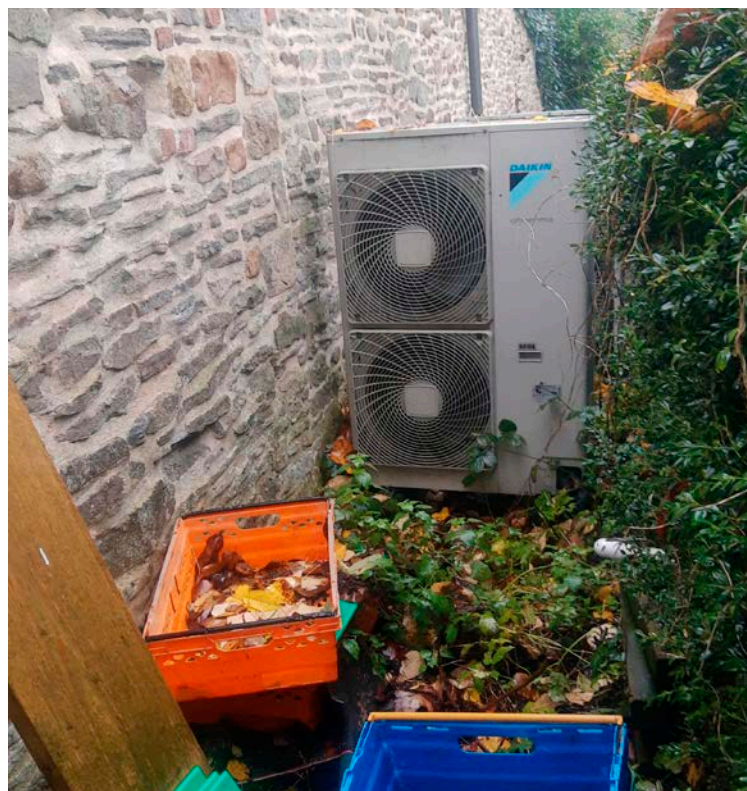
Figure 10: ASHP at the rear of Site 1 workshops.

To reduce the visual impact of external ASHP units, it is common to install them away from well-used areas and behind obstacles. This can affect their efficiency, either due to limited airflow or extended external pipe runs. It can also cause issues with maintenance if the ASHP is placed too close to an obstruction and there is not enough room to safely work on it. During the site visit, it was clear that it was difficult to access the ASHPs. There was no clear pathway to reach them, and there was a lack of space around them to carry out maintenance (Figure 10).

When ASHPs are out of view, the area around them is often overlooked during general building maintenance checks. This can lead to a build-up of leaves and rubbish, as well as plants growing over the units. As a result, air inlets can become clogged and block the airflow.

All these maintenance issues were observed during the site visit.

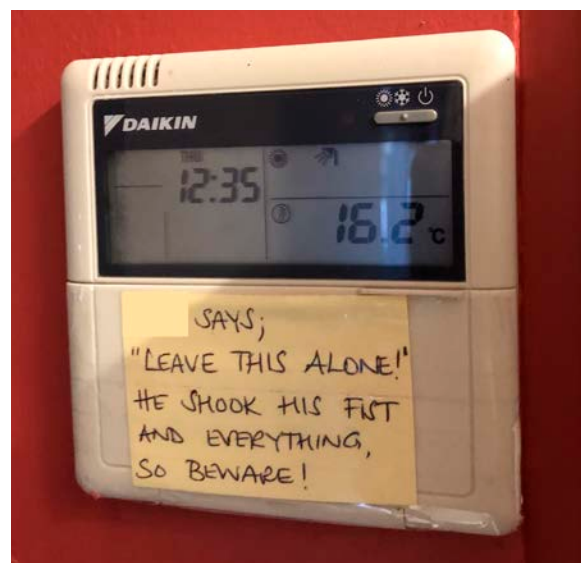
Figure 11: ASHP controller.

The facilities manager and site staff had limited knowledge of how to use the heating controls. The older generation Daikin controller was not intuitive and required close reference to a manual. This reduced the efficiency of the heating system because key parameters, such as temperature difference, target temperatures and run times, were not optimised. Installers should provide comprehensive instructions on how to control the heating and domestic hot water system as an essential part of the handover process.

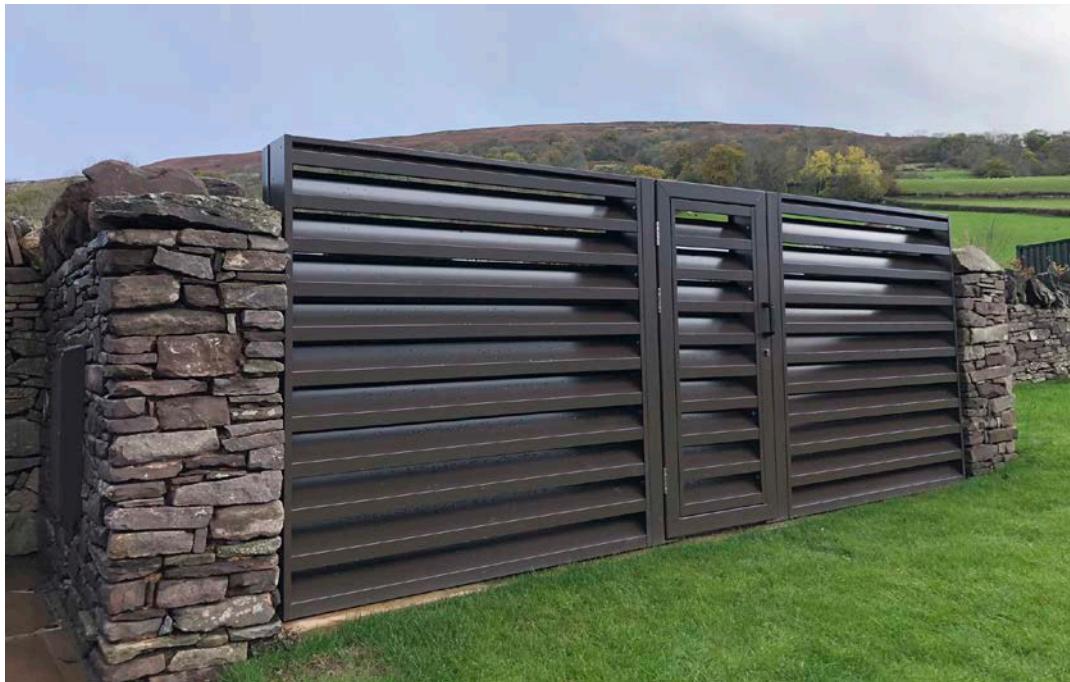
Figure 13: ASHP enclosure at Site 2.

Vaillant state that the sound power level (a measure of the acoustic energy) of the ASHP when tested to international standards is 65dB(A). With no barrier, this relates to a sound pressure level of 47dB(A) at a distance of 5m from the ASHP. The combined sound pressure level of both ASHPs is 50dB(A). For reference, a normal conversation being held at a distance

of 1m has a sound pressure level of 60dB(A) (<https://svantek.com/academy/sound-pressure-level-spl/>), twice as loud as the combined sound pressure level of both ASHPs at a distance of 5m. Even without an acoustic enclosure, the noise from the ASHPs should have minimal impact on people using the adjacent picnic area.

An acoustic enclosure reduces the noise and visual impacts of an ASHP, but a cost-benefit analysis needs to be done before installing one. This should consider both the upfront cost of the enclosure and the enclosure's effect on the performance of the ASHP, as discussed above.

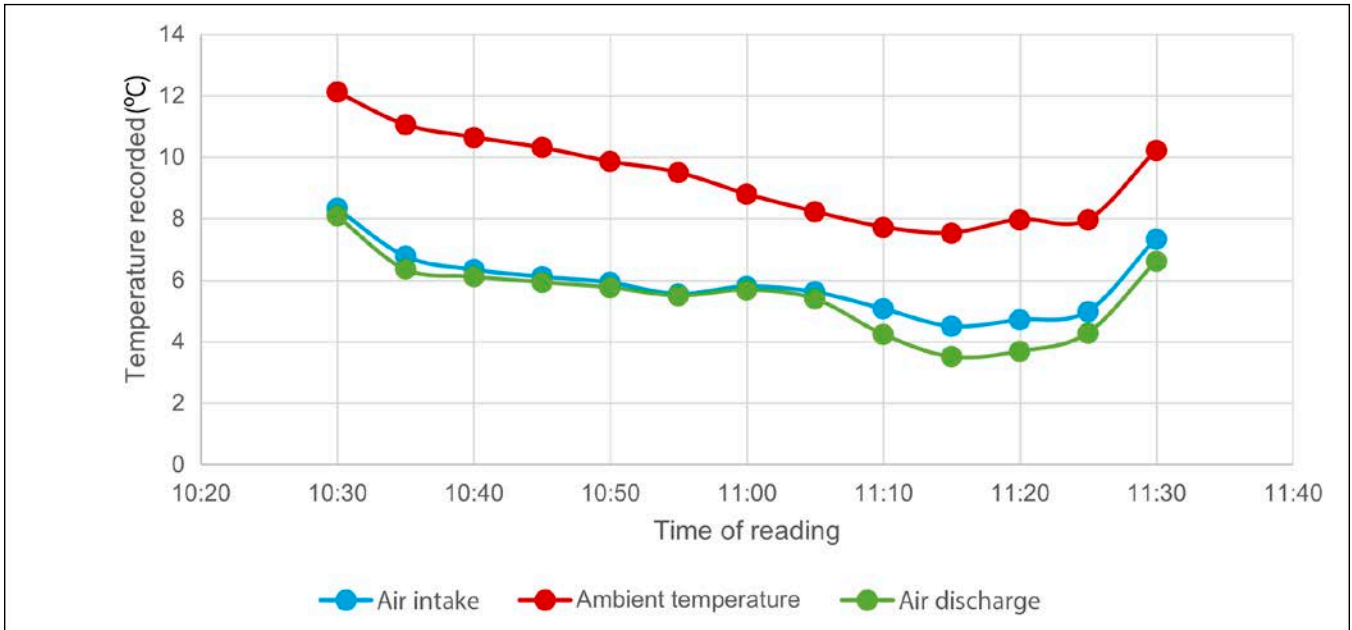
Figure 14: Recorded temperature readings taken at the intake and outlet of the ASHP and the ambient air temperature.

During the site visit, temperature loggers were placed by the air intake and exhaust areas of the external ASHP units. An additional sensor was placed further away from the unit to record the ambient temperature. The results from these loggers are shown in Figure 14.

The data show that the temperature of the discharge air from the ASHP was lower than the ambient air temperature, as expected. The data also show that the air temperature by the intake was on average more than 3°C lower than the ambient air temperature. The decrease in air intake temperature compared to ambient air temperature was assumed to be caused by the recirculation of air from the discharge, which, in turn, was likely caused by the enclosure. This temperature decrease reduced the efficiency of the ASHP and, therefore, increased running costs.

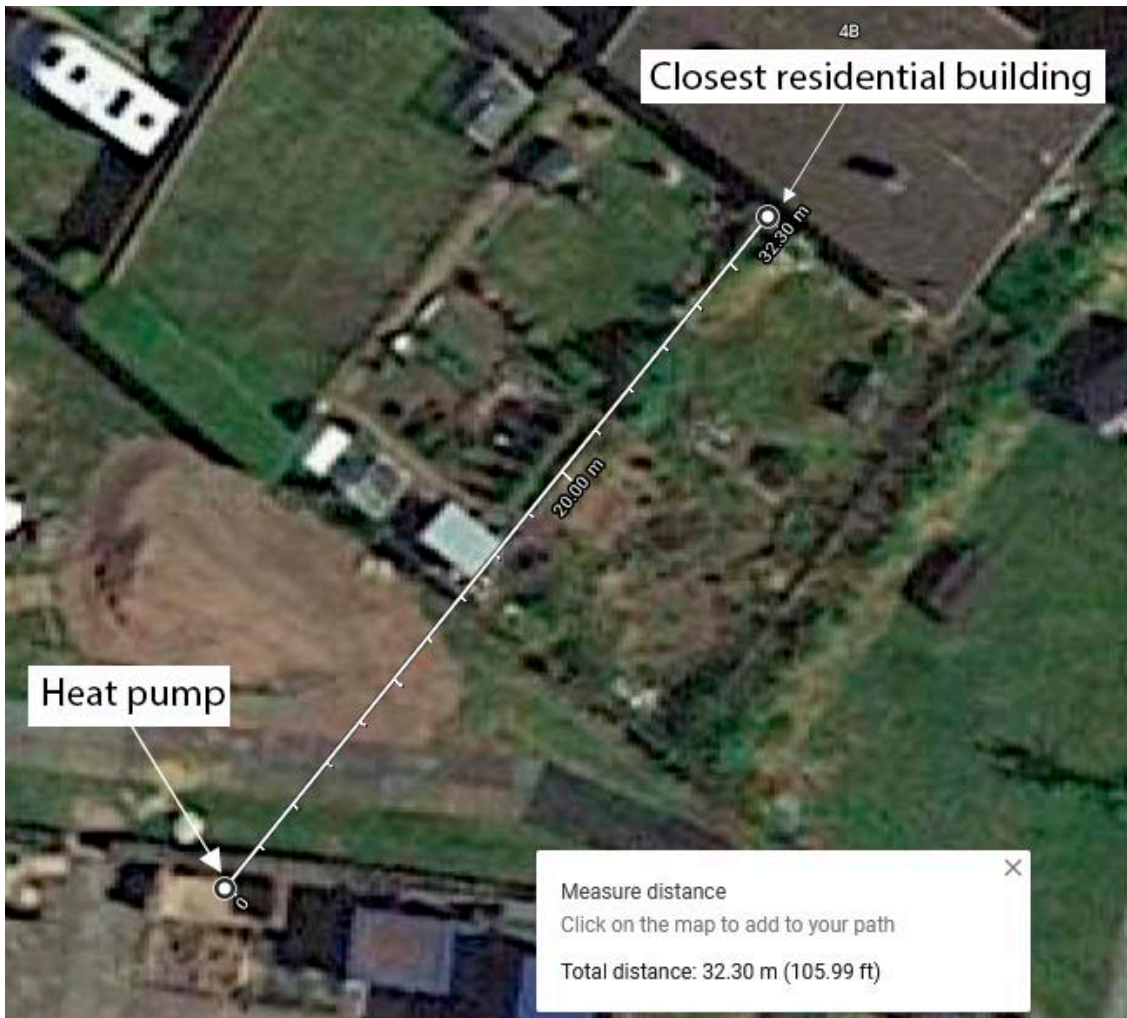
The distance between the external ASHP units and the closest building not associated with the site was approximately 30m, as shown in Figure 15. With no barrier, the calculated sound pressure level from the ASHPs at the closest noise-sensitive location was 34dB(A). With the acoustic enclosure in place, the sound pressure level was expected to be negligible.

Figure 15: A satellite view showing the distance between the ASHP enclosure and the nearest neighbour. Google Maps, Map data © 2025. Markup added by Historic England.

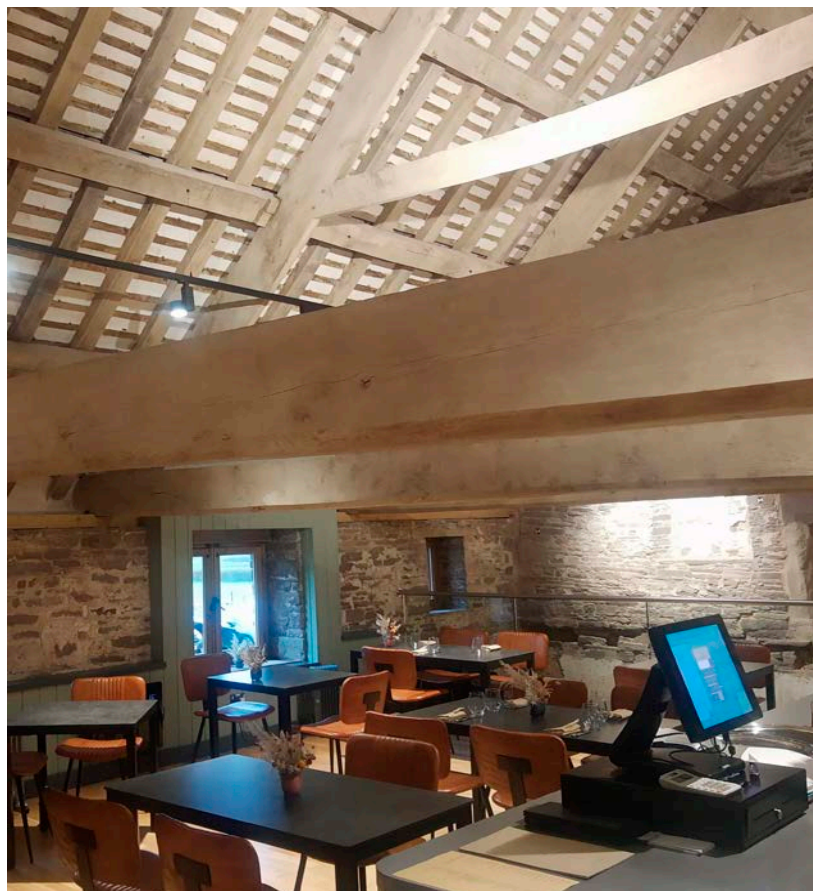
Figure 16: Restaurant at Site 2.

The low temperature difference and high flow rate that underfloor heating requires are ideal for obtaining optimal performance from ASHPs. During the project, the use of the first-floor space changed from a light cafe to a high-end restaurant (Figure 16). To improve the internal temperature, three 1.5kW direct electric panel heaters were installed, with another two in the lobby.

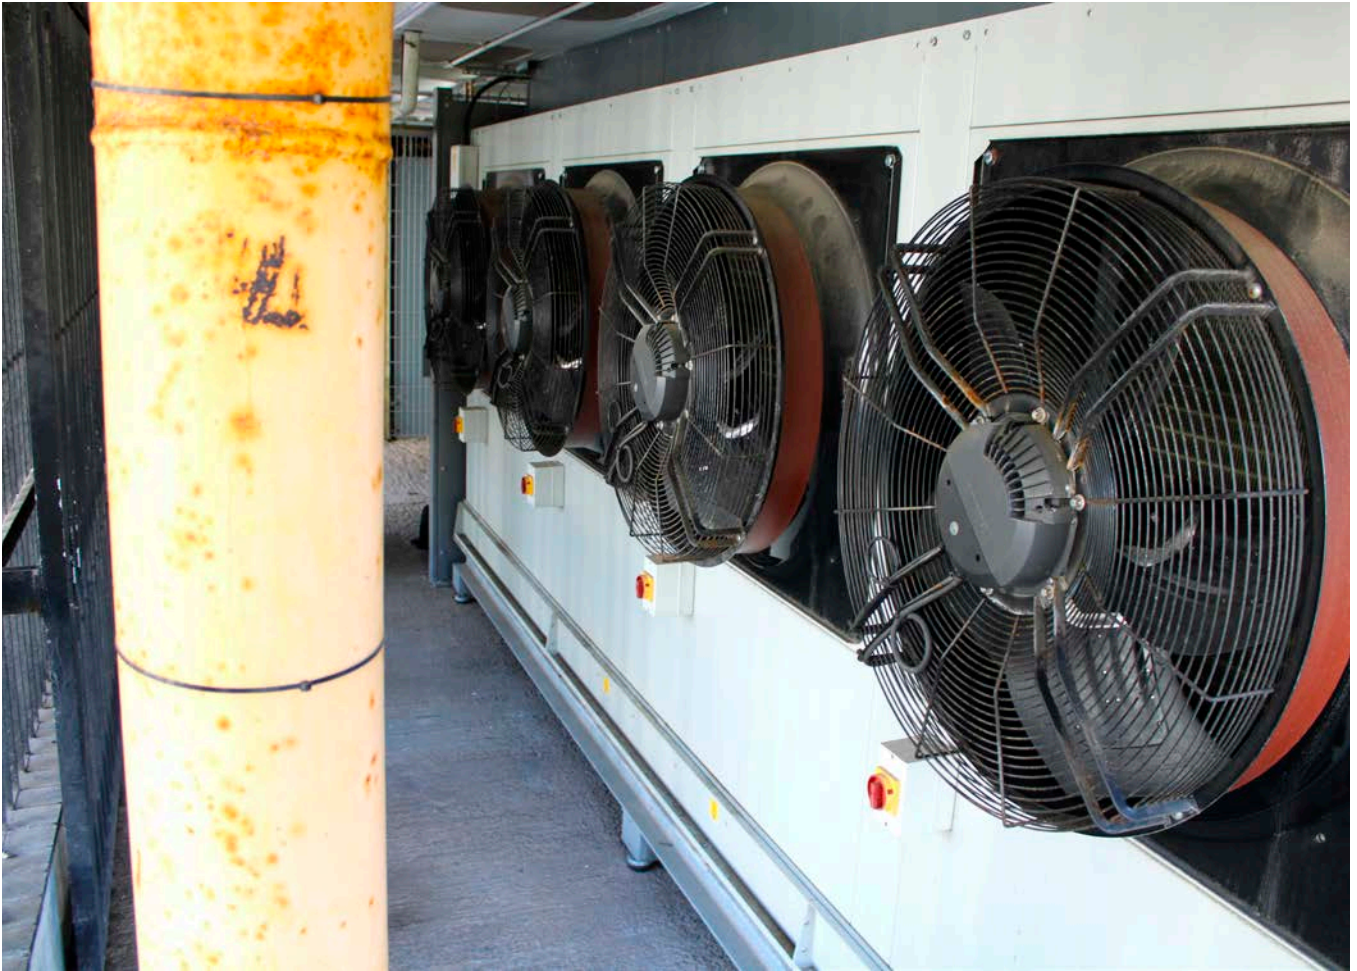
Figure 18: One of four sets of ASHP evaporators (right), pictured with the gas main (left).

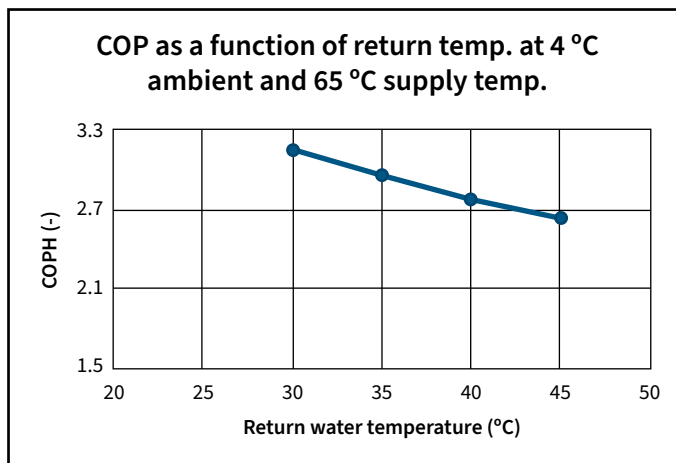
unable to operate and will switch off. This means that a CO₂ heating system must operate with a high temperature difference and a low flow rate, compared to a hydrofluorocarbon system. This is advantageous when replacing an existing gas- or oil-fired heating system, because the pipework will have been sized for high temperature differences and low flow rates. It may, therefore, be possible to reuse the existing pipework.

Figure 19: CO₂ efficiency at varying system return temperatures (COPH is the heating COP) © Clade Engineering. <https://clade-es.com/how-to-use-co2-for-heating-and-hot-water/>

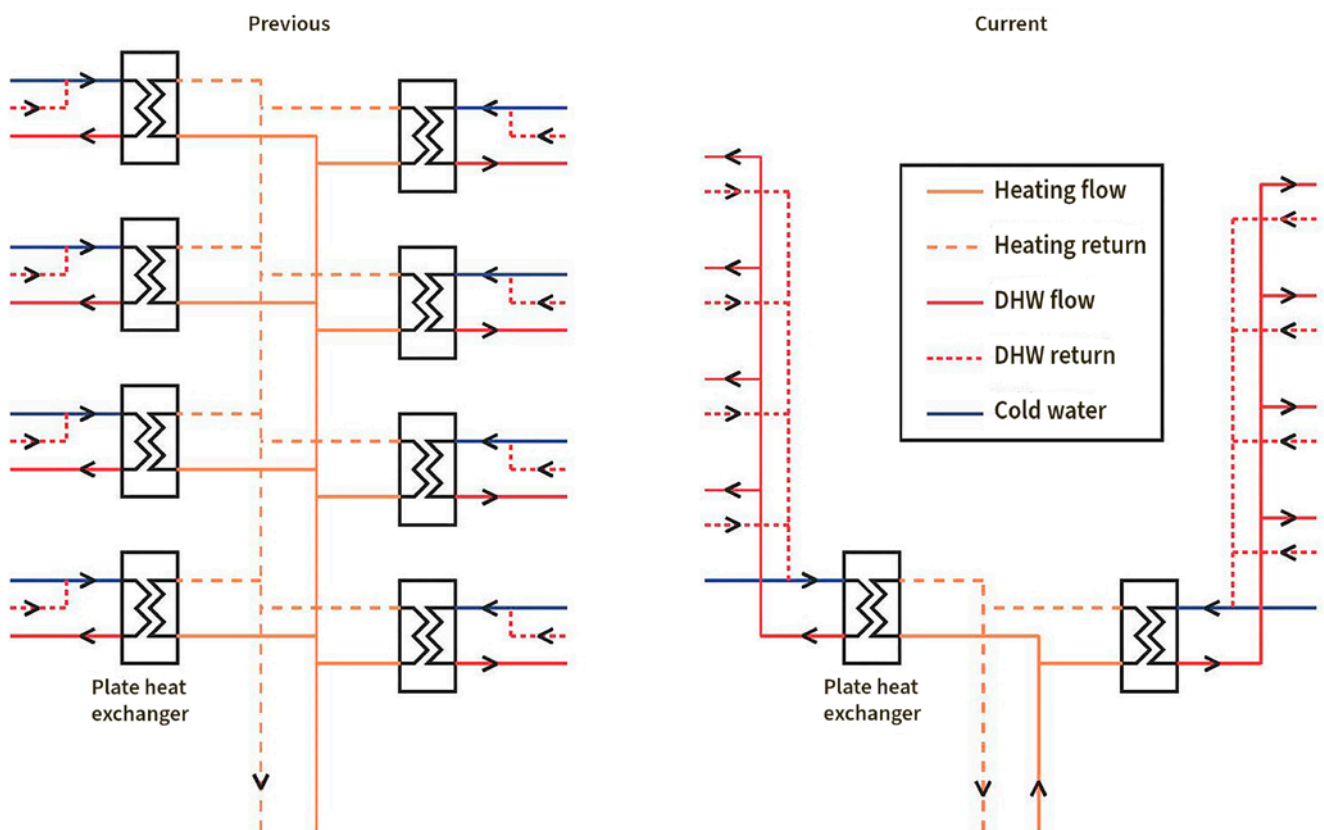
Figure 21: Schematic showing the previous and current domestic hot water system arrangements.

The new system generates domestic hot water via two plant room plate heat exchangers powered by CO₂ ASHPs. The domestic hot water is then distributed across the site. During periods of low demand, the flow in the pipework is reduced to the level required to keep the pipe warm, thereby reducing the pumping energy of the system. Figure 21 shows a schematic diagram of the system.

All the domestic hot water is now produced centrally, and there are significant distribution heat losses as the hot water travels across the building to the points of use. A hot water return system is used to ensure that the hot water stays at the required temperature within the pipework (normally 55°C). As CO₂ ASHPs require a low return temperature to operate efficiently, they are not well suited to provide the slight rise in temperature required to maintain domestic hot water at the target temperature. Instead, a bank of five domestic Samsung R-32 ASHPs are used to raise the hot water temperature. One of these R-32 units is

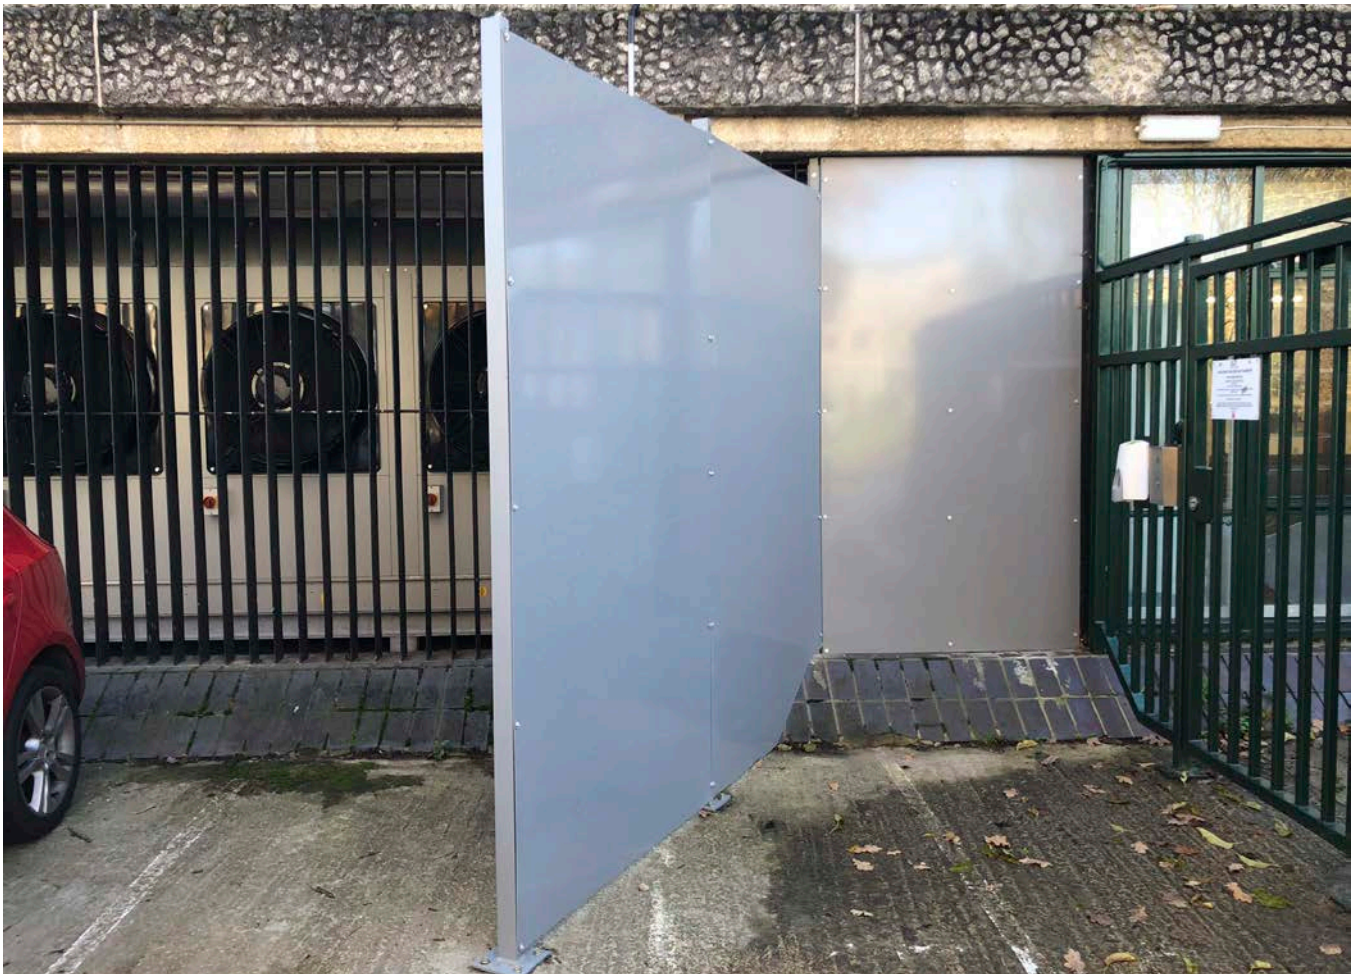
Given the large heating demand of the building, the external evaporators require a significant amount of space. They are neatly sited in two undercroft car park areas, at the expense of some car parking spaces. Other historic buildings may not have the benefit of such a discrete option. These units create a significant flow of cold air, but most of the walkways are far enough away for this not to be an issue. In one area, there is a barrier to protect people accessing the nursery (Figure 22).

Figure 22: Barrier to divert flow of cold air from the evaporators away from the nursery entrance.

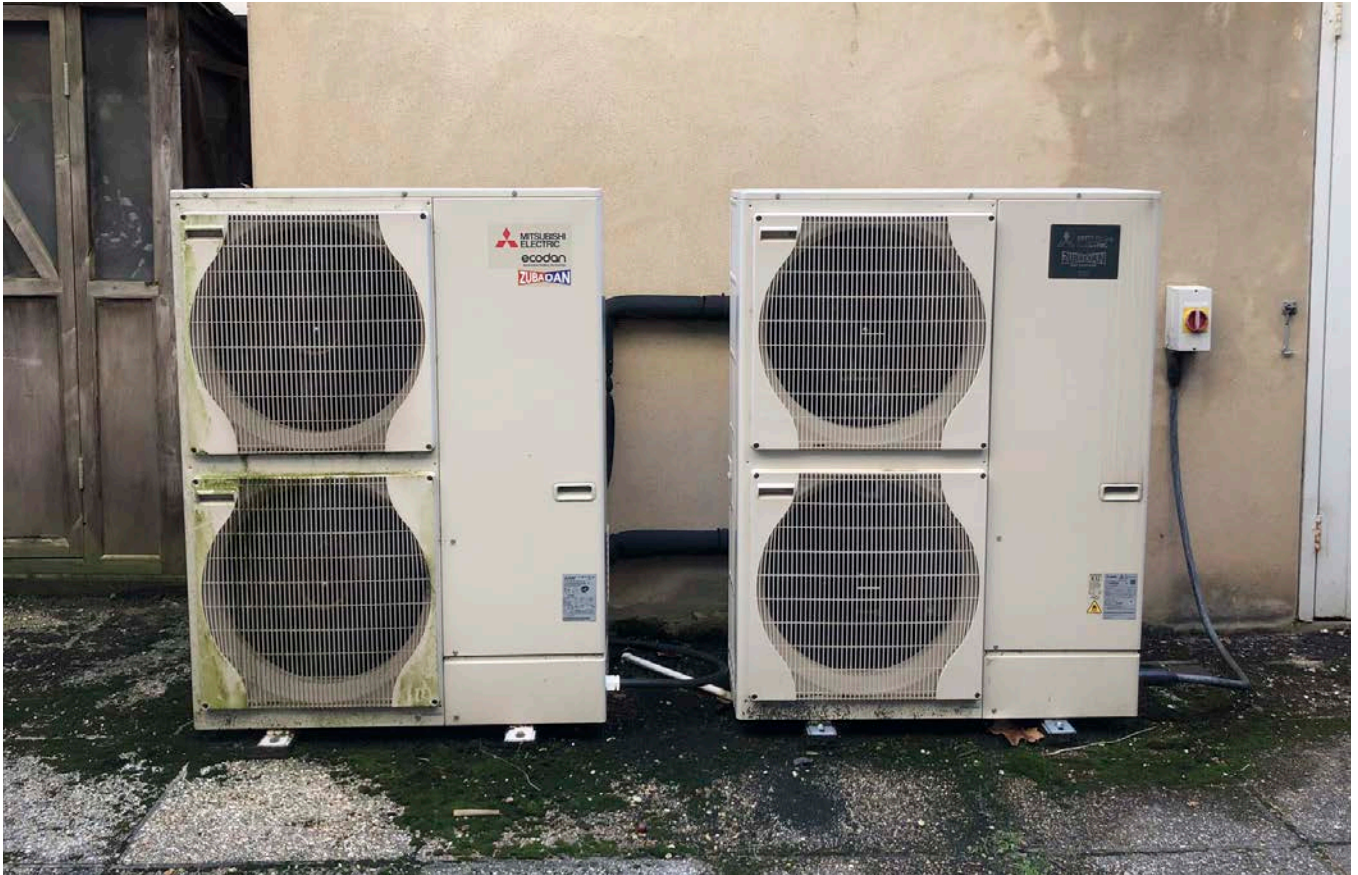
Figure 23: ASHPs at Site 4a.

- The noise from the tearoom kitchen extractor fan was far louder than that from the ASHPs.
- The ASHPs used 4.3kg of R-410A refrigerant with a GWP of 2,088, and 3.3kg of R-32 refrigerant with a GWP of 675. A leak of all the refrigerant in the system would be the equivalent of 11,206kg of CO₂ being released into the atmosphere.

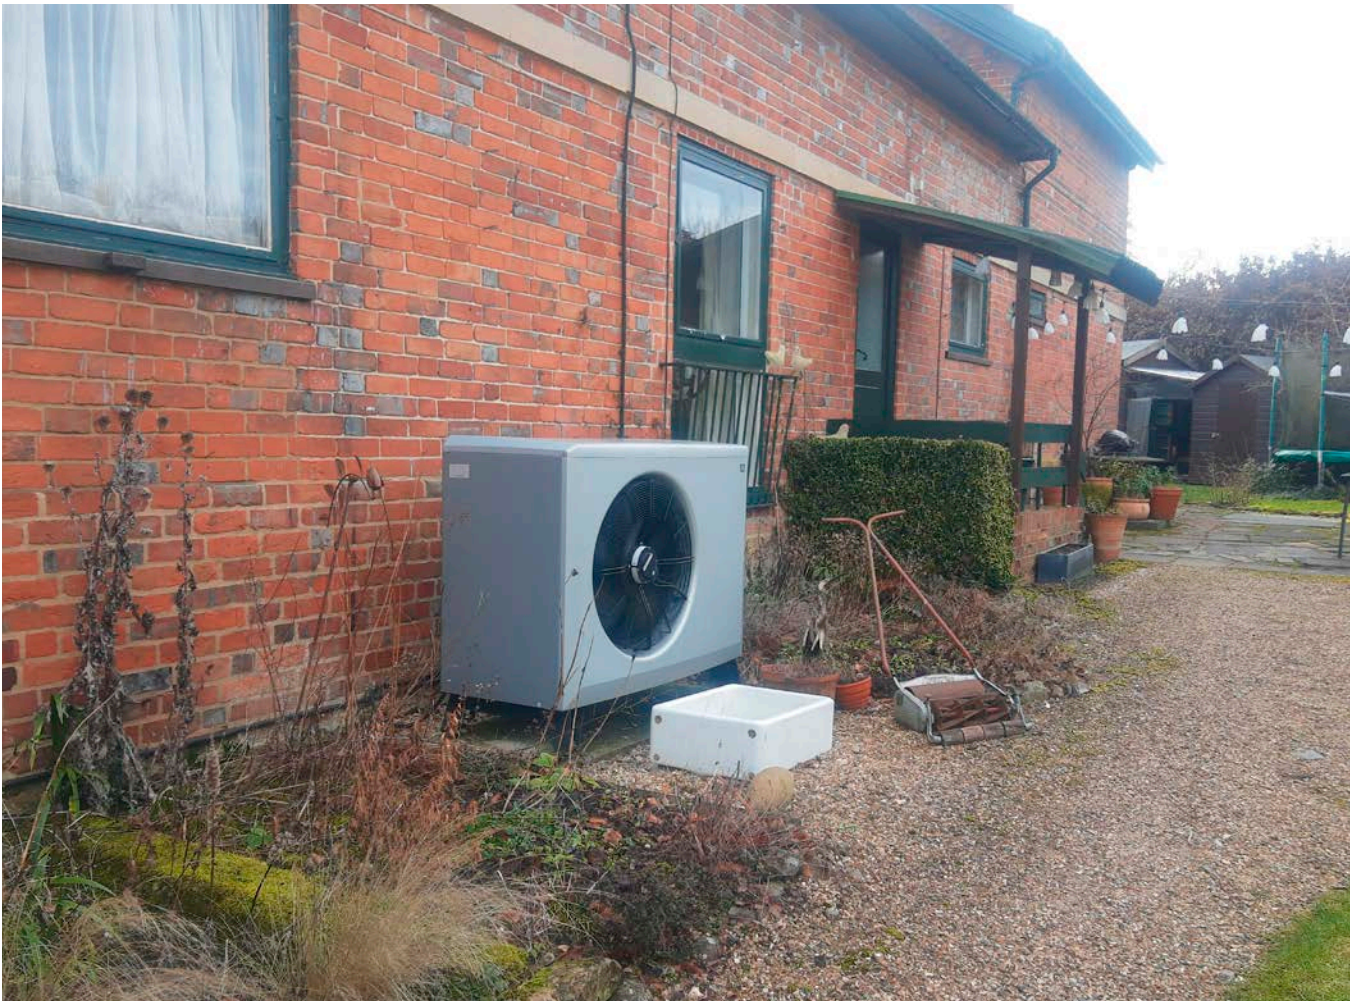
Figure 24: ASHP at Site 4b.

- The stable yard cottage was served by a 9kW ASHP manufactured by CTC, which provided both space heating and hot water. There was also a wood-burning stove in the living room that was used when outdoor air temperatures were low.
- The outdoor unit was clean and had been installed within the manufacturer's spatial guidelines.
- The unit was very quiet in operation.
- The unit was connected to an indoor hydraulic station and hot water cylinder.
- The hot water cylinder operated on a weekly legionella cycle.
- Condensate dripped onto a concrete slab and then drained into a large gravel bed.
