# Control of Microorganisms in Historic Buildings

UVC Irradiation Treatment

Historic England 2026 *Control of Microorganisms in Historic Buildings: UVC Irradiation Treatment*. Swindon. Historic England.

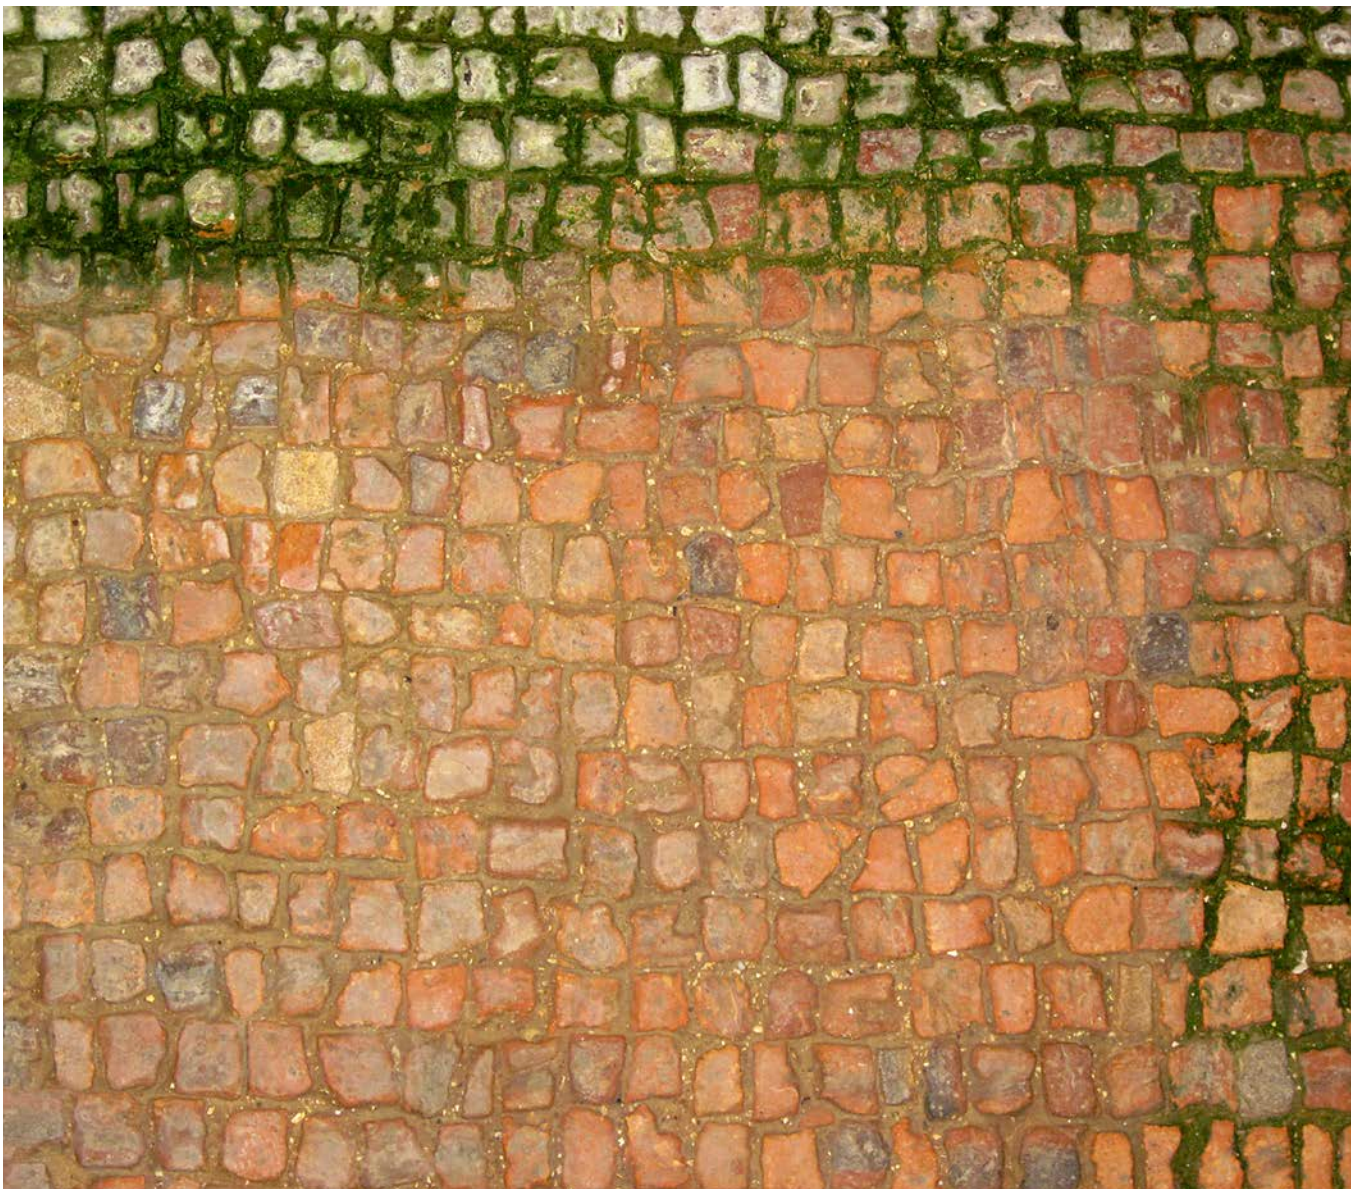
**Front cover:** Roman mosaic at Newport Roman Villa, Isle of Wight, showing treated and untreated areas, five years after initial UVC irradiation.

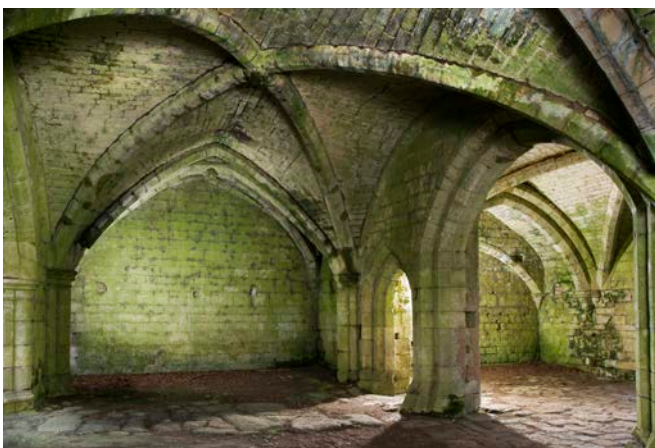
**Figure 2:** A medieval vaulted chamber with an expansive cover of microbial growth. The enclosed nature of the space and the fact that access can be restricted make it an ideal environment for the safe application of UVC technology.

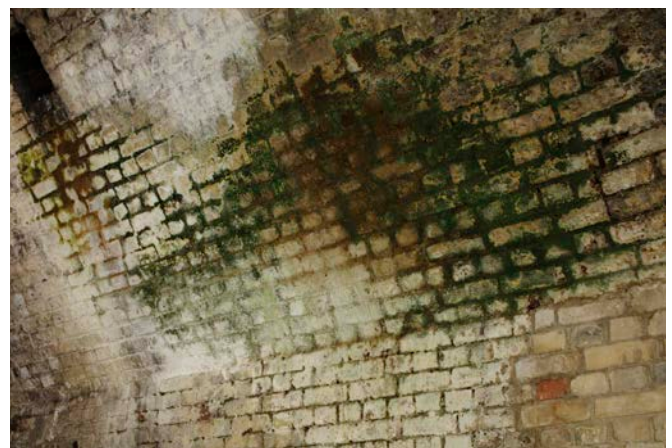
**Figure 3:** Microorganisms on areas of endemic dampness that cannot be easily remedied, such as this subterranean brick vault, can be managed with periodic UVC treatment, followed by wet cleaning (if the condition of the stone surface is not friable).

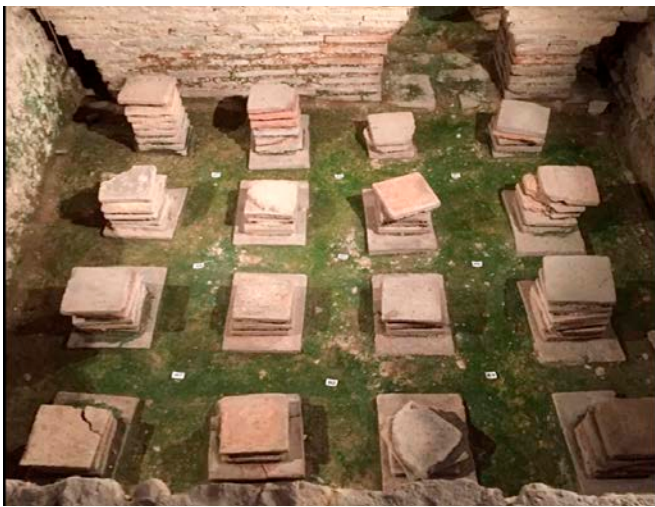
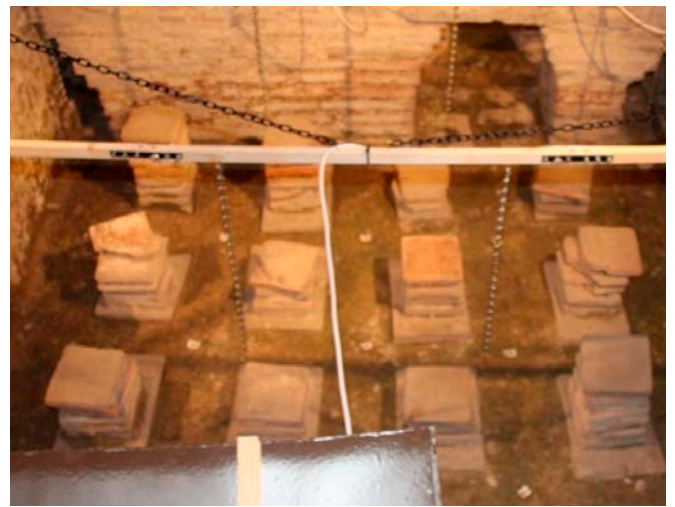
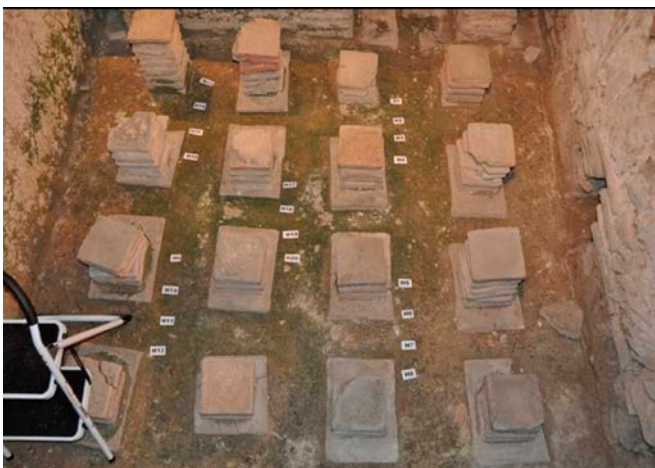
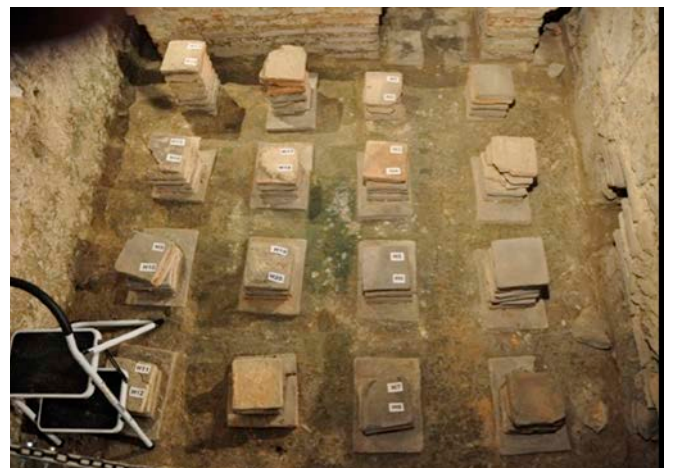
**Figure 10:** The hypocaust at Newport Roman Villa, Isle of Wight, before and after treatment in 2016 and 2018: (a) 2 March 2016, (b) 10 March 2016, (c) 15 February 2018, (d) 22 February 2018. There was a marked decrease in visible microorganisms after initial treatment in 2016. Some regrowth had occurred two years later. In this damp location, regular treatment is required.

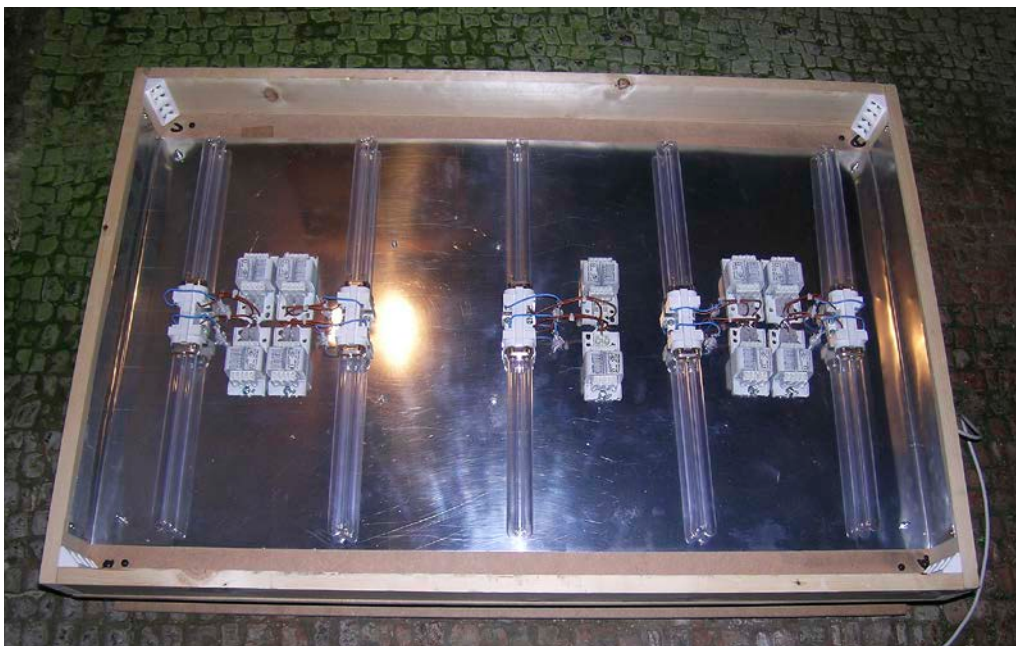
**Figure C1:** The UVC box designed and built for the initial trials is shown here upside-down. The inside of the box was lined with polished aluminium sheet, to reflect maximum radiation from the lamps onto the mosaic.

Security risks were managed by restricting access to the treatment area. In addition, UVC radiation was prevented from leaking out of the bottom of the box by two means. Gaps between the box and the mosaic pavement were filled with foam, and a fitted cover was made to slip over the box, with flaps folding along the floor. The cover was made of UVC-resistant polypropylene, lined with blackout fabric.

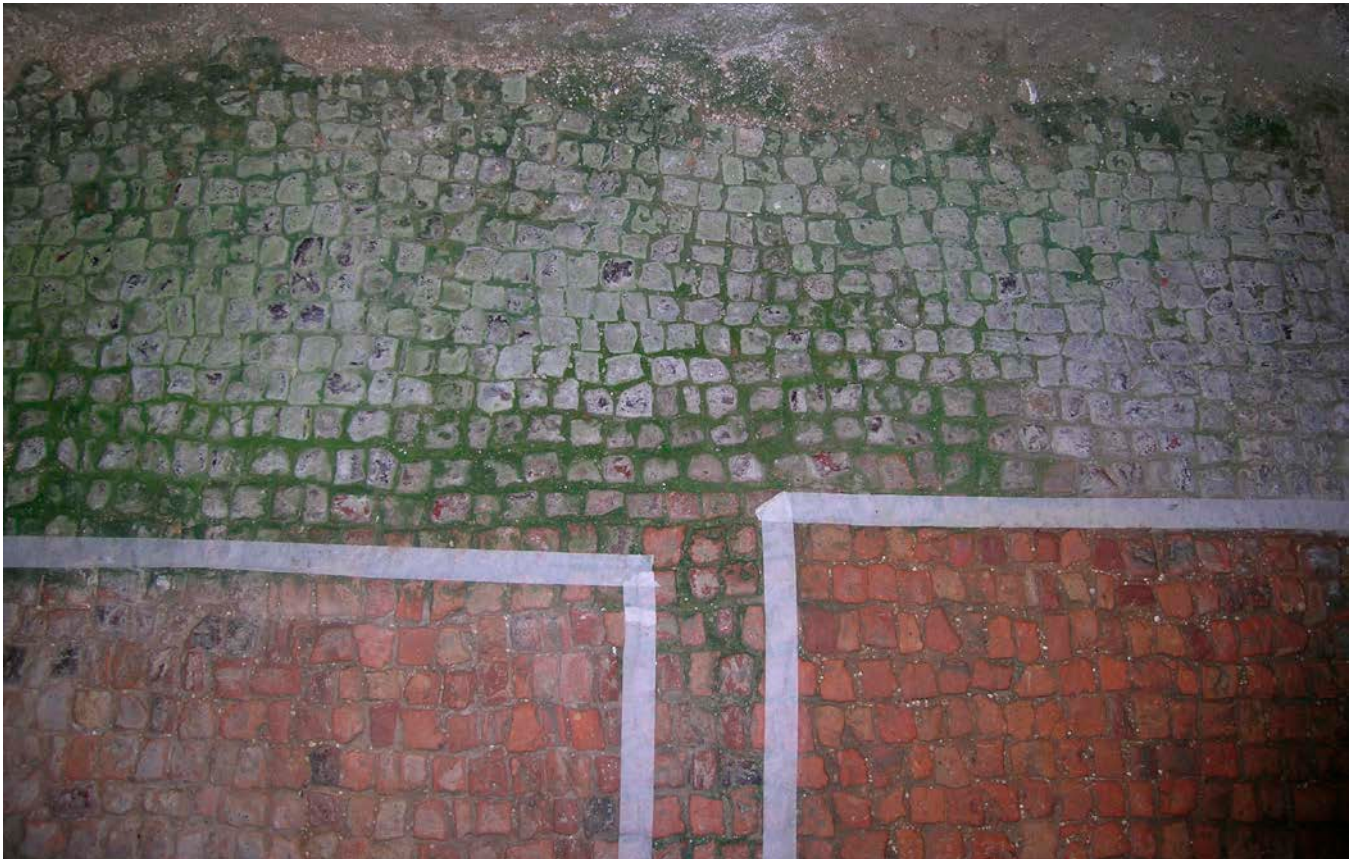
**Figure C2:** Trial area 1 (left) and trial area 2 (right), demarcated by tape, after UVC irradiation and wet cleaning.

Four months after irradiation, and throughout the damp winter months, both trial areas maintained their clean appearance and had no visible regrowth of microorganisms. There was no recorded change in normal environmental conditions within the building compared to the previous year.

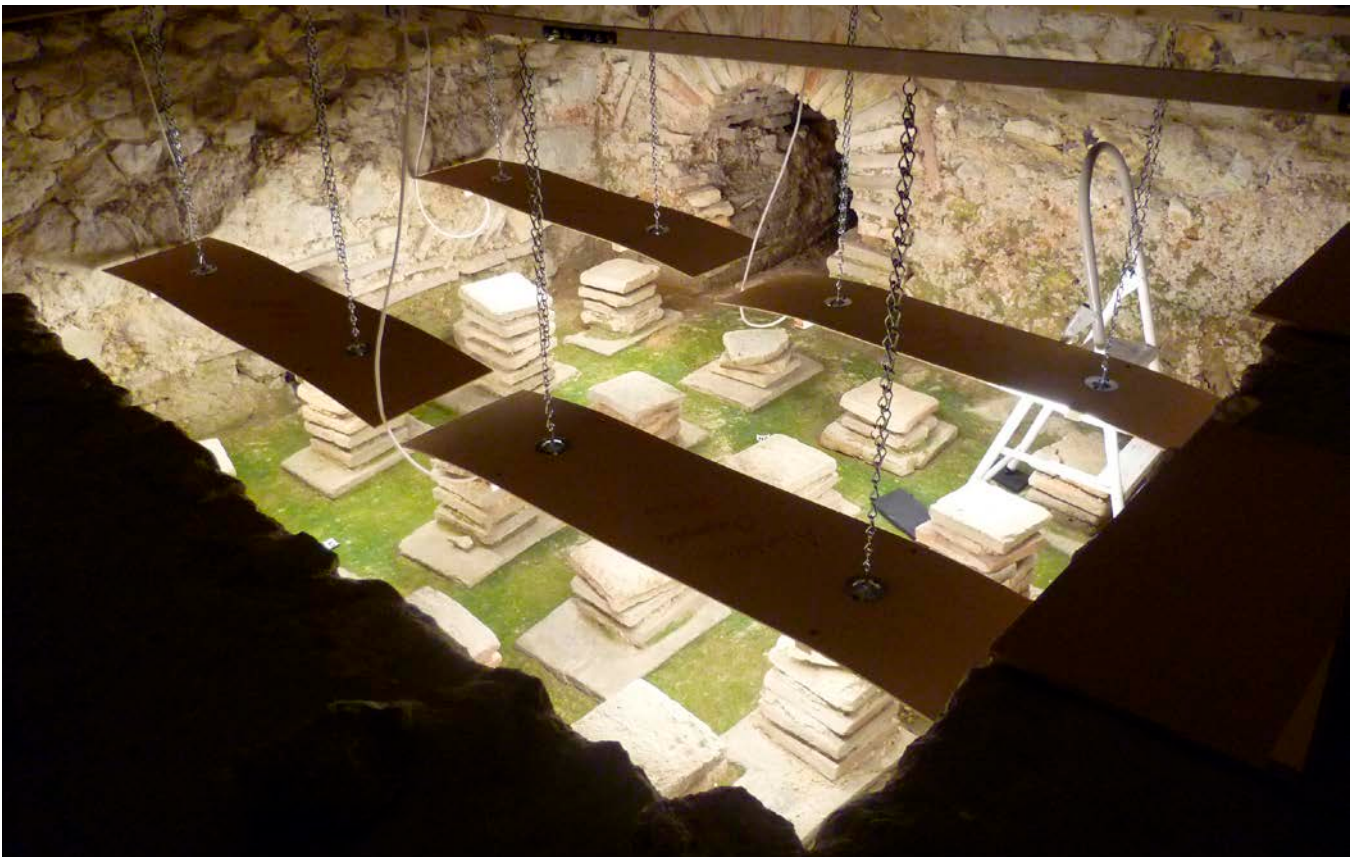
**Figure C3:** UVC irradiation within the hypocaust was provided by lamps fixed to the underside of timber panels, suspended from timber battens supported by lateral walls. (The lamps operating here for setting-up purposes are the ordinary white fluorescent tubes supplied with the batten fittings.) The hypocaust piers are very fragile and great care was required not to disturb them when installing and removing treatment infrastructure and kit.

Two locations at Newport were studied: the hypocaust (see Figure C3) and the kitchen. The hypocaust (nine monitored sites, H1 to H9) had a rich green mat of algae covering the compacted soil base, with occasional areas where the mineral surface could be seen. The kitchen (eight sites, K1 to K8) had a mosaic floor composed of red tesserae tiles. The algal cover was discontinuous and confined mainly to the mortar between the tiles. A paper label was placed within each site, with its number. As this blocked UVC radiation to the surface below, this provided a useful measure of the difference between adjacent irradiated and non-irradiated surfaces.

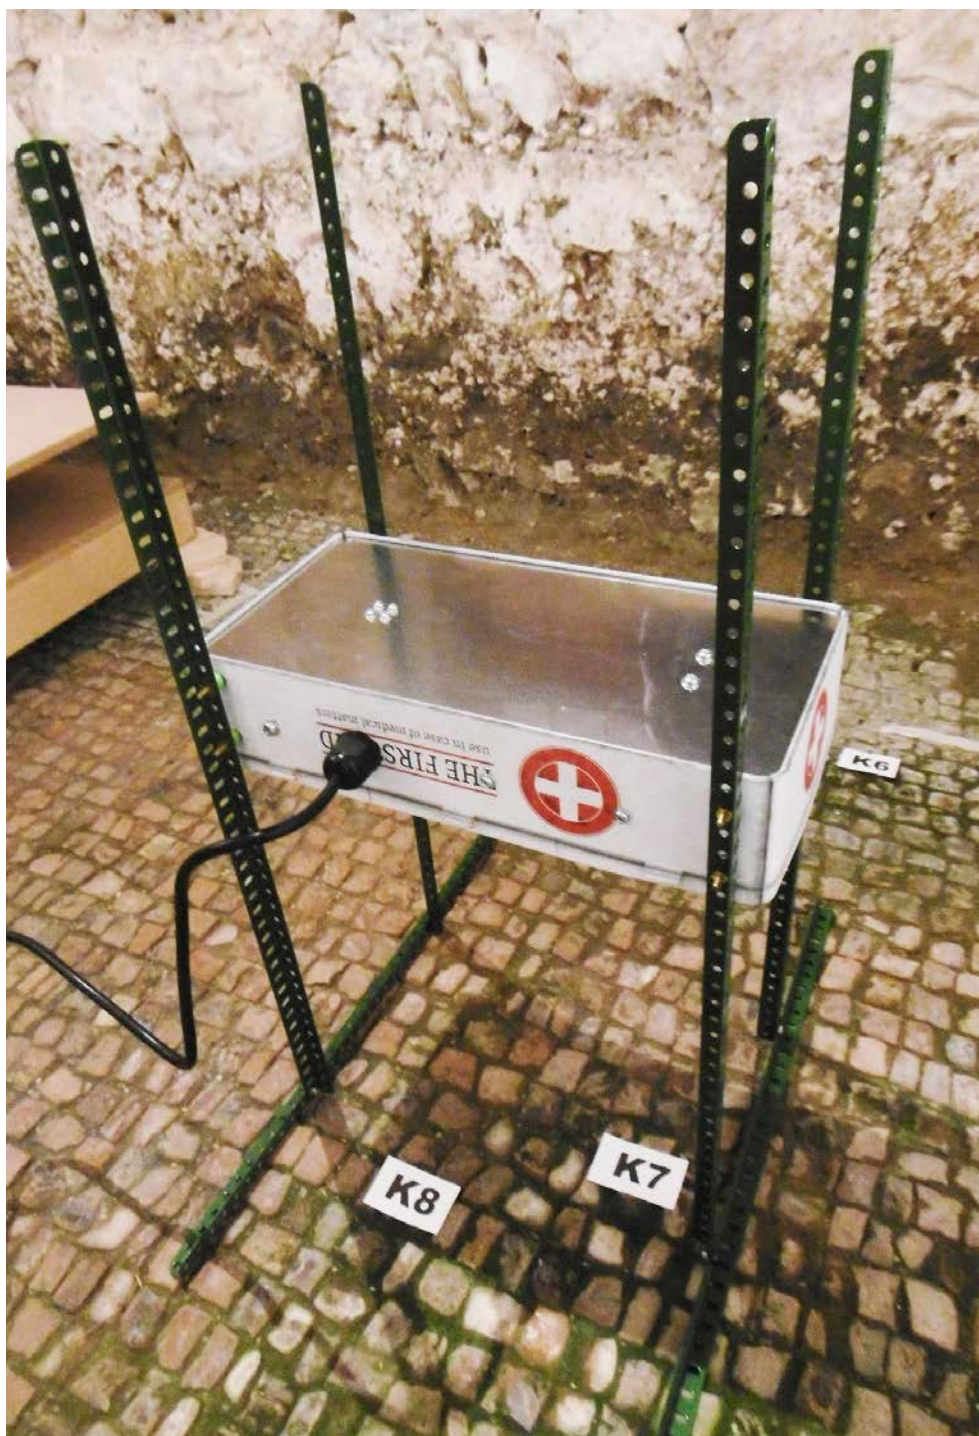
**Figure C5:** The mobile delivery device (made of Meccano parts) and a tin plate box containing UVC lamps. This design enabled the box to be raised or lowered to adjust dosage.

Trials were done during February and March 2018. They set out to further develop the treatment technology and extend biological understanding of the treatment process. UVC treatment was via suspended lamps in the hypocaust. In the kitchen, a large light box (used in the 2016 trial, but raised to reduce the build-up of heat) and a mobile box were used to deliver UVC treatment (see Figure C5).

The versatility of the mobile UVC unit (see Figure C5) was tested in a second trial in a second hypocaust that had retained a luxurious green growth. A transect was chosen for study and showed that the effects of the UVC light extended over a wide area and that shaded parts were dramatically unaffected.

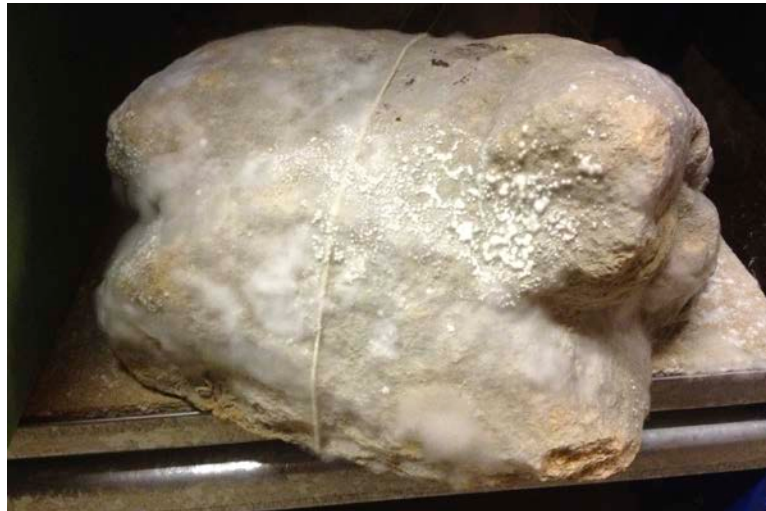
**Figure D4:** An example of the mould, which appeared as a white surface bloom on stonework, pallets and shelving in storage.

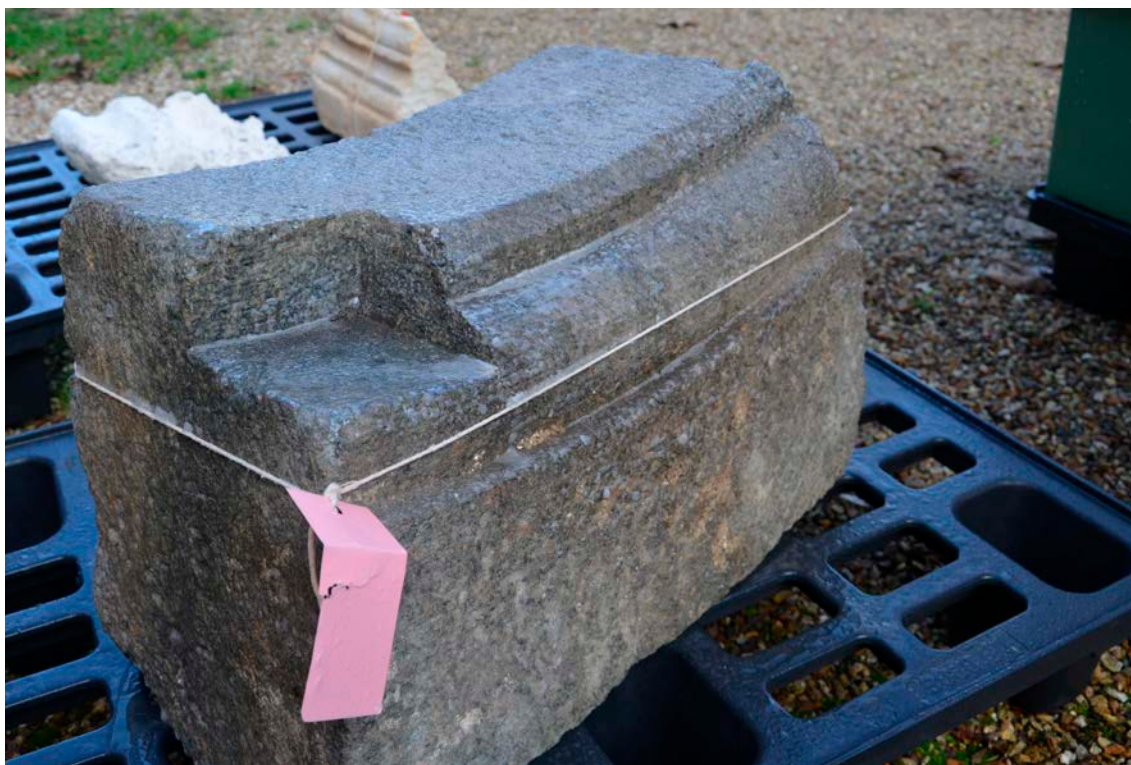
**Figure D5:** Stonework treated with 1.2% hydrogen peroxide solution.

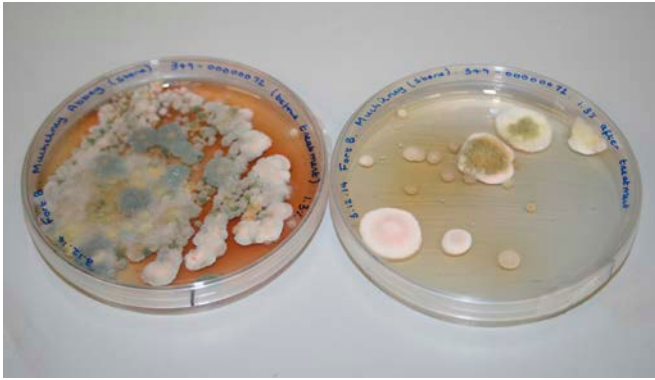
**Figure D6:** Cultured swabs from before and after cleaning with 1.2% hydrogen peroxide: on limestone.

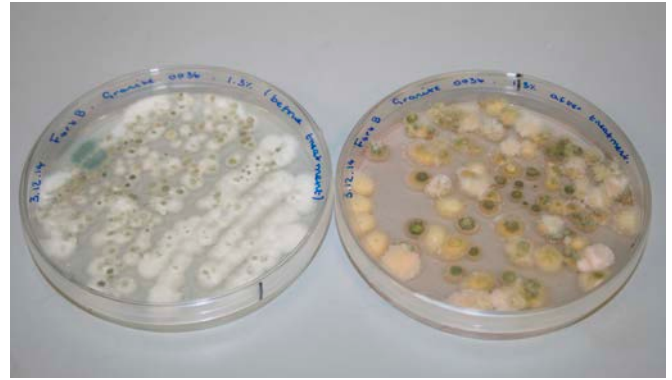
**Figure D7:** Cultured swabs from before and after cleaning with 1.2% hydrogen peroxide: on granite.

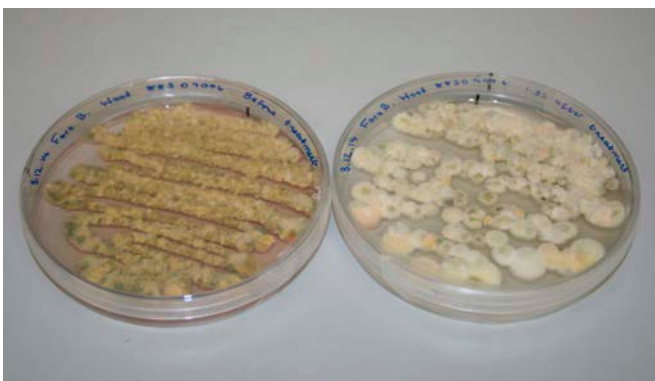
**Figure D8:** Cultured swabs from before and after cleaning with 1.2% hydrogen peroxide: on wood.

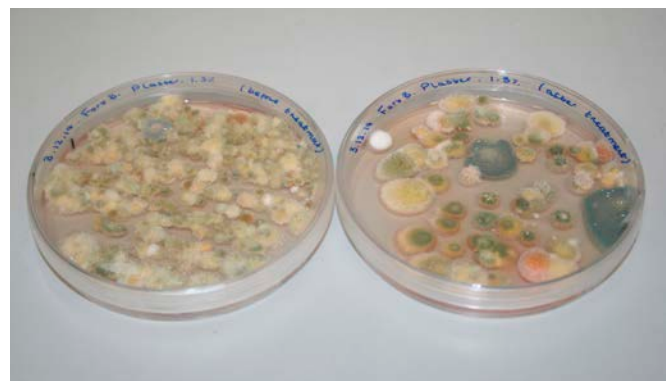
**Figure D9:** Cultured swabs from before and after cleaning with 1.2% hydrogen peroxide: on plaster.

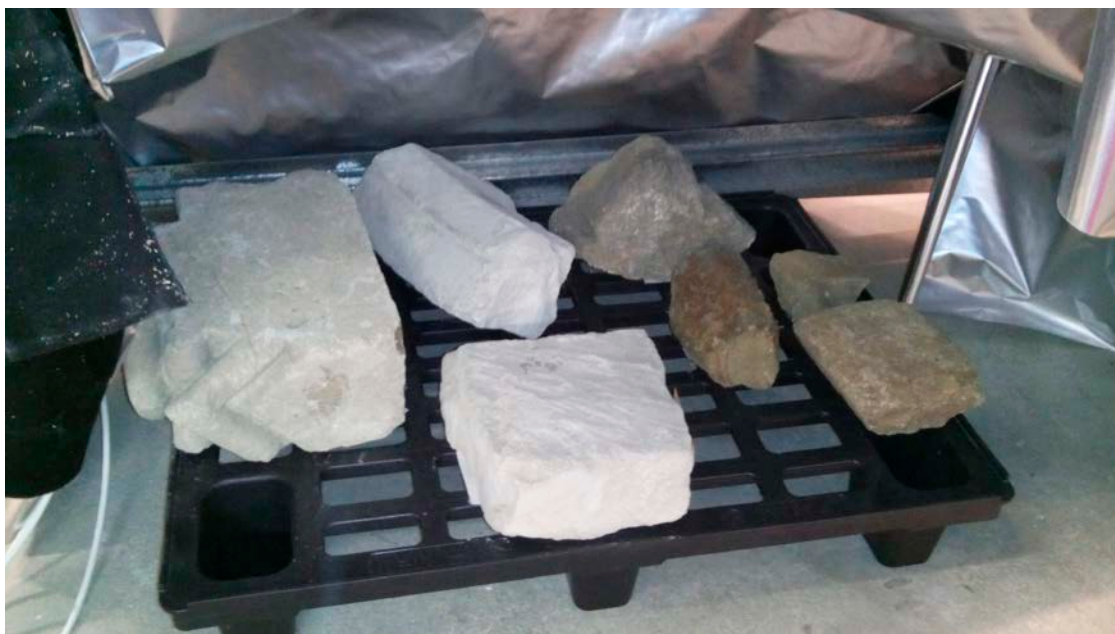
**Figure D10:** UVC trial set-up. Pallet with stones that have been brush vacuumed and are awaiting UVC treatment.

The process was then repeated. A second pallet of stonework was tested using a two-hour exposure. (Calculations demonstrated that to reduce the survival rate for *Aspergillus niger* from 10 per cent to 1 per cent, the treatment time needed to be doubled – from 57 to 114 minutes). The difference in performance after two hours and 24 hours of treatment was negligible (see Table D2), but a treatment time of two hours allowed a batch of stonework to be treated each day.

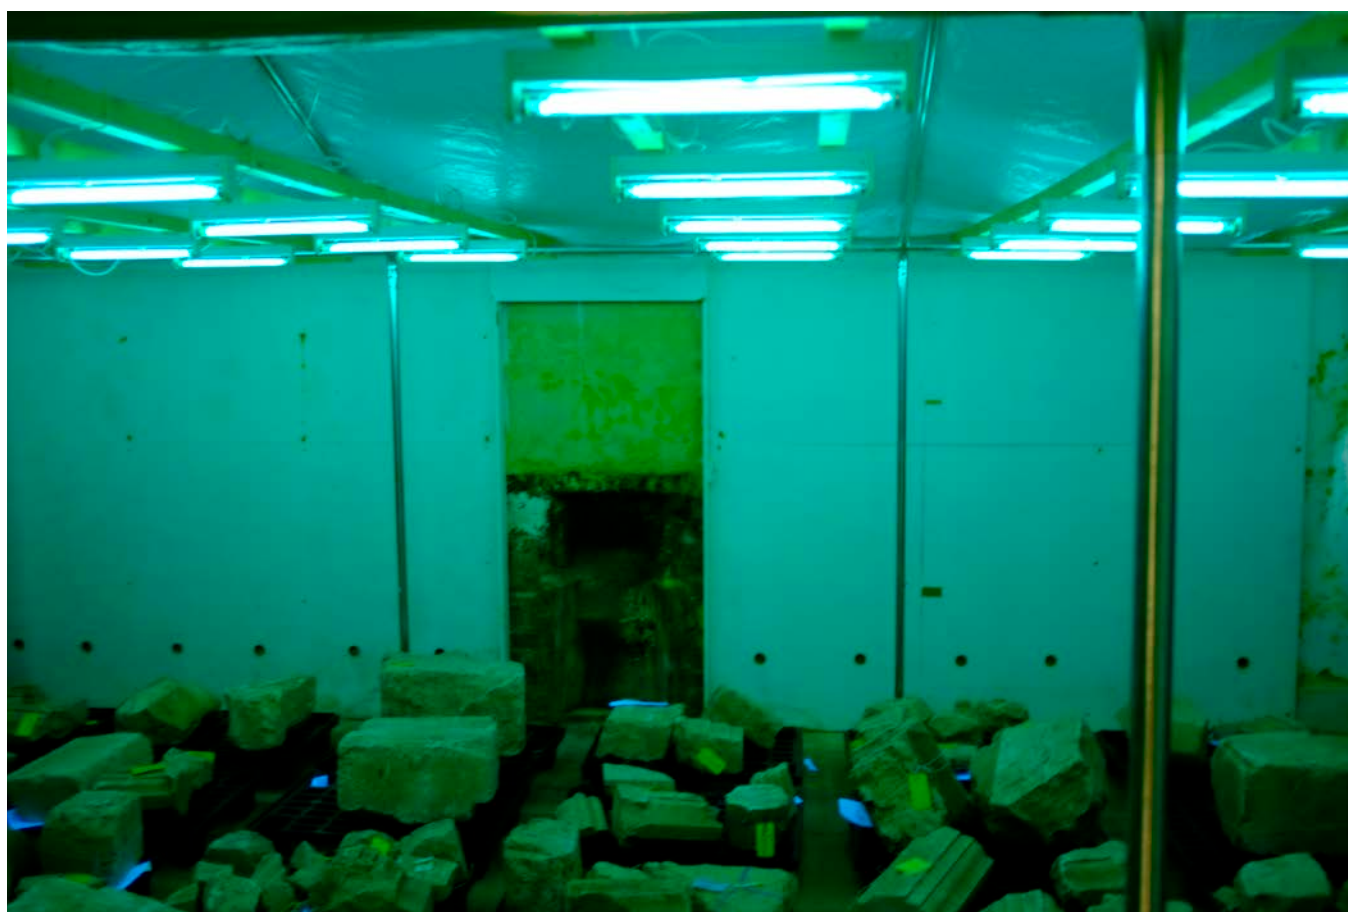
**Figure D11:** Stones being irradiated with UVC bulbs fitted to the marquee frame.

All stonework has now been treated: a total of 486 pallets, or just under 36 tonnes of stonework. Swabs were taken at different points during the treatment, on different collections and types of stone. With the exception of one sample (it is assumed that human error meant this sample was not turned over), all readings gave a reassuringly low result. This is particularly relevant because the distance between the pallets and the lights was increased from approximately 1m to 2m, and treatment times should have been recalculated accordingly.
