# Energy Efficiency and Decarbonisation Case Study

Keelmen's Hospital, Newcastle upon Tyne

This case study focuses on the decision-making process during the design phase of the project. It demonstrates how energy efficiency and decarbonisation goals can be balanced with protecting and enhancing heritage significance while meeting statutory requirements. It shows how:

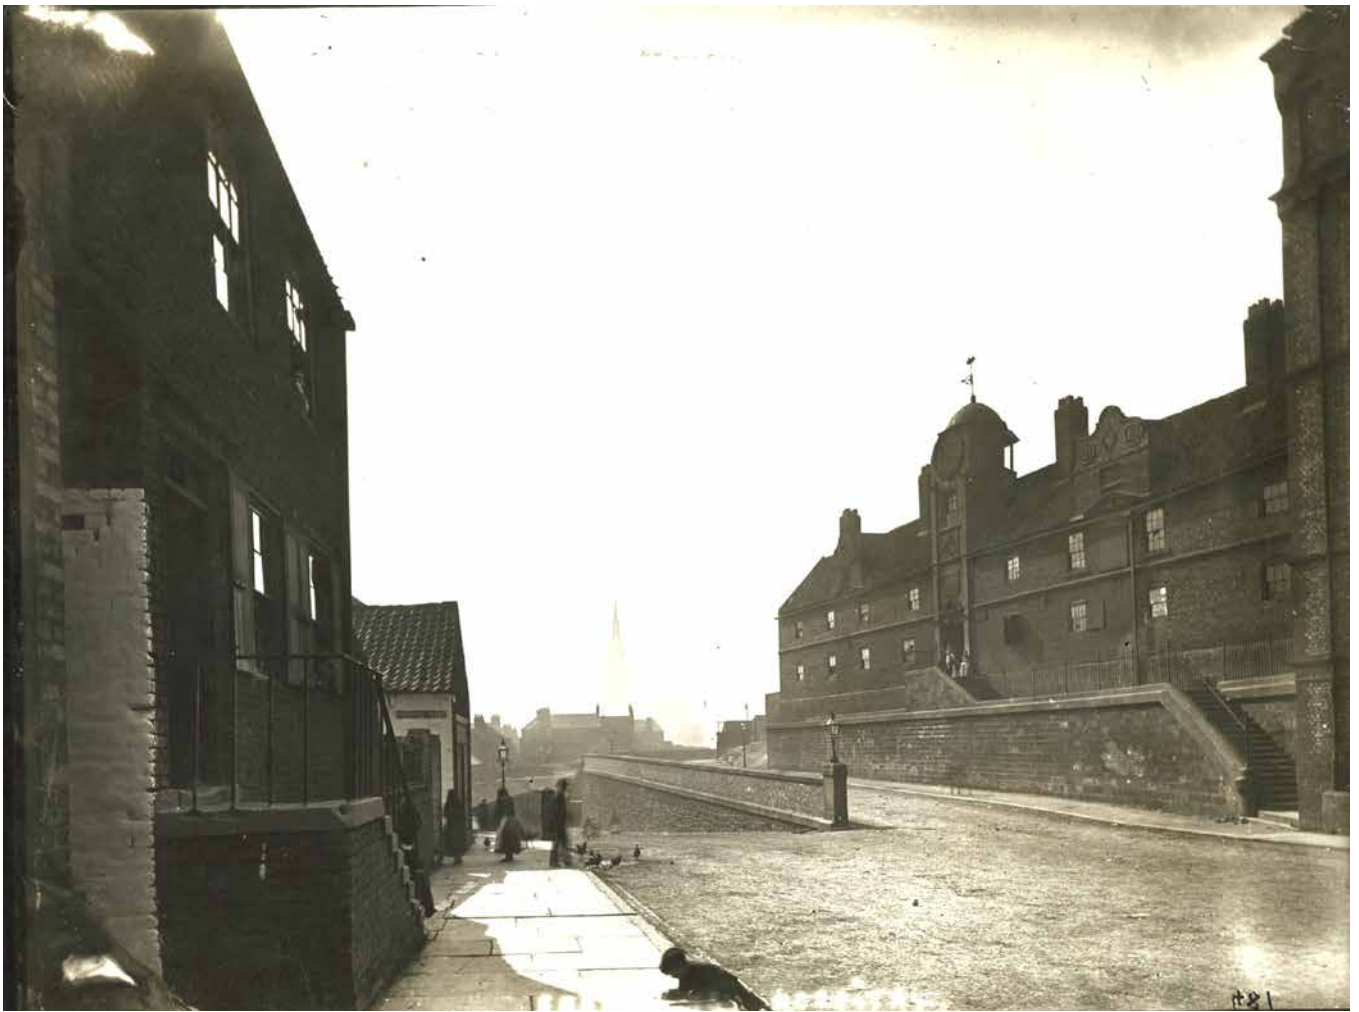
Figure 1: South-east elevation of Keelmen's Hospital, 1879. © Newcastle Libraries.

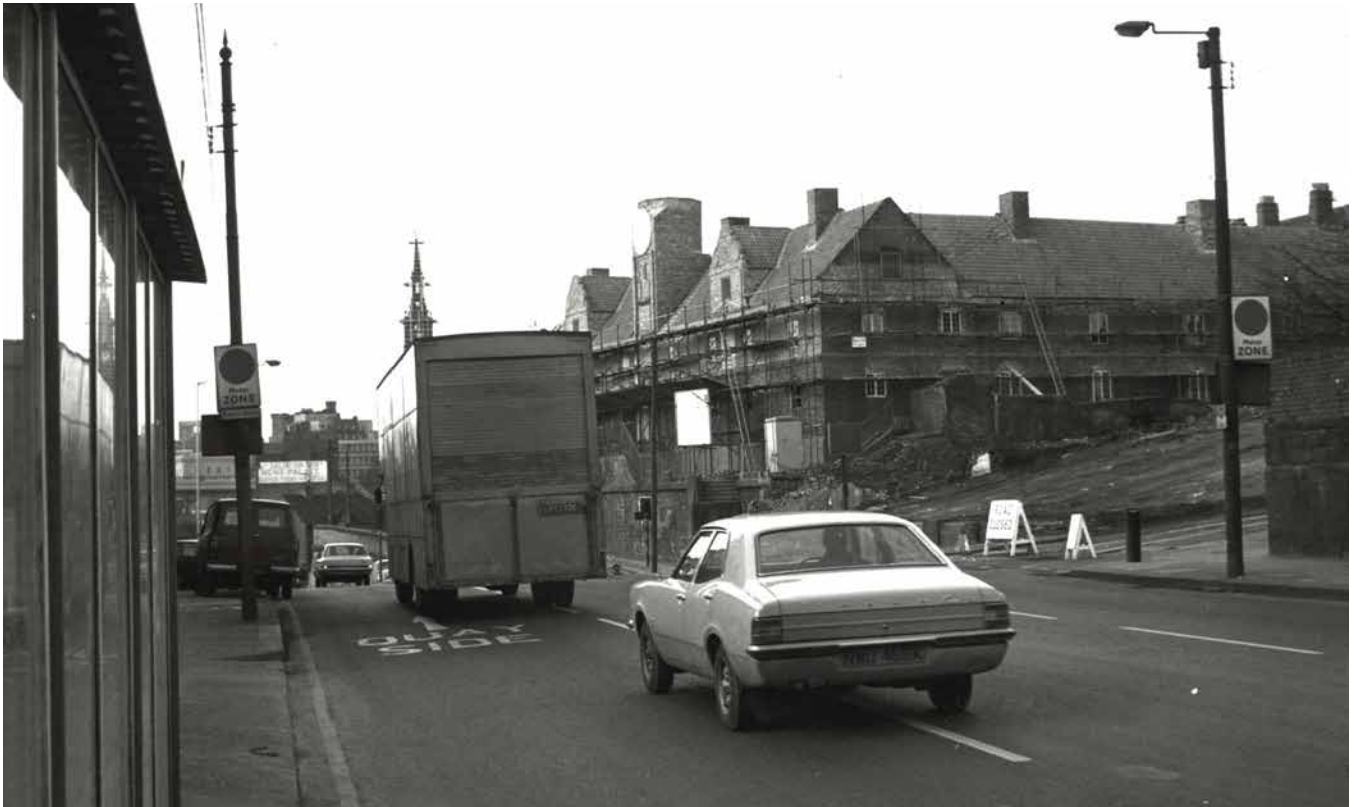
Figure 2: South-east and north-east elevations during building works, 1973. © Newcastle Libraries.

Keelmen's Hospital was built in 1701 as an almshouse to house sick and ageing keelmen and their families. The keelmen continued to use the building until Newcastle Corporation took over its management towards the end of the 19th century. A major restoration in the 1970s caused the loss of much historic fabric.

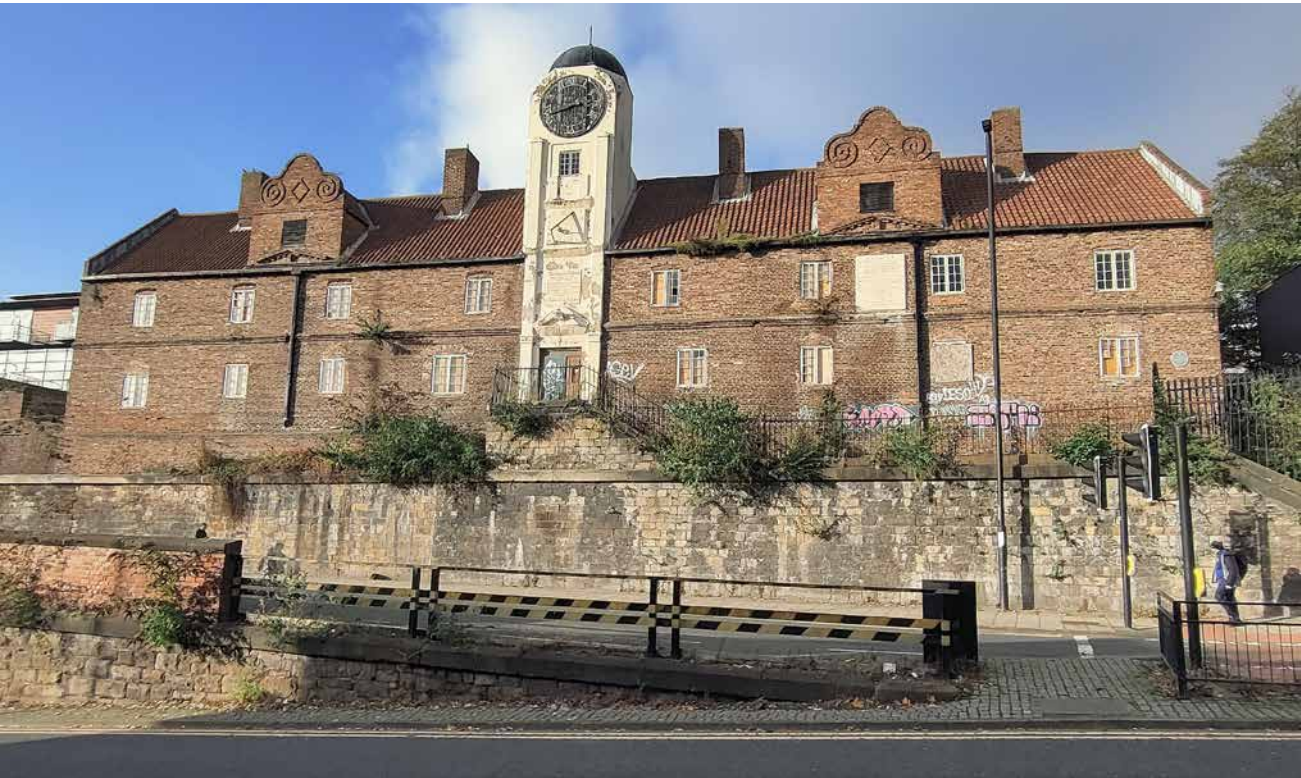
Figure 3: South-east elevation of Keelmen’s Hospital, 2025. © Maya Polenz.

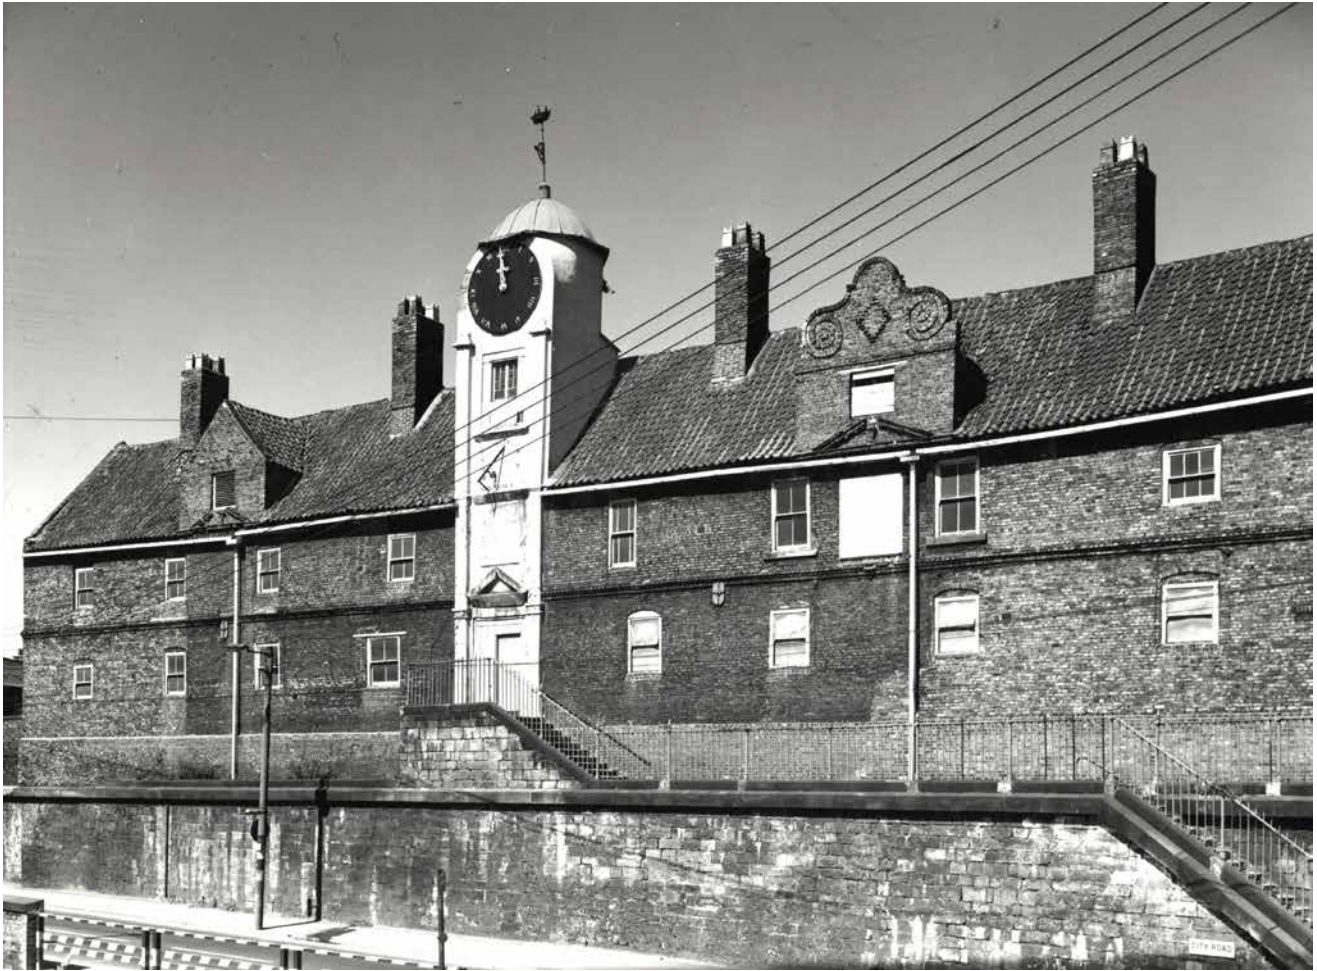
From the late 18th century onwards, original windows were replaced with sash windows to increase ventilation and daylight. By the late 19th century, photographs show only sash windows, alongside enlarged openings intended to improve internal daylight.

Figure 5: South-east elevation of Keelmen's Hospital, 1969 (pre-1973 works). © Newcastle Libraries.

Major restoration works in 1973 replaced all the windows with outward-opening timber casements. These are of very slim construction and are in extremely poor condition following nearly two decades of neglect after the building became unoccupied in 2009. They have neutral heritage significance.

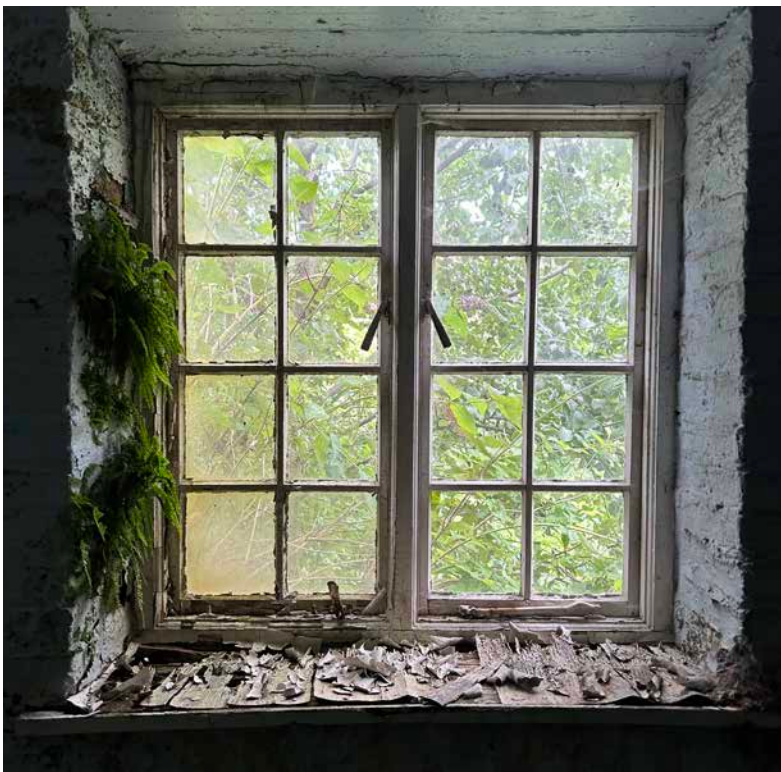
Figure 6: Condition of window pre-development, 2023. © JDDK Architects Ltd.

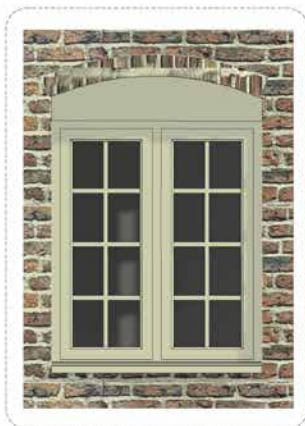
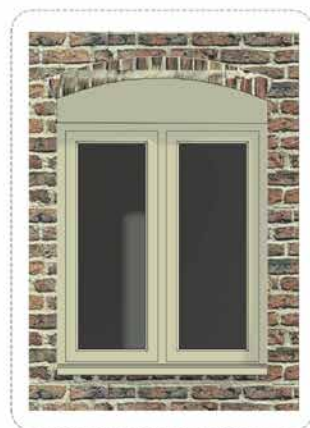
Figure 7: Window layout study. © JDDK Architects Ltd.

The weight of double-glazed units means that true glazing bars would result in unacceptably bulky profiles. The design team considered two other options:

- Stuck-on or applied glazing bars: These were deemed inappropriate because they are a visually and technically inauthentic solution.
- No glazing bars: This was recognised as a heritage impact. However, standard double glazing without glazing bars would offer the best technical solution for the replacement windows at Keelmen's Hospital, maximising daylight provision and resident well-being, and reducing long-term risk to the historic structure.

Window Study - 8 pane casements

Window Study - Single pane casements

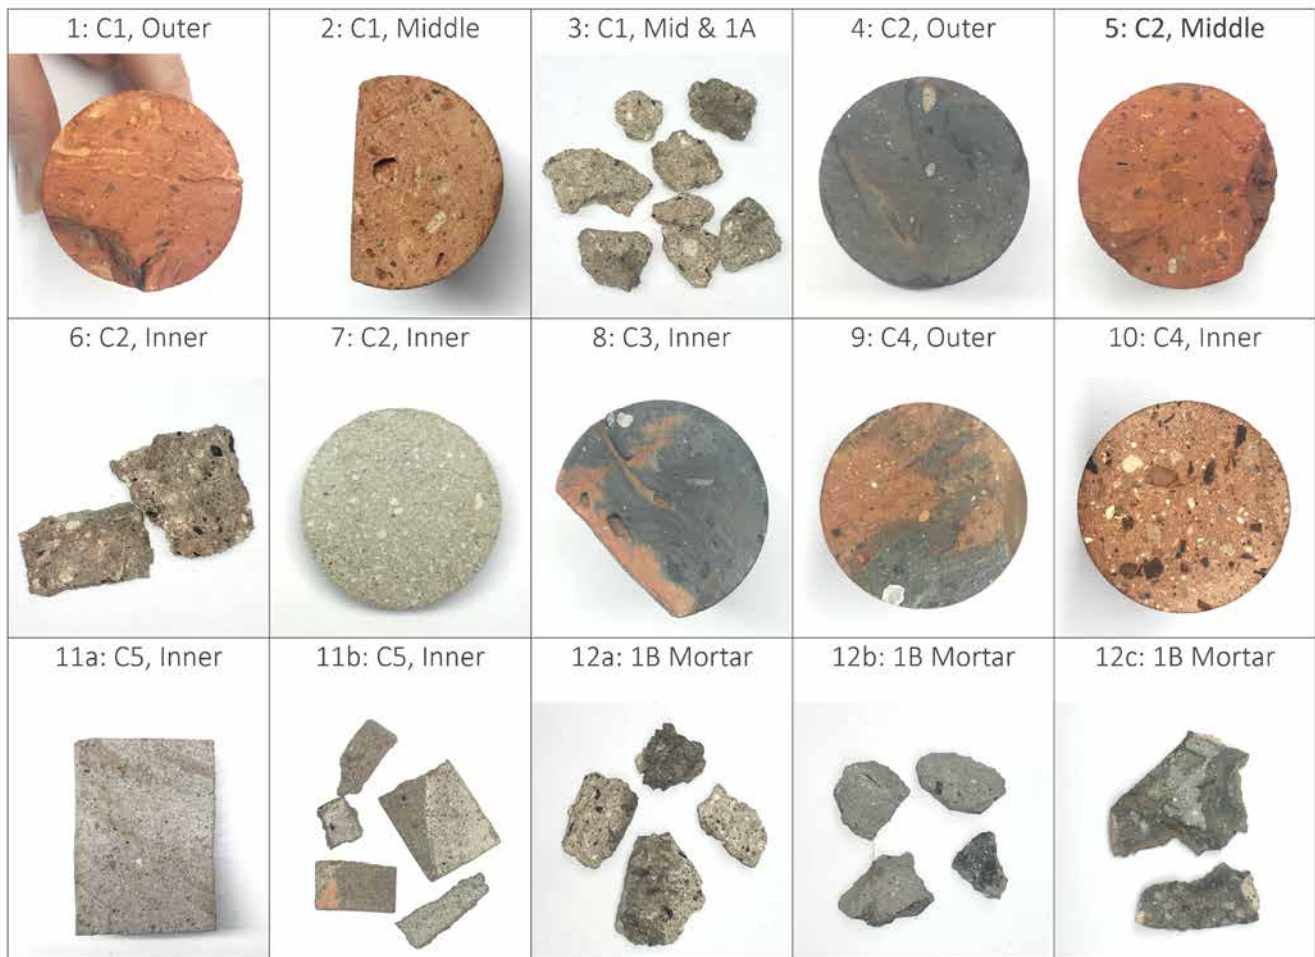
Figure 9: Photographs of material samples tested. Nine samples were selected for full characterisation of density, absorption coefficient, saturation water content and reference water content: seven brick samples from cores C1-C4 (numbers 1, 2, 4, 5, 8, 9 and 10); one plaster sample (number 7); one modern mortar joint sample (number 11). Five sets of original mortar fragments were selected for partial characterisation of density, saturation water content and reference water content (numbers 3, 6, 12a, 12b and 12c). © Greengauge.

Analysis of two historic brick samples showed significant differences in water absorption coefficients and saturation water contents. This variability in material properties highlights the importance of sample size, especially when working with historic buildings.

With permission from the local conservation officer, Greengauge carried out material testing of existing materials to determine their key physical and moisture transport properties and to inform the inputs for the hygrothermal risk assessment. Samples analysed included brick, mortar and internal plaster from the existing external walls, as well as coatings to the inside of the courtyard walls. The measurements included density, reference water content, saturation water content and water absorption coefficient by partial immersion. The site-specific material data informed the selection of representative material inputs to allow a more accurate analysis of the building's performance.

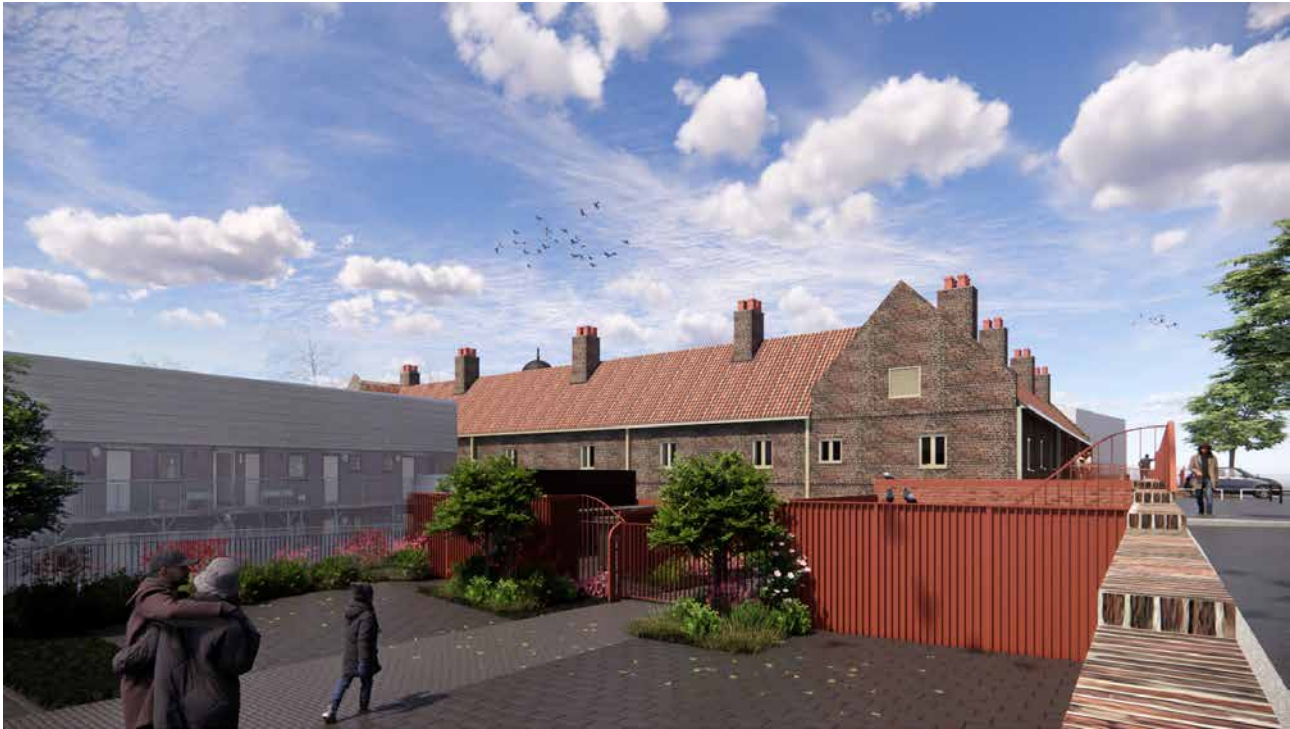
A centralised system is to be installed at the north-east corner of the site within a plant compound. This location has limited impact on the heritage setting, minimises noise impact to Keelmen's Hospital and the surrounding neighbouring buildings, and delivers the most efficient heating solution.

Figure 13: CGI image of air source heat pump centralised plant enclosure at new entrance location. © JDDK Architects Ltd.
