# *THE PROTECTED WRECK OF HIS MAJESTY'S SUBMARINE BOAT A1 (1902)*

CONSERVATION STATEMENT AND MANAGEMENT PLAN

Written by D.M. MCELVOGUE of TrenDive for Historic England

PROTECTED WRECK OF *HIS MAJESTY'S SUBMARINE A1* (1902)

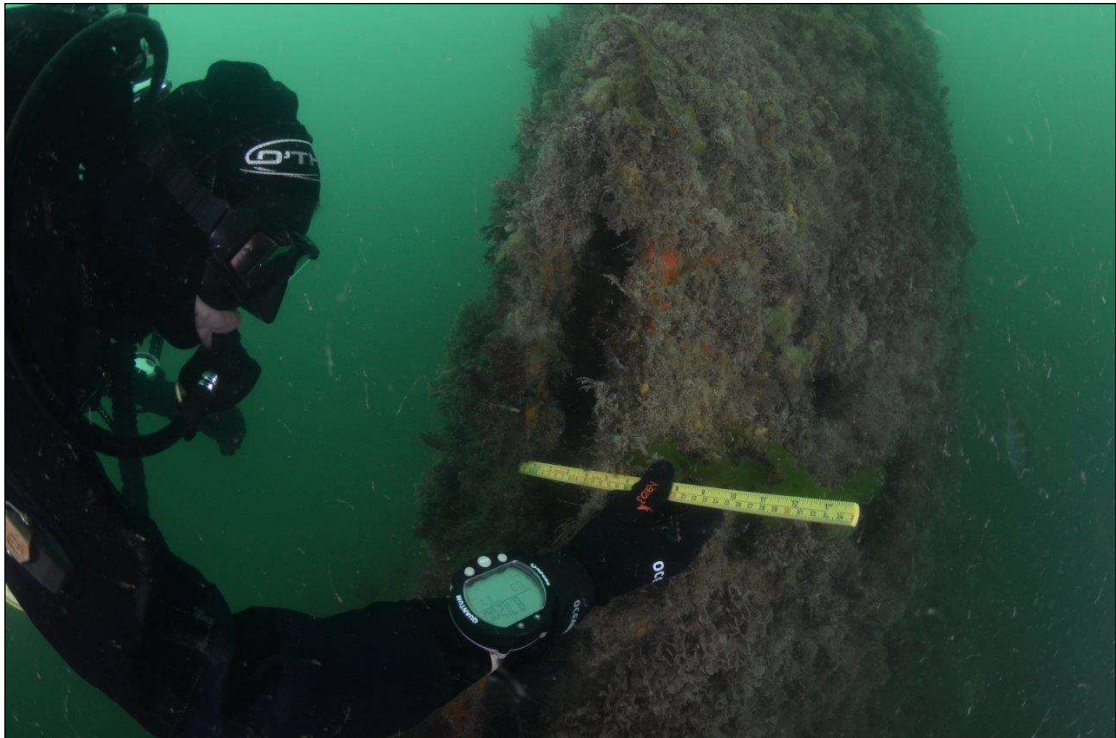
Figure 11 The leading edge of the conning tower where the two pieces of plating appear to be separated creating what has been interpreted as a crack in the conning tower. (© Martin Davies, 2013).

- 2.8.11 The midship area is defined by the leading edge of the conning tower. The forward protective covering can no longer be discerned. The two pieces of plating appear to be separated creating what has been interpreted as a crack in the conning tower (Figure 11), which does not appear to be increasing. It has been monitored over time by the Principal Licensee. All the glass deadlights are now missing, leaving empty voids. There is a large hole on the portside above the join to the pressure hull, allowing visual access to the inside of the conning tower. Measuring roughly 450mm by 600mm, it corresponds to the position of an access hatch that was bolted at the base of the conning tower.

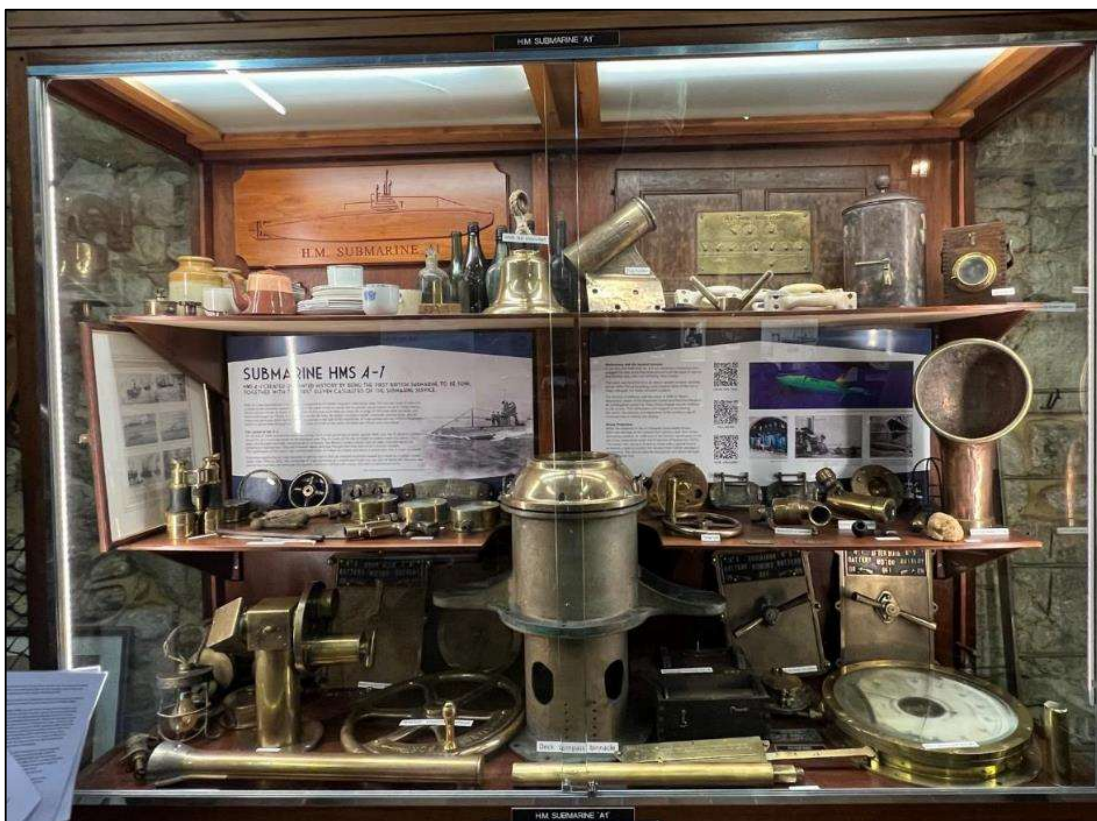
Figure 12 Recovered artefacts, including the *A1*'s bell, on display at the Isle of Wight Shipwreck Centre and Maritime Museum.

- 2.12.1 Artefacts have been recovered from the *A1* since it was first found. The compass binnacle was the first artefact raised on the first dive. The conning tower hatch was also recovered early on and before the site was protected. These artefacts were either recovered by Martin Woodward or divers from Triton Chichester BSAC group. All such artefacts are held at the Isle of Wight Shipwreck Centre and Maritime Museum, which

2.12.2 There are ninety-six recorded artefacts ranging from a ladder to depth gauge, hatch covers, smoking pipe, tea urn, plates, and cups.

- 5.4.3 Visitor access is also enabled through the Shipwreck Centre and Maritime Museum, Arreton, Isle of Wight. The museum has a specific cabinet that displays recovered artefacts from the A1 (Figure 12), and display telling the story of service and its discovery. The Centre has over eight thousand visitors per year (Woodward personal comment, 2023).
- 5.4.4 Virtual access to the site is enabled through the online virtual dive trail. This has the
