# Heat Pumps in Historic Buildings

The Viability of Water Source Heat Pumps in Historic Buildings

# Summary

This project was commissioned by Historic England and carried out by Max Fordham LLP. The research aligns directly with Historic England's climate change and sustainability objectives.

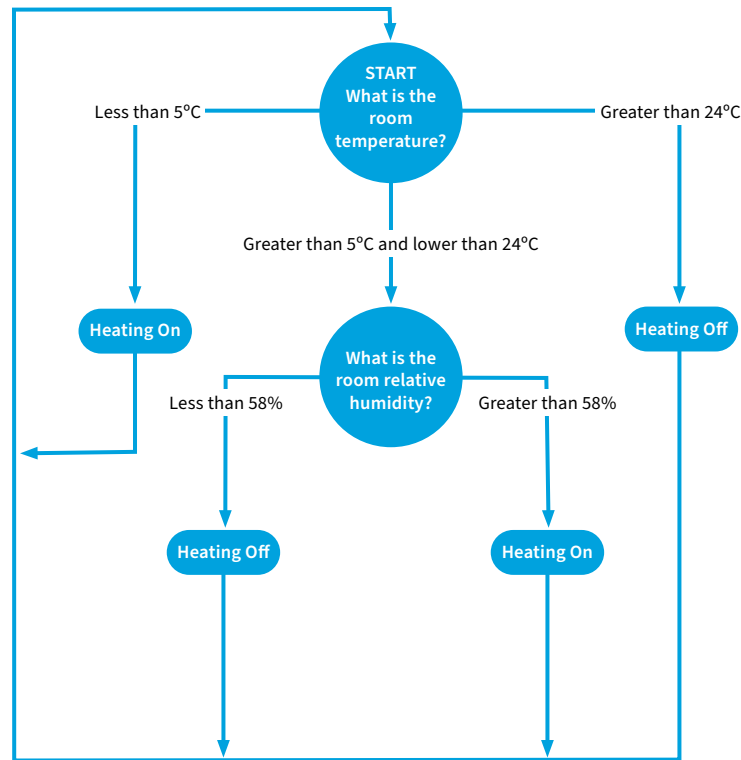
This method is the operating principle of conservation heating. It means that the heating system is not usually driven by the need for thermal comfort. In summer, the heating may be active to reduce the relative humidity, making the space uncomfortably hot. In winter, the relative humidity may be quite low, meaning that the heating does not come on, and the space is uncomfortably cold. Some systems balance the needs of conservation and comfort to ensure that the internal spaces are still within reasonable comfort temperatures, by setting lower and upper bounds on the indoor temperatures. Figure 2 shows an example of the control strategy that a conservation heating system may use. The set points are indicative and they are usually changed over the year. In summer, the relative humidity will naturally be higher than in winter, so a higher set point is used to reduce the quantity of heating required. The key objective is to prevent sharp swings in RH as this is what leads to damage of fabric and contents.

Figure 2: An example control strategy for a conservation heating system.

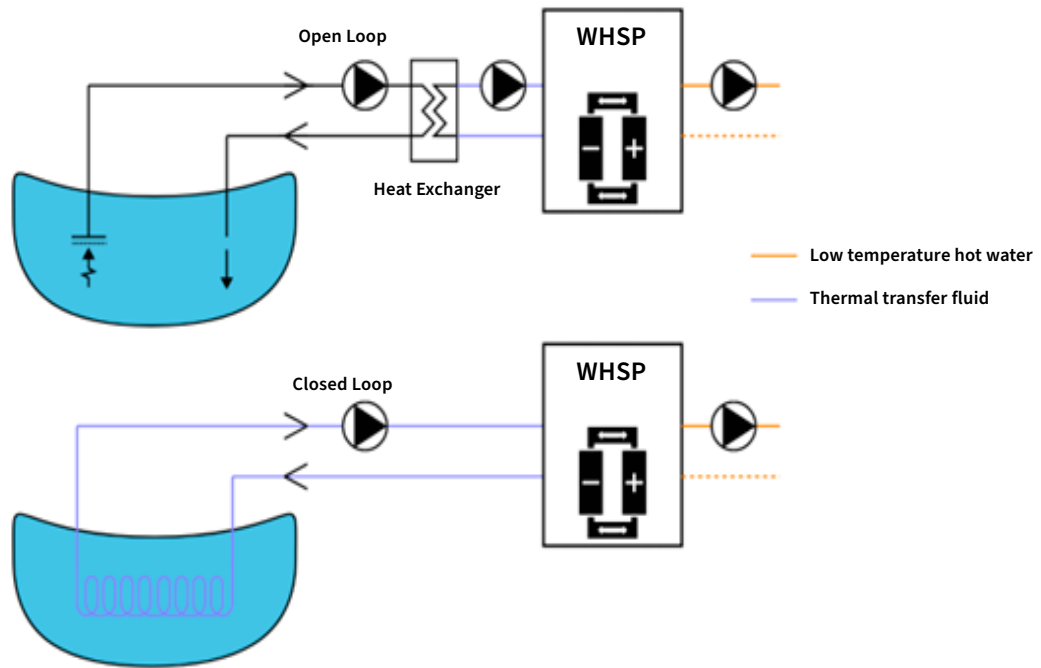
A WSHP extracts heat from a body of water, such as a river, lake, sea or canal. The system can be configured as open loop or closed loop, as shown in Figure 3. In an open-loop system, water is extracted from a source, passed through a heat exchanger and returned to the source. In a closed-loop system, the heat exchanger is submerged in the water source, usually as a thermal transfer fluid pipe or 'brine' loop. No water from the source enters the system.

Figure 3: Open loop and closed loop systems.

Provided there is suitable volume and flow, a smaller body of water can be used for an open-loop system because it does not have to accommodate the large lengths of pipe coil used in a closed-loop system. The installation process is also simpler.

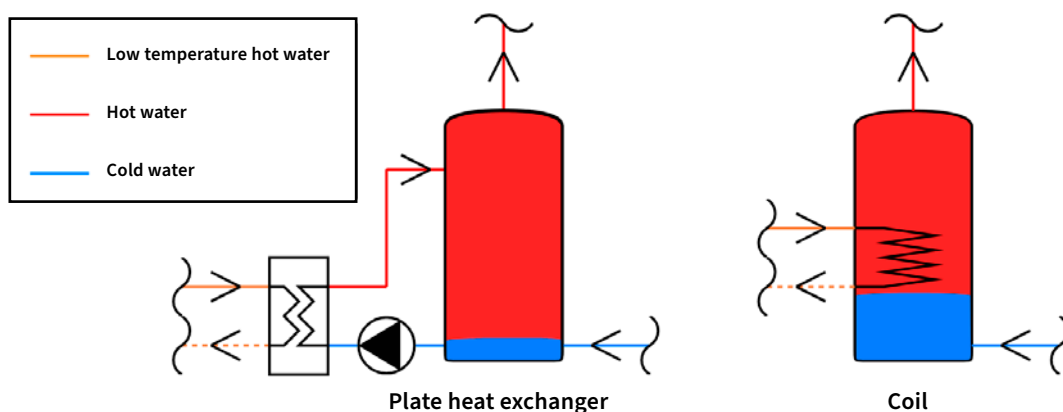
There are several methods to transfer heat from a WSHP to the water in a hot water storage cylinder. Two common types, coil and plate heat exchanger (PHX) are shown in Figure 4. When deciding on the best option, it is important to consider the specific characteristics of the WSHP, the required recovery time and storage utilisation (the amount of hot water storage that a particular building requires).

Figure 4: Domestic hot water cylinder configurations .

A coil-fed storage cylinder is often used because it is cheaper and more compact than having a separate plate heat exchanger within the plant room. However, it is important to note that the former typically has a lower heat output. This can lead to longer hot water reheat times. A properly sized plate heat exchanger can use the full heat output of a WSHP, enabling a faster reheat time for the water.

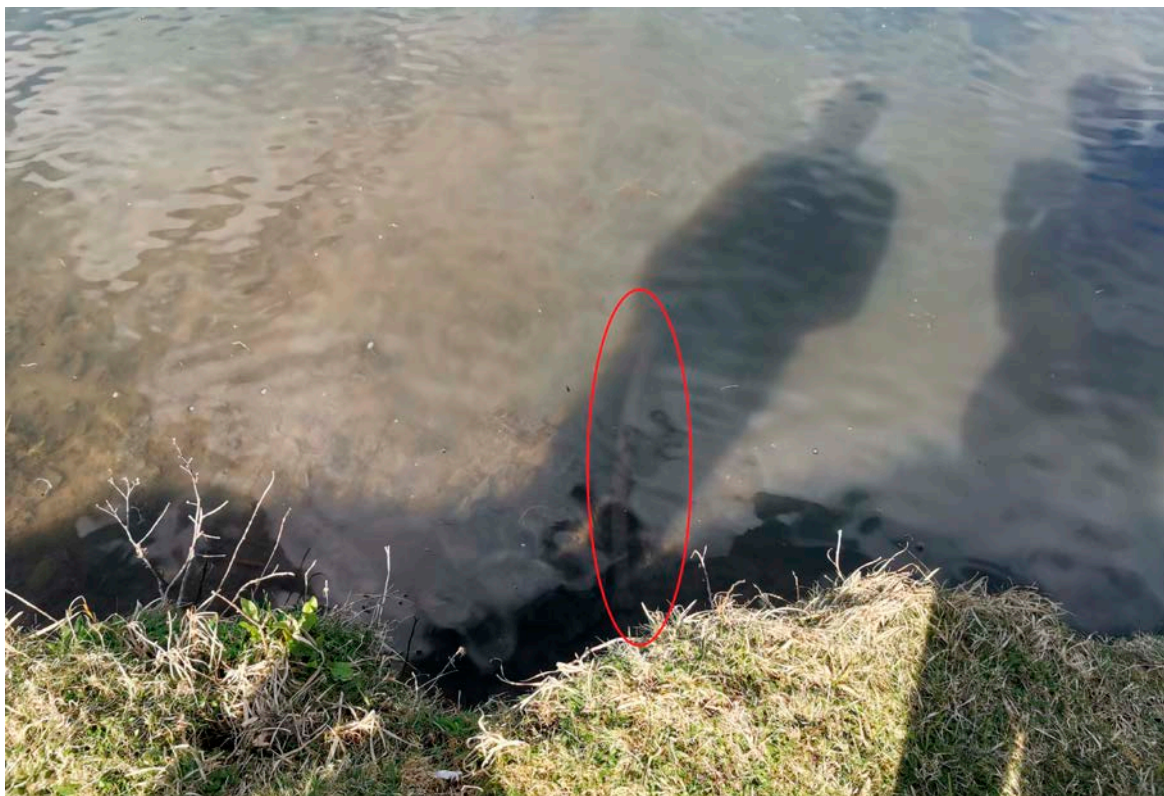
For a historic building or landscape, the visual impact of any works will be of particular concern. At all five case study sites, some form of external groundwork was required. Pipes were run between the plant room and the heat collector, often via a manifold chamber located close to the water source. However, during the site visits, it was difficult to spot where the groundwork had taken place, and closed loop heat collectors were only visible upon close inspection at the water's edge, as shown in Figure 5.

Figure 5: The closed loop collector.

Often, the only visible signs were the covers for the access hatches to the manifolds. These covers would probably go unnoticed by the public, but the visiting engineers were actively seeking signs of groundwork and often knew where to look. The site with an open loop system

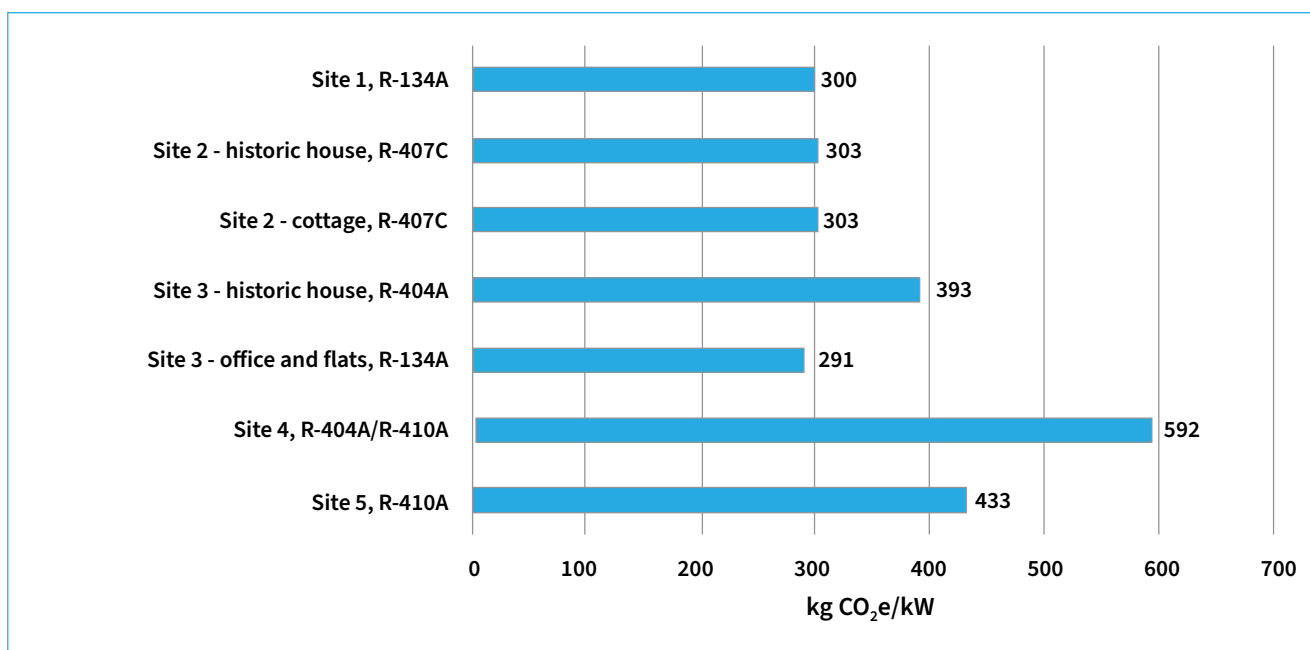
Selecting a WSHP with a low GWP refrigerant is essential for minimising the system's emissions. Figure 6 shows the full leakage emissions and system output for each of the WSHPs in the study, based on the GWP of the system refrigerant. It does not account for the embodied carbon that is emitted during the manufacturing of the refrigerant.

Figure 6: Total refrigerant leakage emissions per kW of installed system output.

System designers should select a low GWP refrigerant WSHP to minimise the equivalent emissions in the event of a leak. Furthermore, a key goal of Fluorinated gas (F-gas) regulations is to phase down using refrigerants that have significant GWP when released into the atmosphere, such as R-410A. These high GWP refrigerants will, therefore, have a more constrained supply, meaning the price is likely to rise significantly. This is important because it means that the costs of repairing a R-410A WSHP that develops a leak will probably

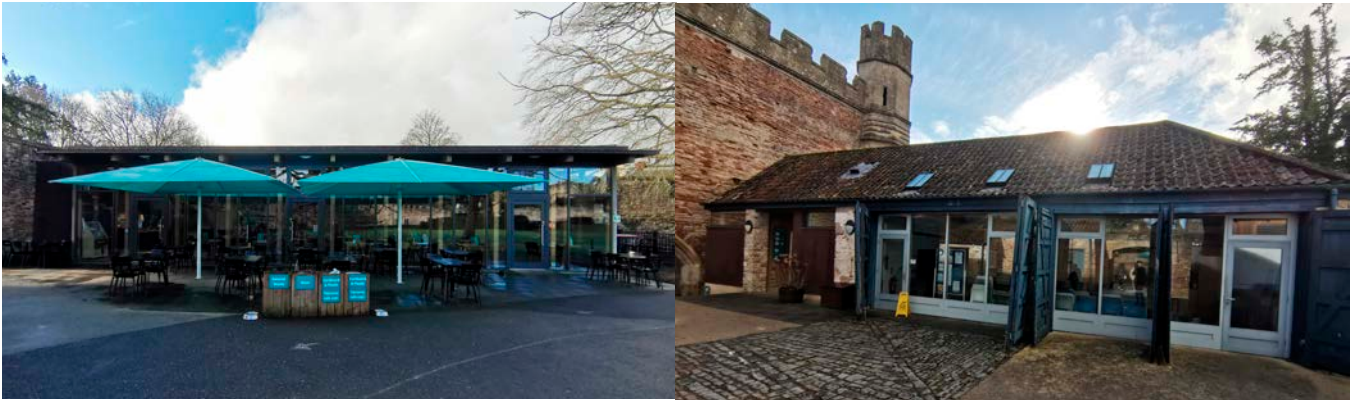
Site 1 uses a 20kW WSHP to heat the outbuildings. A closed-loop collector placed within the moat on a sunken platform provides the heat source. Underfloor heating is used to heat the toilets, learning centre and cafe, while radiators heat the office.

Figure 9: The cafe (left) and learning centre and toilet block (right), heated by the WSHP.

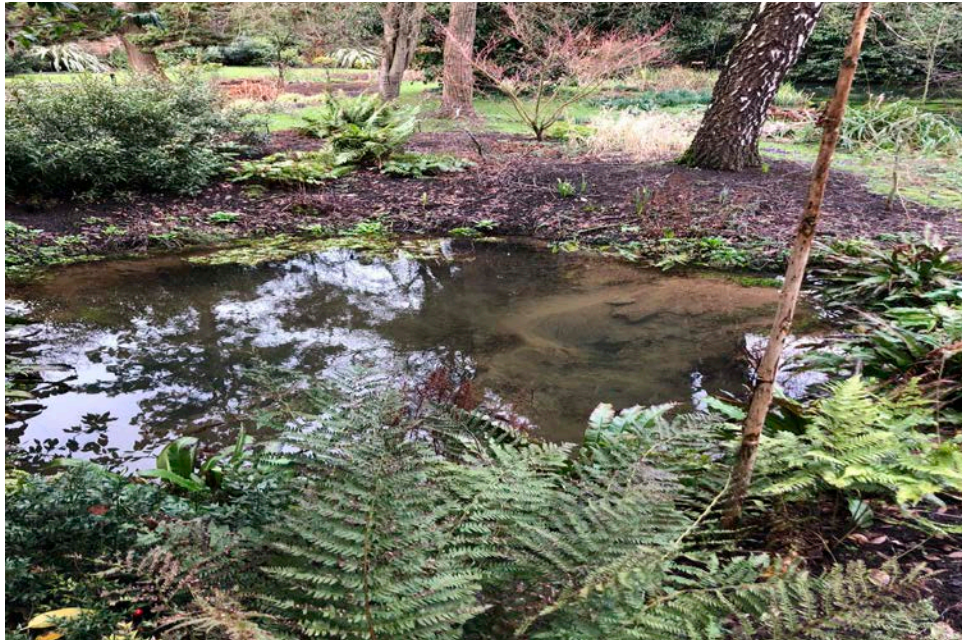
At this site, there is a sluice gate that controls the water level in the moat. Originally meant to prevent flooding, it can also be used to drain the moat, which was very helpful when the heat collectors were installed.

Figure 10: One of the springs from the emerging river that feeds the moat.

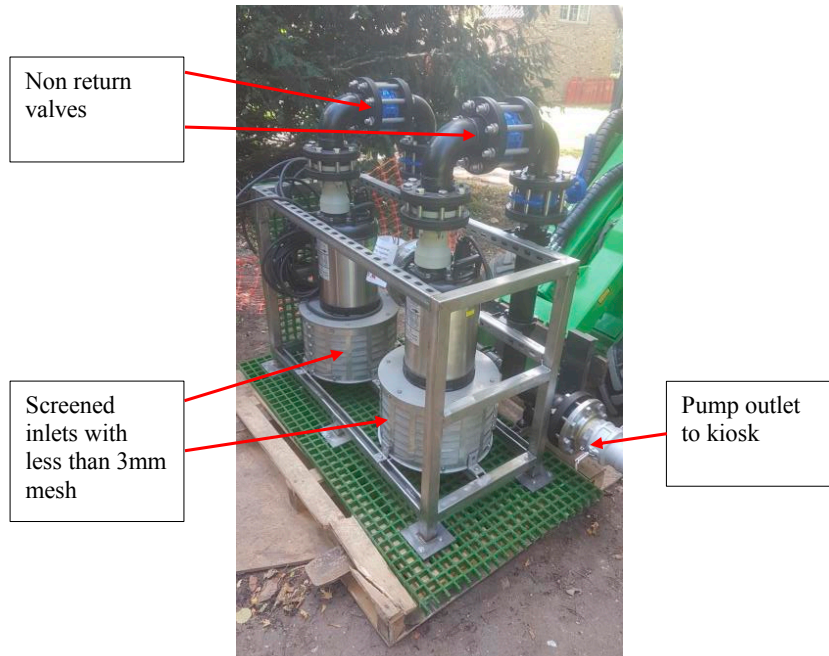
The pumps' location in the middle of the river and under the footbridge, makes maintenance very difficult. Examining the installed pumps and the image of the pump assembly shown in Figure 12, it appears that some parts of the screened inlets are covered by debris on the riverbed. This will reduce the flow available to the system. A full risk assessment must be undertaken to safely carry out pump maintenance.

**Figure 12:** Extract from the installer's handover document, showing the pumps before they were installed in the riverbed.

Closed-loop systems require no maintenance in most cases, and the site owner has expressed an interest in converting to a closed-loop system in the future. All the other sites in this study have yet to carry out any maintenance on their closed-loop collectors. However, a closed-loop system requires significantly more space in the river than an open-loop system, because long runs of coils are needed to extract the necessary heat. At Site 2, the river is relatively narrow, and so a larger length of the river would be required for heat collectors if a closed-loop system were used.

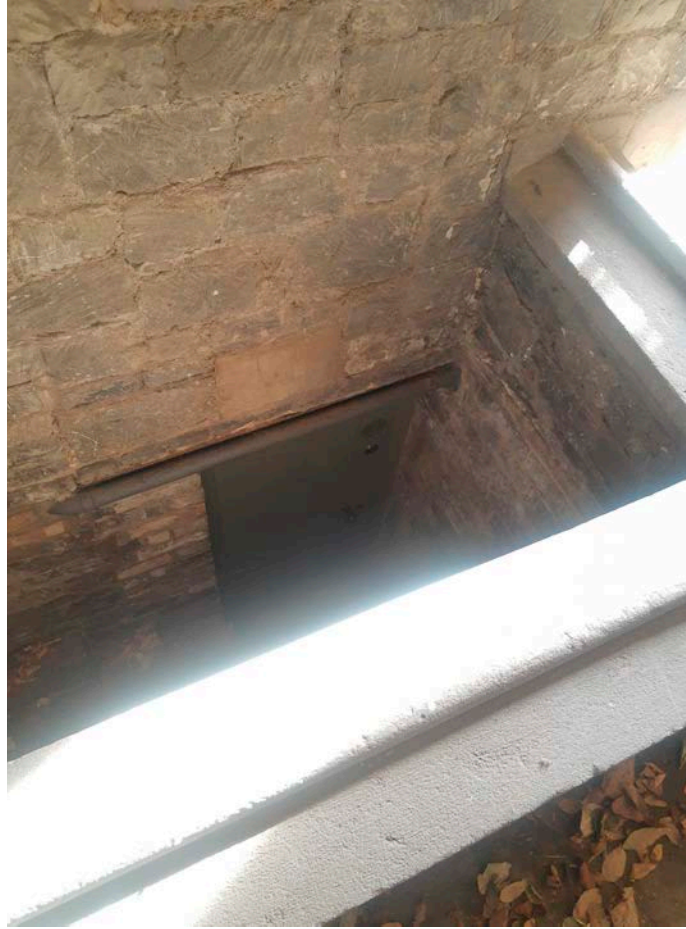
The WSHPs are located in a plant room in the basement of the cottage, which previously housed an oil boiler. The space is very restricted, with little standing room and densely packed equipment. Using the existing basement reduces the likelihood of noise from the WSHPs and means that space is not lost on the ground and other floors. However, access to this basement is down a narrow stairway with a 90-degree bend, shown in Figure 13.

**Figure 13:** Cottage plant room door, located at the bottom of a staircase.

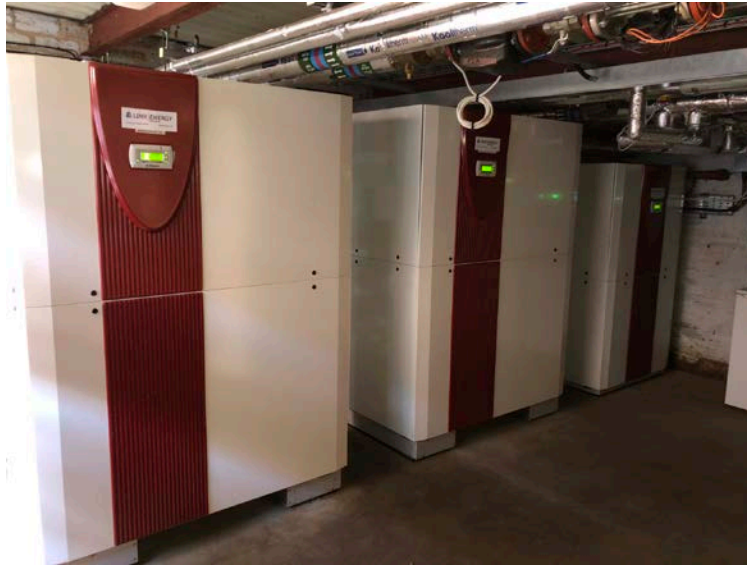
Heating for thermal comfort is provided on separate circuits to the office accommodation and flats, powered by a 40kW and a 20kW WSHP, sharing a 500l buffer vessel. The offices and flats use modern radiators to deliver heat. Oil boilers have been retained to provide back-up heat to these areas.

Figure 15: Dimplex WSHPs in the plant room.

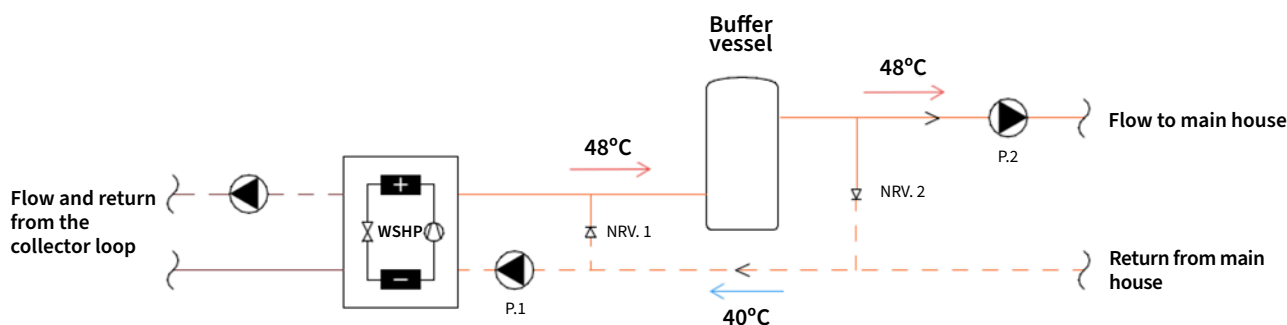
To guarantee that minimum operating flow rates are available to the WSHP at all times, including when P.2 is inactive, a second bypass is fitted to the right-hand side of the buffer vessel. The non-return valve (NRV.2) on this bypass is also essential. Without it, some heating system return water would flow through the bypass, rather than make its way back through the buffer vessel or heat pump.

**Figure 16:** A schematic of how the two-pipe buffer vessel and bypass legs should have been installed according to the schematic found during the site visit.

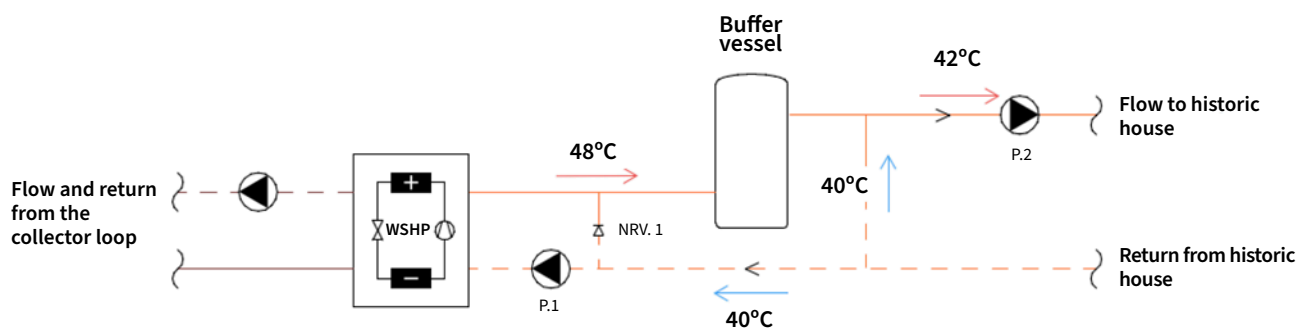
Figure 17 shows the temperatures observed during the visit. The WSHP could improve its efficiency by approximately 15 per cent if it produced 42°C water instead of 48°C.

**Figure 17:** A schematic of the two-pipe buffer vessel arrangement that was installed on site, with readings taken from temperature gauges on site.

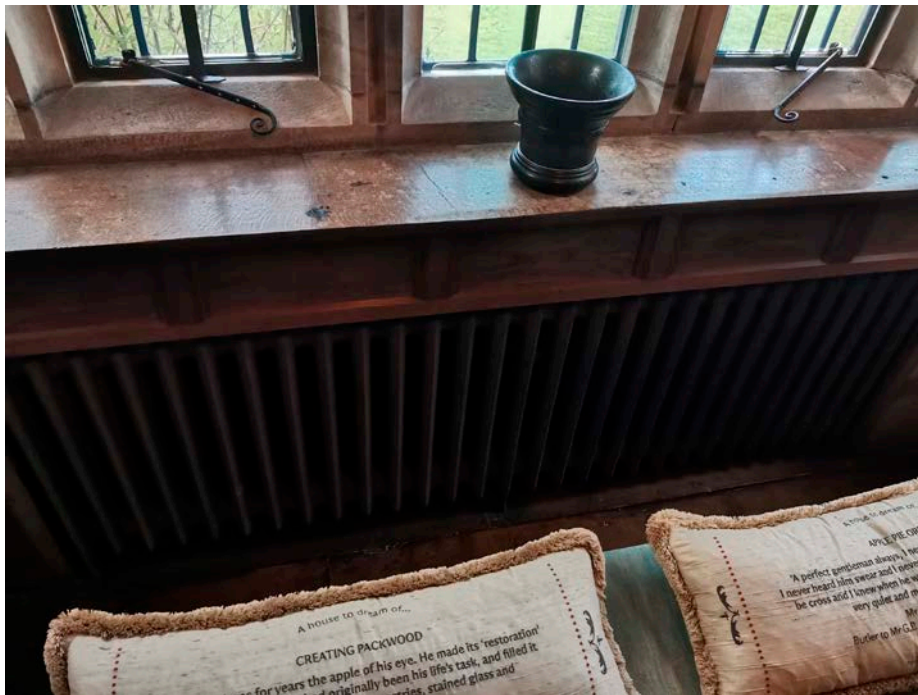
flow temperatures, this avoids any negative impact on the WSHP's performance that may result from running it at high temperatures. Third, it reduces the installation work required, resulting in lower costs and fewer modifications to the historic building.

Figure 18: Historic radiators underneath a window sill.

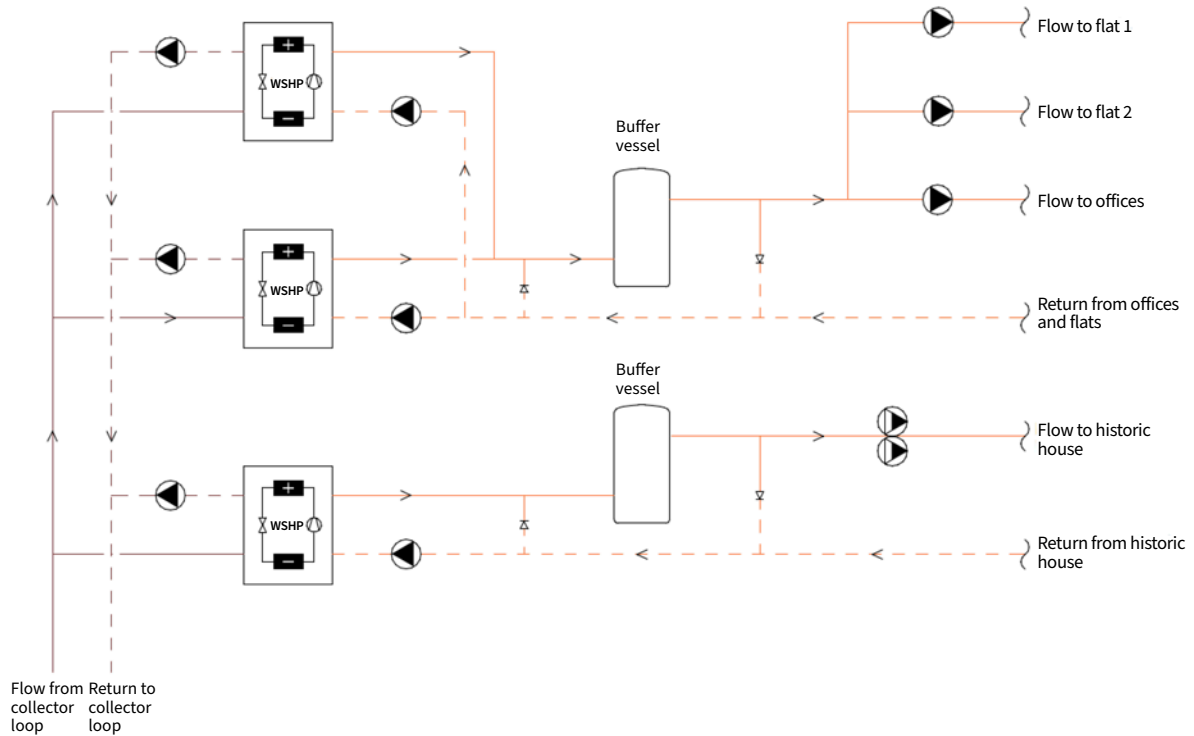
Generally, it is advisable to separate the thermal comfort and conservation heating circuits, similar to the system at Site 3, shown in Figure 19 below.

**Figure 19:** A simplified schematic of the heating system at Site 3, using separate WSHPs for conservation heating and thermal comfort.

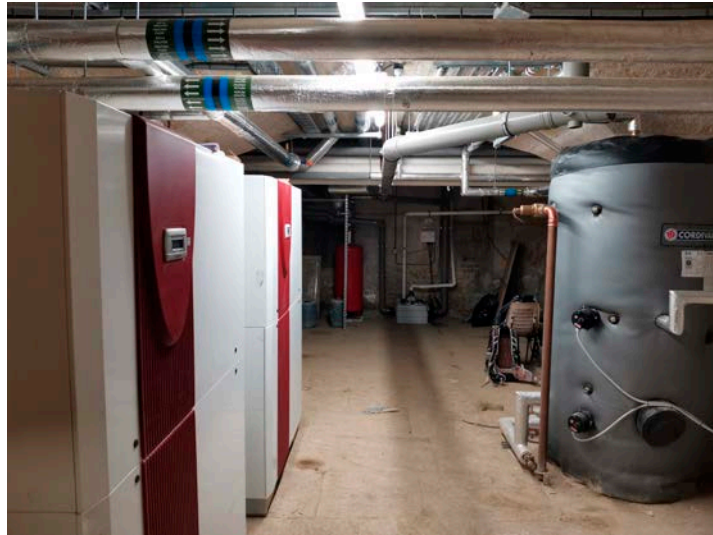
Figure 22: Dimplex SI 75TU WSHPs in the basement plant room at Site 4.

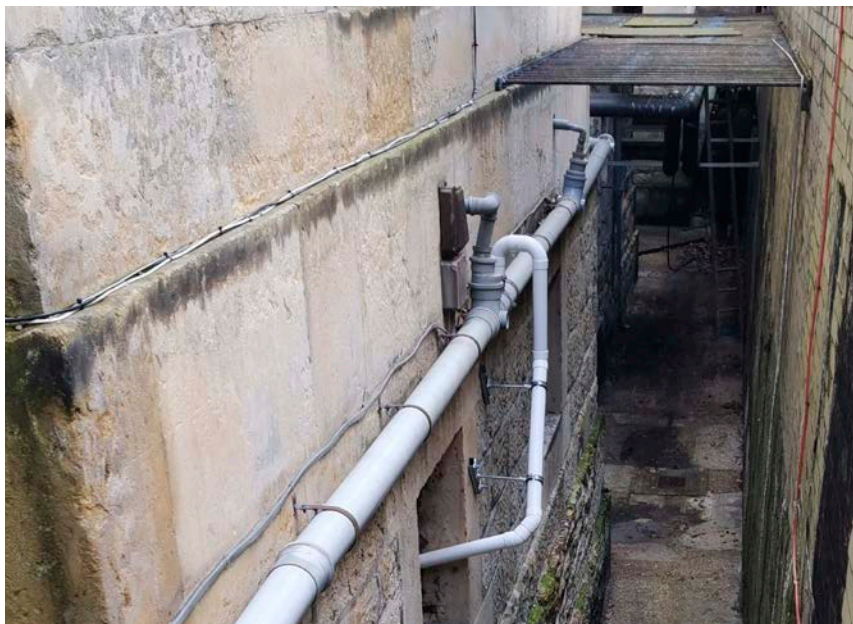
**Figure 23:** Black pipework that connects the lake heat collector to the plant room in the background.

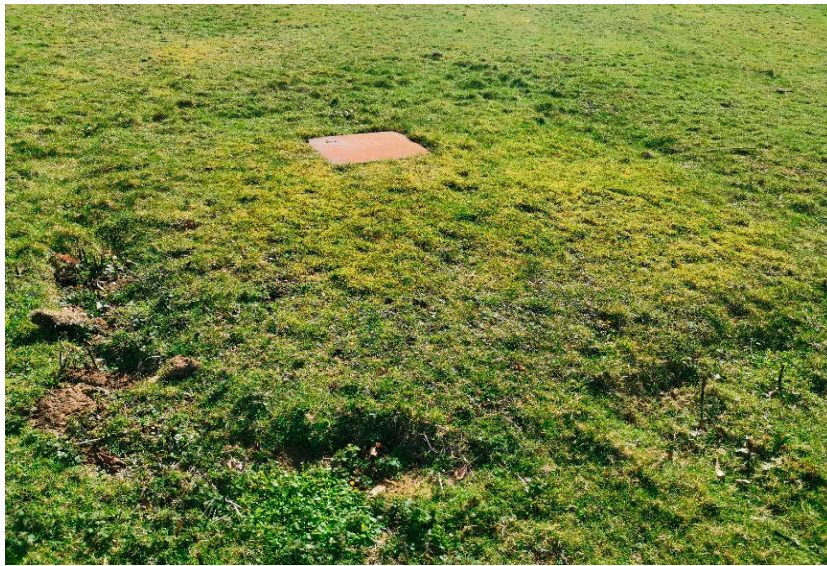
- The WSHPs use a closed-loop collector system.
- Multiple pipe loops are submerged in the Dairy Pond.
- The loops are placed at least 2m apart and located in an area of approximately 200 x 50m.
- The multiple loops are gathered in a collector manifold in a below-ground chamber, close to the pond's edge.
- For the collector, coils were chosen over flat loops.
- The area where the collector is buried can be seen against the surrounding landscape, see Figure 24.
- Some pipes are visible in the pond. The pipe that runs out to the collector manifold has caused minor visible differences.

Figure 24: The raised ground around the manifold collector chamber.

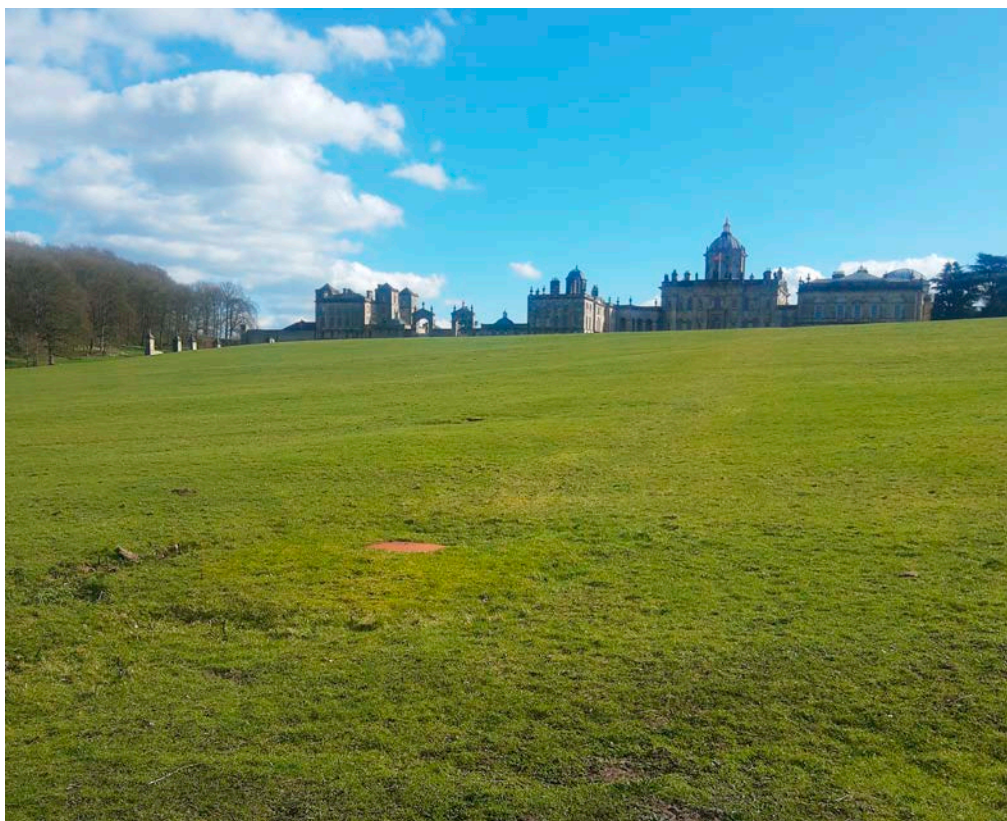
When the WSHPs were installed in 2009, spare pipework was added between the plant room and the pond. This meant that less groundwork was required when the additional WSHPs were installed in 2020. It also reduced the installation costs and minimised the disruption. The pipe run from the plant room to the water source is approximately 270m, and it crosses a well-used path. An additional manifold and manifold chamber, plus more collector loops had to be installed in 2020.

**Figure 25:** The manhole for one of the collector loop manifolds, with the historic house in the distance.

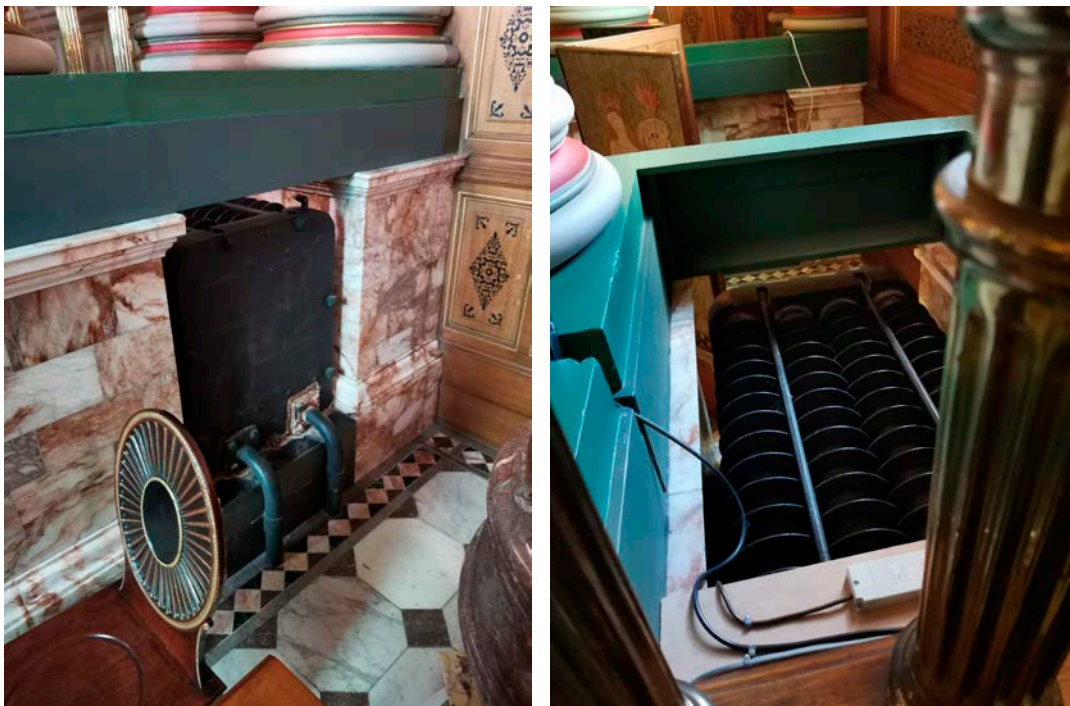
Using existing heat emitters may save money initially, but there may be significant repair costs in the future, which should be budgeted for. Historic England recommends that the refurbishment of historic radiators should include painting, flushing and pressure testing to help mitigate this issue.

Figure 26: Historic radiators within the chapel.

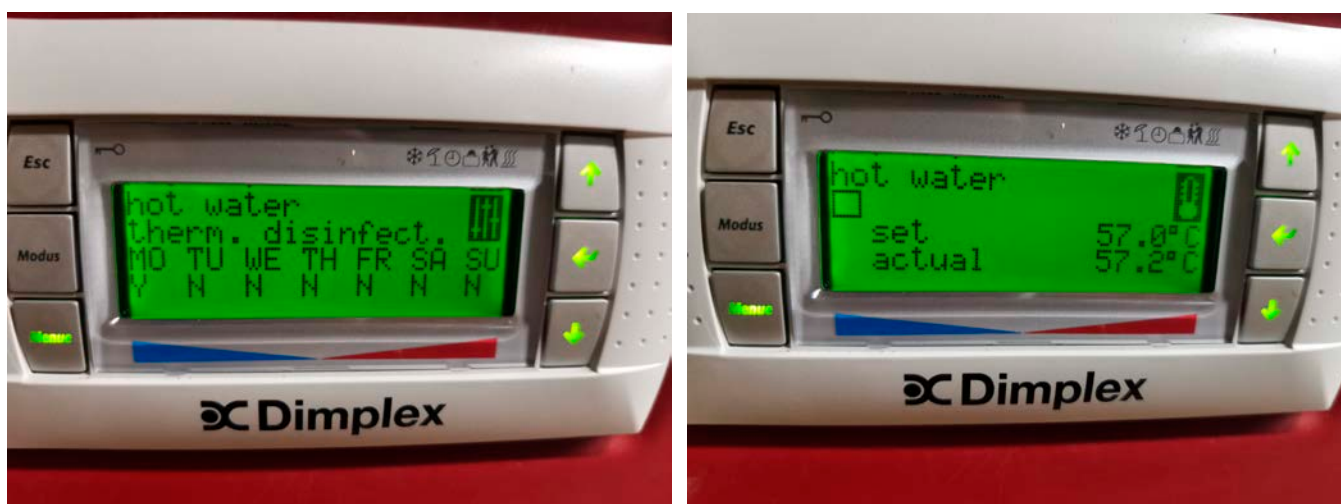
The domestic hot water cylinder for the 2020 WSHPs was installed with two 12kW immersion heaters. These heaters will be able to heat the hot water to a higher temperature than the WSHPs can achieve, and they will supplement the WSHPs. The controls for the heaters are linked to the WSHP control panel. There is a risk of the less efficient immersion heaters taking over the heating of the hot water, which will greatly increase running costs. As the immersion heaters are directly controlled by the WSHPs, they should only operate when required. The heat pump has recorded the run time of the immersion heaters to be 451 hours.

Figure 27: The WSHP control panel for the thermal disinfection cycle (left) and the hot water temperature (right).

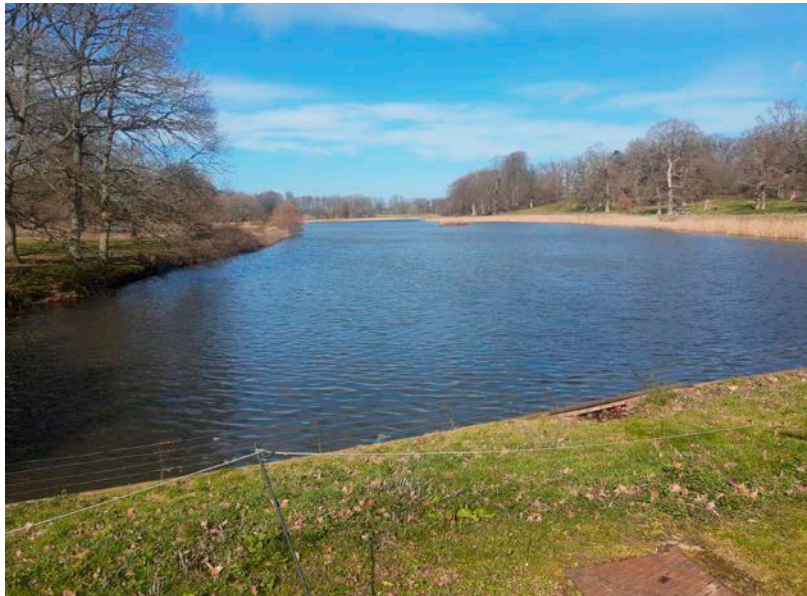
In 2016, two WSHPs were installed with a combined capacity of 205kW. Extracting heat from the nearby lake via a closed-loop system, the WSHPs provide conservation heating to the visitor areas of the main house and comfort heating to the staff offices and accommodation. Heat is delivered through a variety of historic radiators, which were previously powered by an oil boiler. The staff offices contain some modern twin-panel radiators. In addition to the WSHPs, there is also an LPG boiler that serves as a back-up in case the WSHPs fail.

Figure 29: Lake at Site 5, with manifold chamber cover.

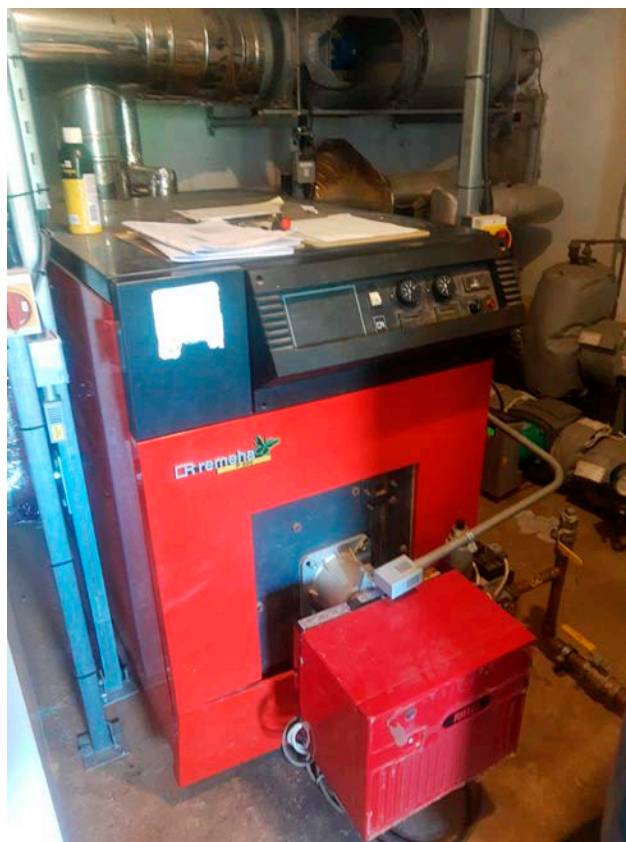
The WSHPs are backed up by a 150kW LPG boiler, shown in Figure 30. This was originally one of the old oil boilers and was adapted for LPG use. It was determined that retaining an LPG boiler as a back-up heat source was a worthwhile additional cost. LPG is also favoured over oil due to the reduced environmental risk in the event of a fuel leak.

Figure 30: Existing oil boiler, which was repurposed to LPG.

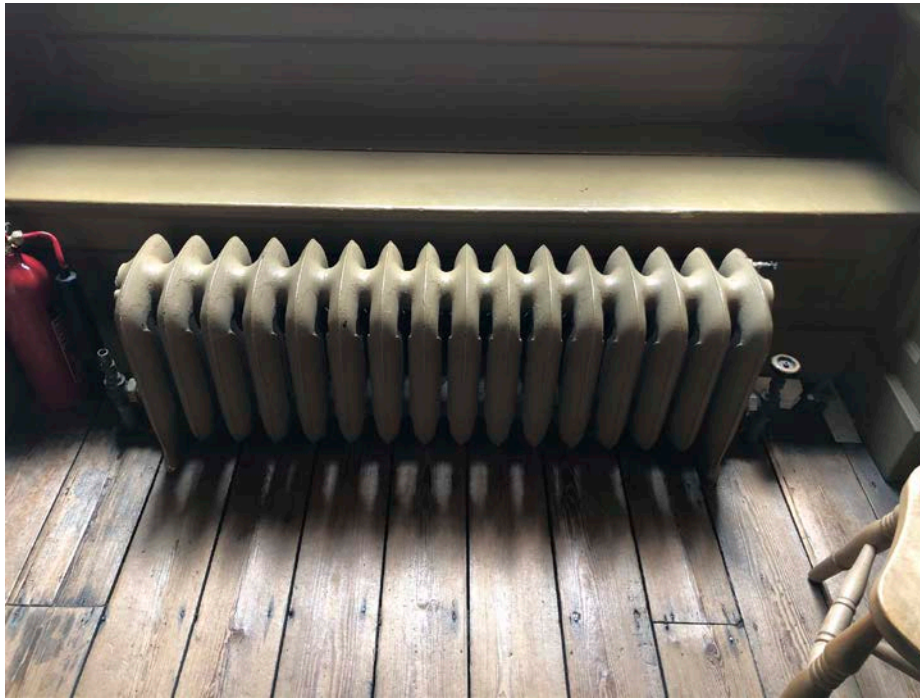
The staff at the main house reported that the new system, which focuses on conservation rather than comfort, was surprisingly more comfortable than the previous oil-fired system. In contrast to the oil boiler's short bursts, the consistent operation and lower flow temperatures of the WSHP likely contributes to this improvement.

Figure 31: Cast iron radiator at Site 5.
