# Assessing Damp in Historic Buildings

A Practical Guide to Investigation and Diagnosis

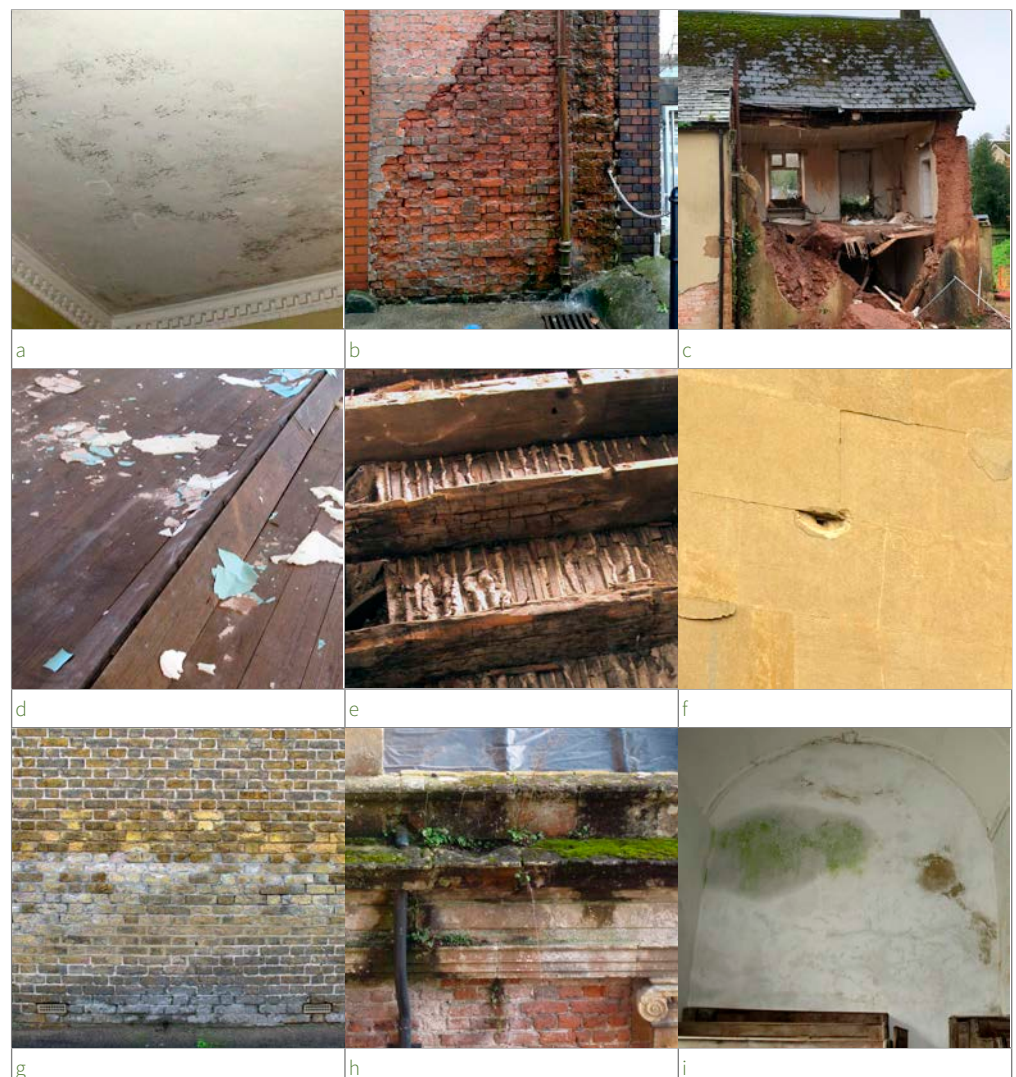
**Figure 3:**  
Deterioration and damage caused by excess moisture:  
a. Mould growth on internal surfaces.  
b. Freeze/thaw damage to brickwork saturated by blocked rainwater pipe.  
c. Collapse of earthen walling caused by water trapped by impermeable surface finishes.  
d. Warping and buckling of floor boards saturated by flooding.  
e. Timber decay and infestation.  
f. Spalling of masonry caused by corrosion of embedded iron cramps.  
g. Salt crystallisation damage to brickwork.  
h. Colonisation of surface by algae, moss and plants.  
i. Damp patches – internal finishes disfigured and damaged.

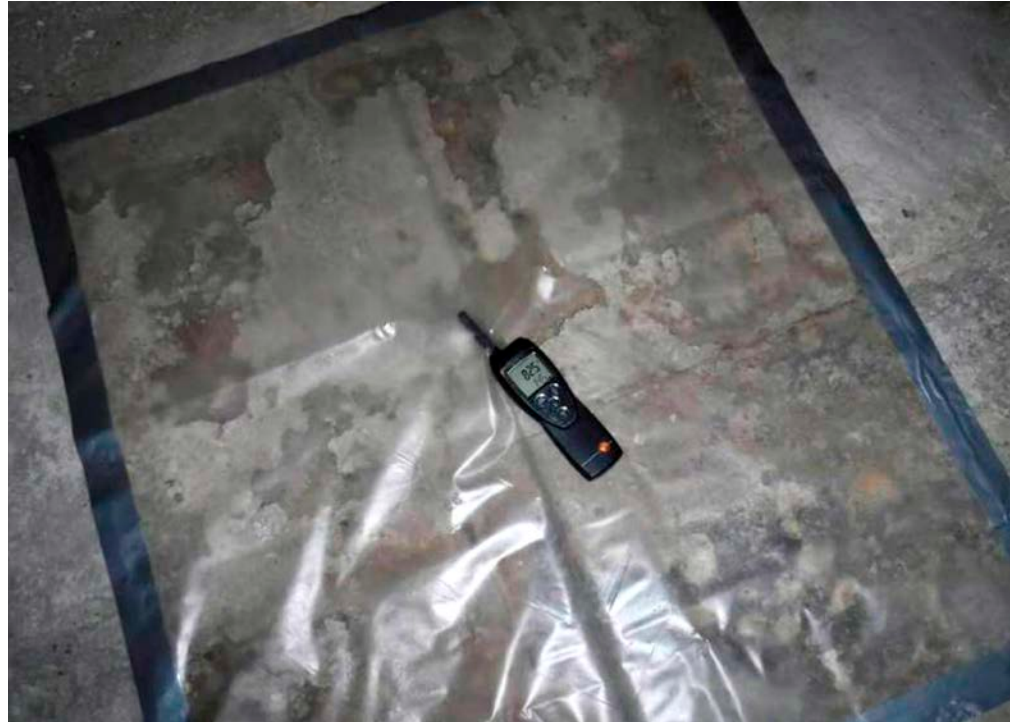
Figure 6:

The surveyor was asked if moisture was rising through a basement floor slab. Moisture meters produced erratic readings, so squares of polythene were taped down in a grid pattern and left overnight. In the morning, a small slit was cut in the centre of each, and the probe of a thermohygrometer was inserted. Readings from each square (converted into absolute air moisture content) were compared with readings obtained from the room.

Another method for assessing damp migration through walls and solid floors is to determine the humidity of air trapped beneath a sheet of polythene. Ideally, the polythene sheet should be about 1m<sup>2</sup> and sealed around the edges with tape (Figure 6). However, this will not always be practical, and the surveyor may have to improvise. On floors where it is not possible to use tape, the edges of the polythene sheet can be weighted down with sand or a wooden frame (Figure 7). Alternatively, a shallow polythene box might be used. This would also have to be weighted down and sealed around the

If time is not a constraint, moisture levels in a wall can be assessed more reliably by using a data logger to record the temperature and relative humidity of air trapped behind a polythene sheet, as described previously (see Figures 6 and 7).

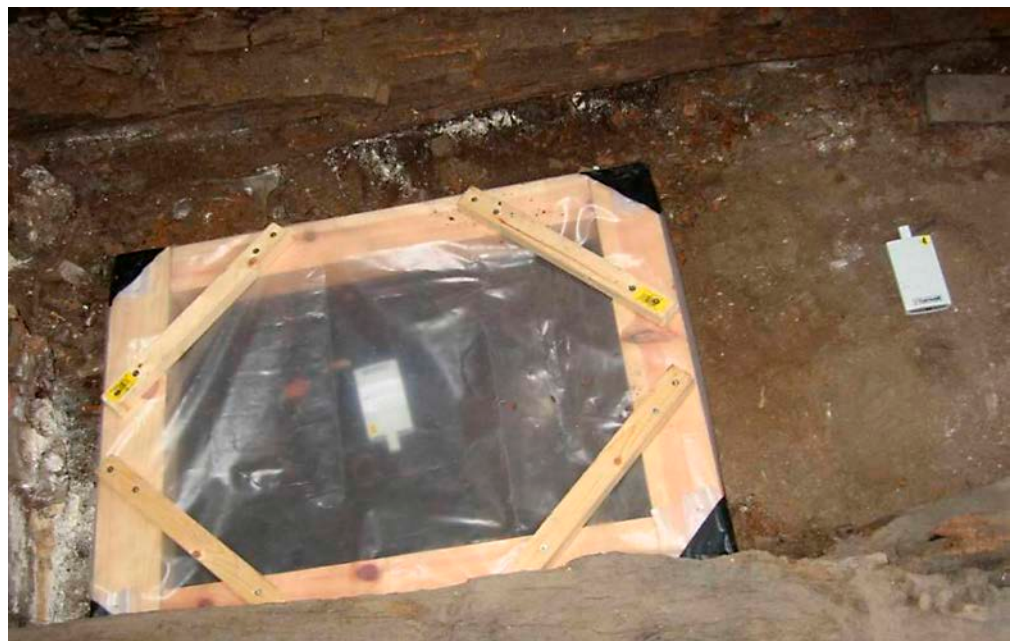
Figure 7:

In this case, because space was limited and adhesive tape was not practical, a wooden frame was used to produce an enclosed environment. The assemblage was left for several days, after which logger readings within and outside the enclosure were compared.

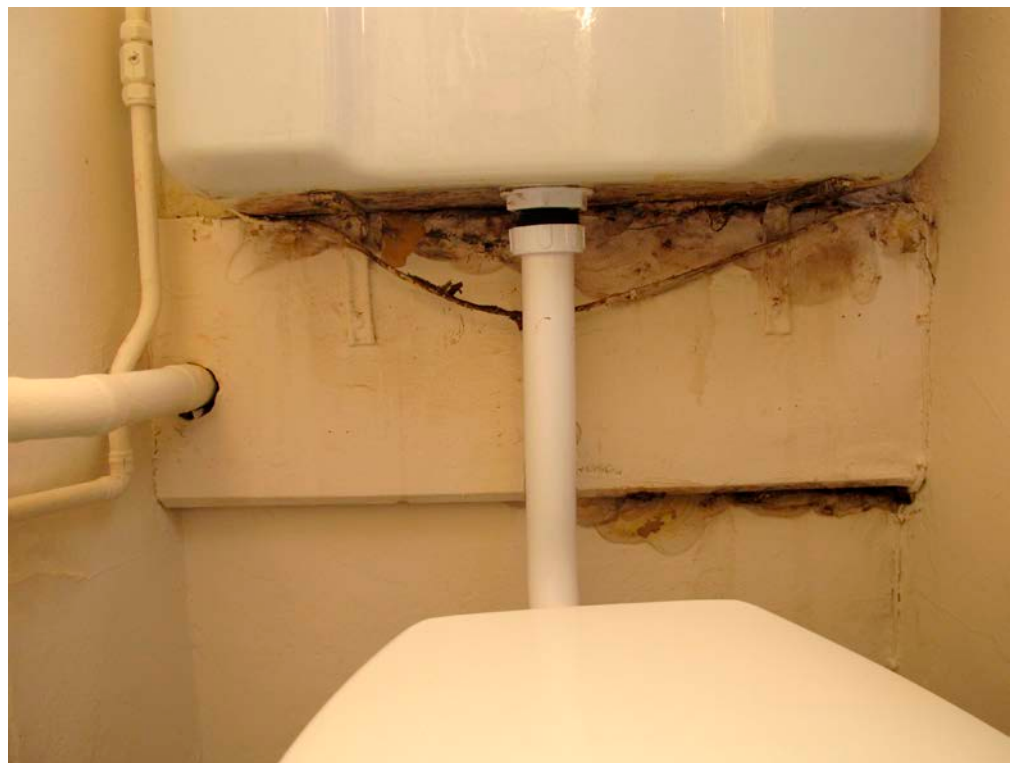
Figure 14:  
Water from a leaking  
cistern has resulted in  
fungal decay in a timber  
pattress.

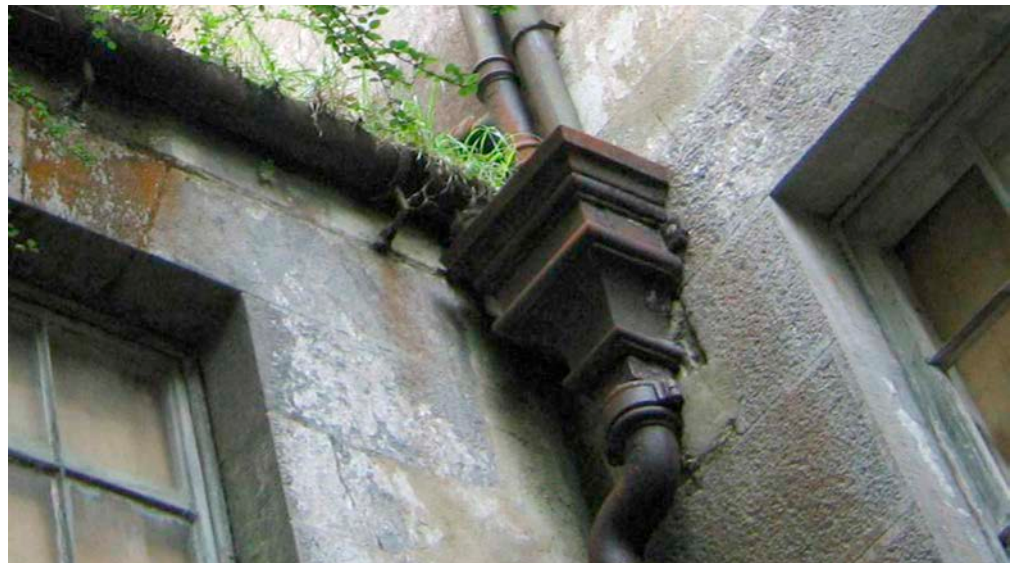
Figure 15:  
Rainwater overflowing from a partially blocked gutter and hopper head was indicated by the algae staining the wall. In addition, the back of the hopper had corroded and water was leaking into the wall through open joints.

Gutters, especially valley and parapet gutters and outlets, should be inspected regularly to ensure they are free from blockages. In addition, rainwater pipes should be checked regularly to make sure they are draining freely. Damp staining on walls behind pipes might indicate blocked **hoppers**, leaking joints or perhaps rust damage at the back of a cast iron pipe. If vegetation is visible, it is usually a sign that the gutter is blocked; rainwater will be finding pathways down the walls and into open joints. Inspection and clearance are often fairly straightforward (Figure 15) but can be difficult where there is restricted access (Figure 16).

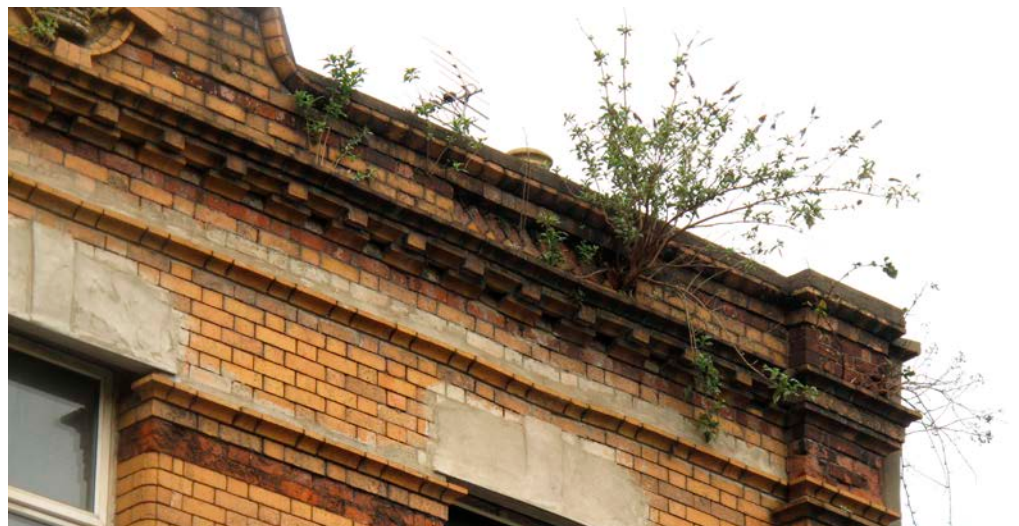
Figure 16:  
Height and restricted access can make gutter inspection and clearing difficult and expensive. However, if vegetation is visible from ground level, it is likely that rainwater will be finding its own way down through the building.

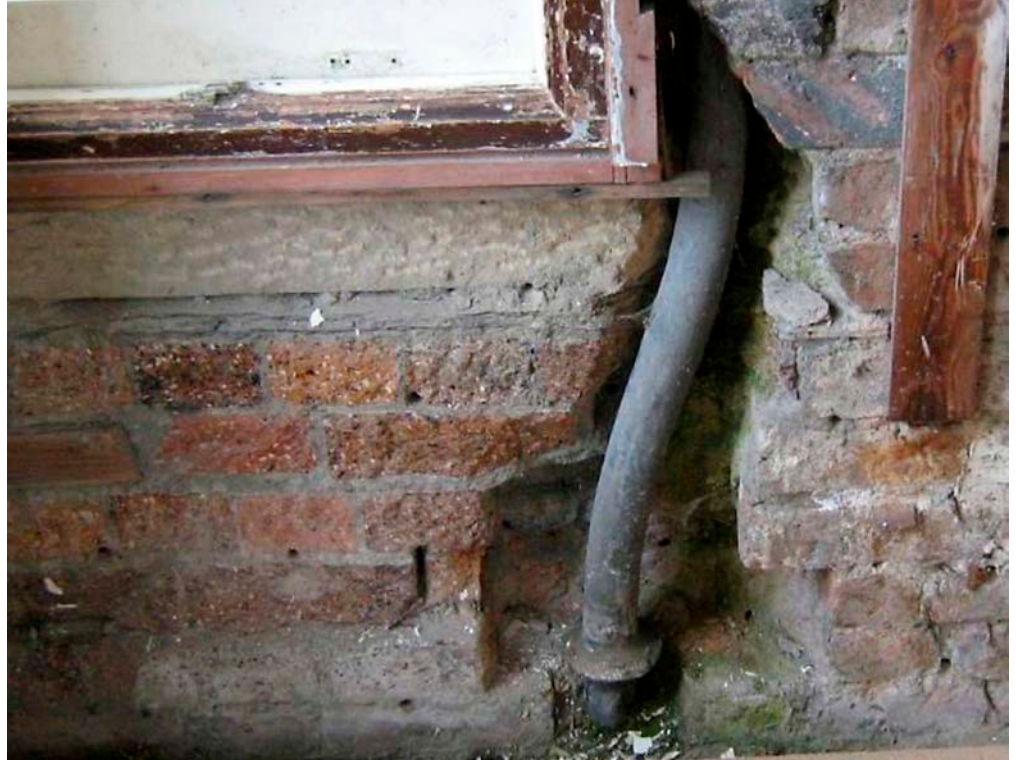
Figure 17:  
An old lead internal  
rainwater pipe revealed  
when wall linings were  
removed.

Occasionally, architects do not want rainwater pipes to be visible on the principal elevations. In such cases, concealed and often complex drainage routes are devised. For example, a parapet gutter might drain into a lead-lined wooden trough within the roof space, before discharging into a rainwater pipe on the rear elevation. Rainwater pipes might also be routed inside the building. These are often boxed in or concealed within the thickness of walls (Figure 17), and only visible in the basement. If these internal rainwater pipes become blocked, they can cause considerable decay and damage (Figure 18). Surveyors should look for hatches or access points at intermediate levels in order to reach the source of damage.

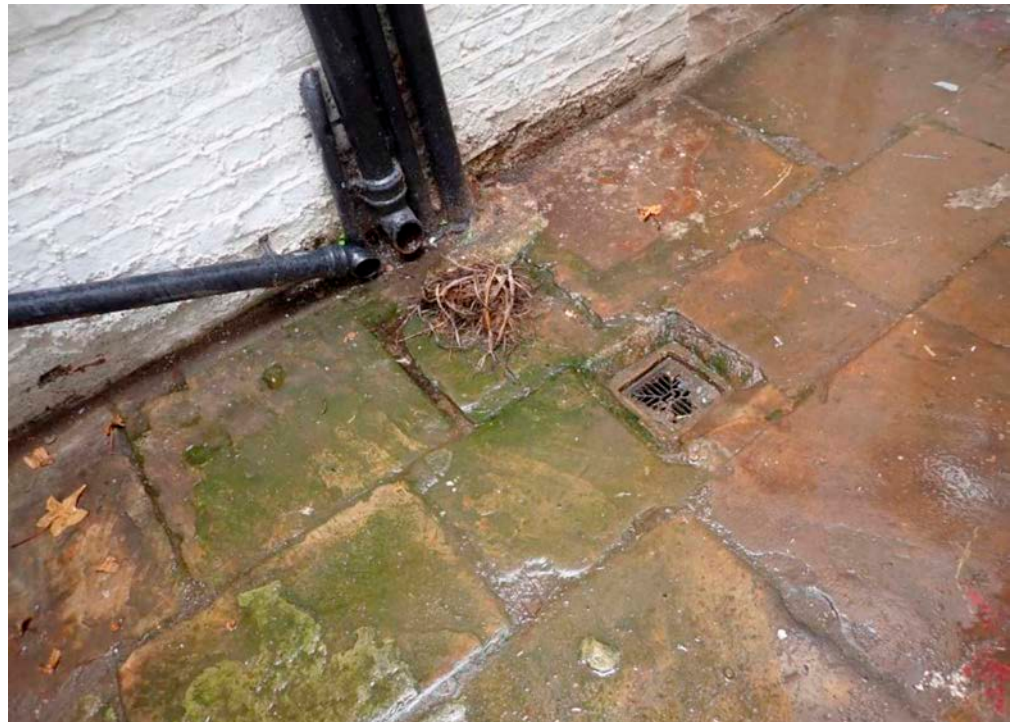
Figure 19:  
The ground floor in this building is at the same level as the external ground level, so it is essential that the external area is well drained. Unfortunately, water discharging from the rainwater pipe does not reach the gully because of the unevenness of the paving. Instead, it soaks into the joints between the slabs, allowing vegetation to grow and saturating the ground beneath. Moisture then rises within the wall.

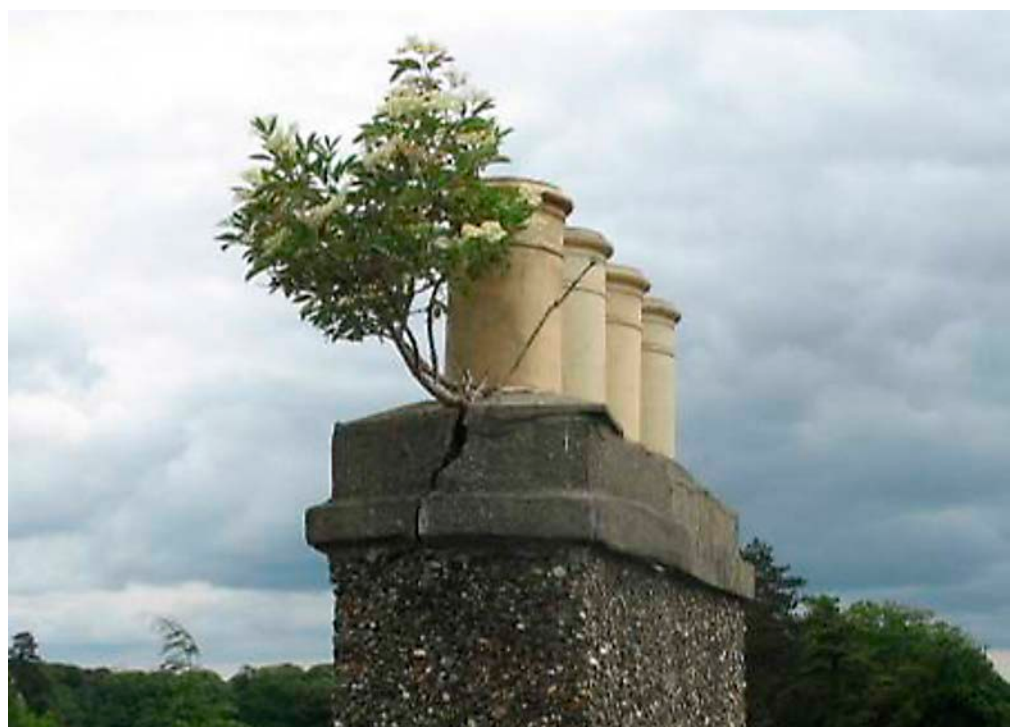
Figure 20:  
The roots of a shrub growing in a chimney stack cause structural damage and allows water penetration. These problems will get worse as the plant grows.

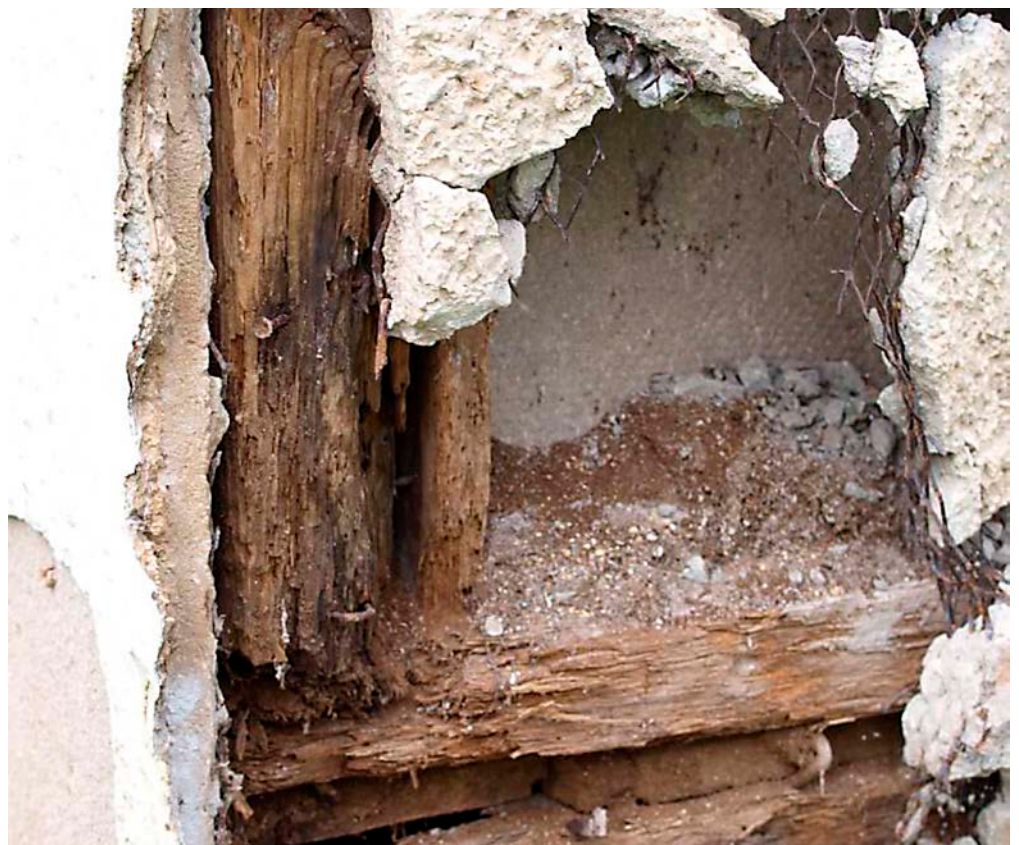
Figure 21:  
This timber frame  
was covered by an  
impermeable cementitious  
render on metal mesh.  
Fine shrinkage cracks  
allowed moisture to  
penetrate. In addition,  
condensation occurred on  
the cold interior surface of  
the render. Trapped  
moisture at the interface  
between the frame and the  
render caused the timber  
to decay.

Cementitious renders have proved to be particularly harmful when applied to timber-framed buildings. Renders crack, allowing water penetration, but they also produce an impermeable cold internal surface within the thickness of the wall on which condensation forms (Figure 21). Cement-rendered infill panels produce similar problems. Original daub panels expanded when wet, forming a seal with the surrounding timber framing, but the cementitious material shrinks away, leaving fine cracks that allow water ingress. Trapped moisture can then cause significant decay. It also allows deathwatch beetles to thrive. In earthen constructions, water trapped by cementitious renders may weaken walls to the extent they become unstable and collapse.

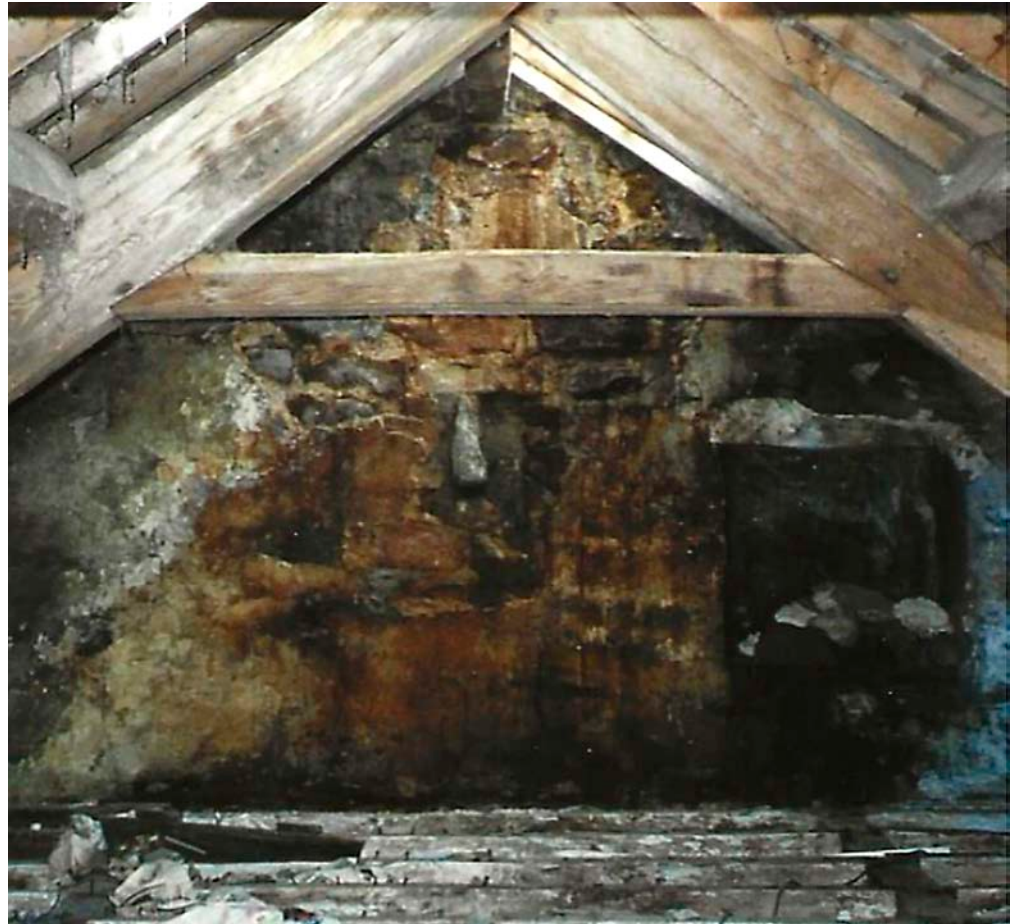
Figure 22:  
The 'blood in the bath  
mystery'.

The combustion products of wood and coal are also a source of salts. In 2013, the purchaser of an old farmhouse in Clitheroe, Lancashire, was alarmed to find a blood-like fluid dripping through the ceiling and into the bath. An inspection of the roof space above found that the gable wall, which contained a flue, was discoloured with red water run marks (Figure 22). Analysis of the fluid showed that it contained predominantly calcium chloride with potassium, magnesium and ammonium salts. The red material was a water-soluble combustion product from lignin. Wood and coal had been used as a domestic fuel for many years, and water penetration at the back of the chimney stack was mobilising contaminating salts from the unlined flue.

Patches of plaster with hygroscopic discoloration are sometimes found on walls containing old flues. They indicate moisture movement and the consequential migration of contaminants. The abnormally high chloride level in the Clitheroe example may have been partially due to hydrogen chloride emissions from lime kilns further down the valley.

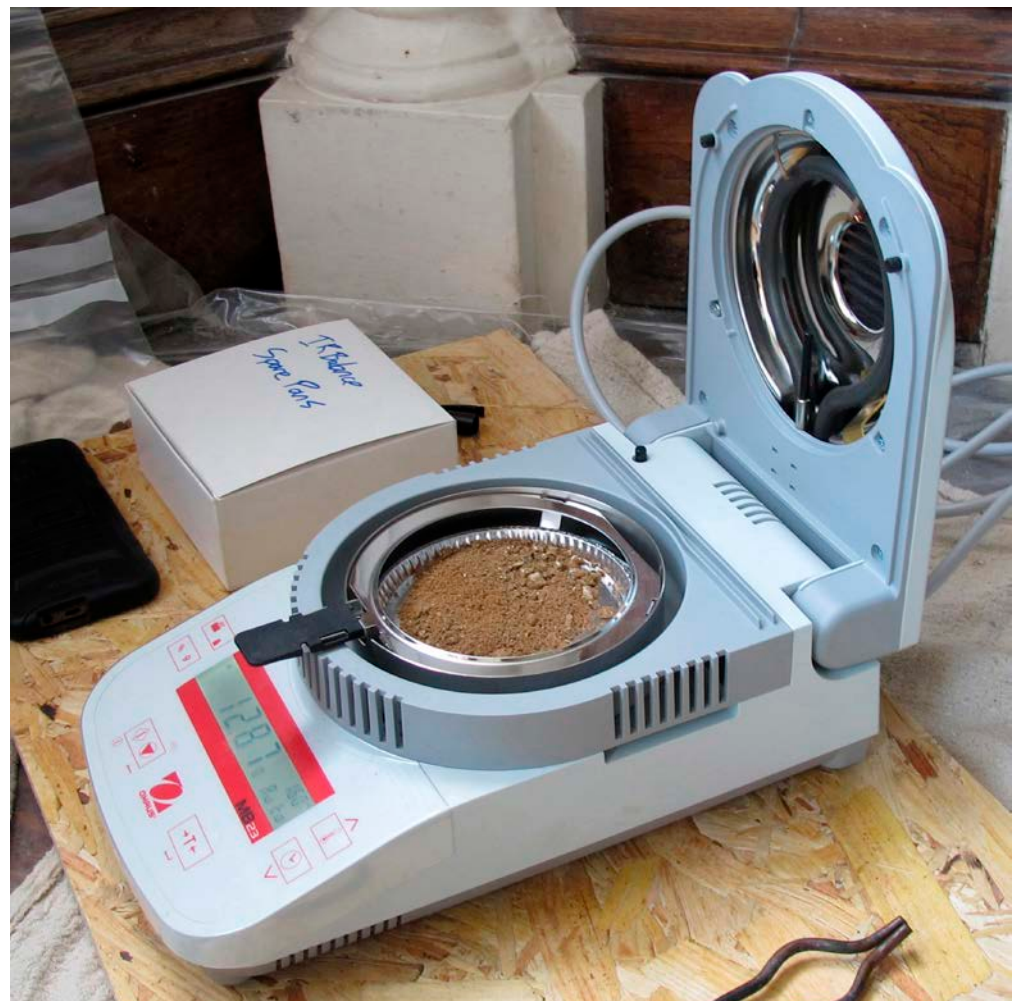
Figure 23:  
Gravimetric moisture  
analyser.

This automated device allows the absolute moisture content of powdered samples of masonry and mortar extracted by drilling to be determined quickly on site. It measures the weight of the wet sample before drying it with a built-in heater and reweighing it. The analyser then calculates and displays the moisture content of the sample as a percentage of its dry weight.

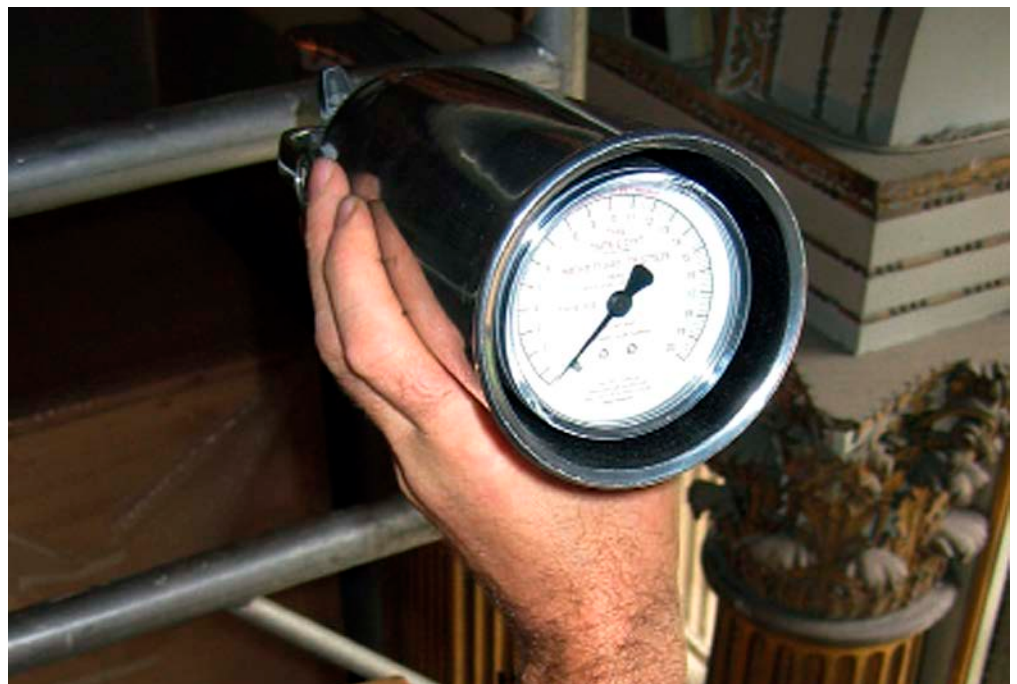
Figure 25:  
Gas carbide meter.

On-site measurements can also be obtained with a gas **carbide meter**. This device measures the pressure generated by the acetylene gas produced when moisture in the sample reacts with calcium carbide (BRE Digest 245). Commercially available meters work by mixing a fixed weight of powdered test material with a fixed volume of calcium carbide in a pressure cylinder. The cylinder is fitted with a manometer calibrated as percentage moisture content (%mc). Carbide meters indicate free water and are not, therefore, largely influenced by the type or properties of the test material, provided it can be powdered. These meters require a fixed weight of sample, commonly 6g. If hygroscopicity is to be assessed, a further quantity will be needed for a separate laboratory test.

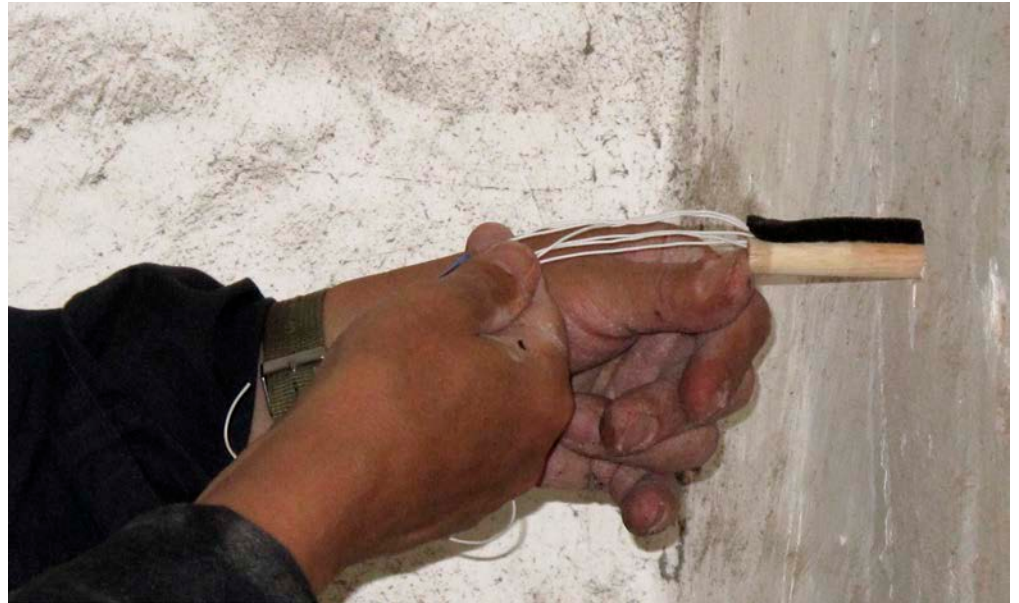
Figure 28:  
Inserting segmented  
timber dowel into a hole  
drilled in wall.

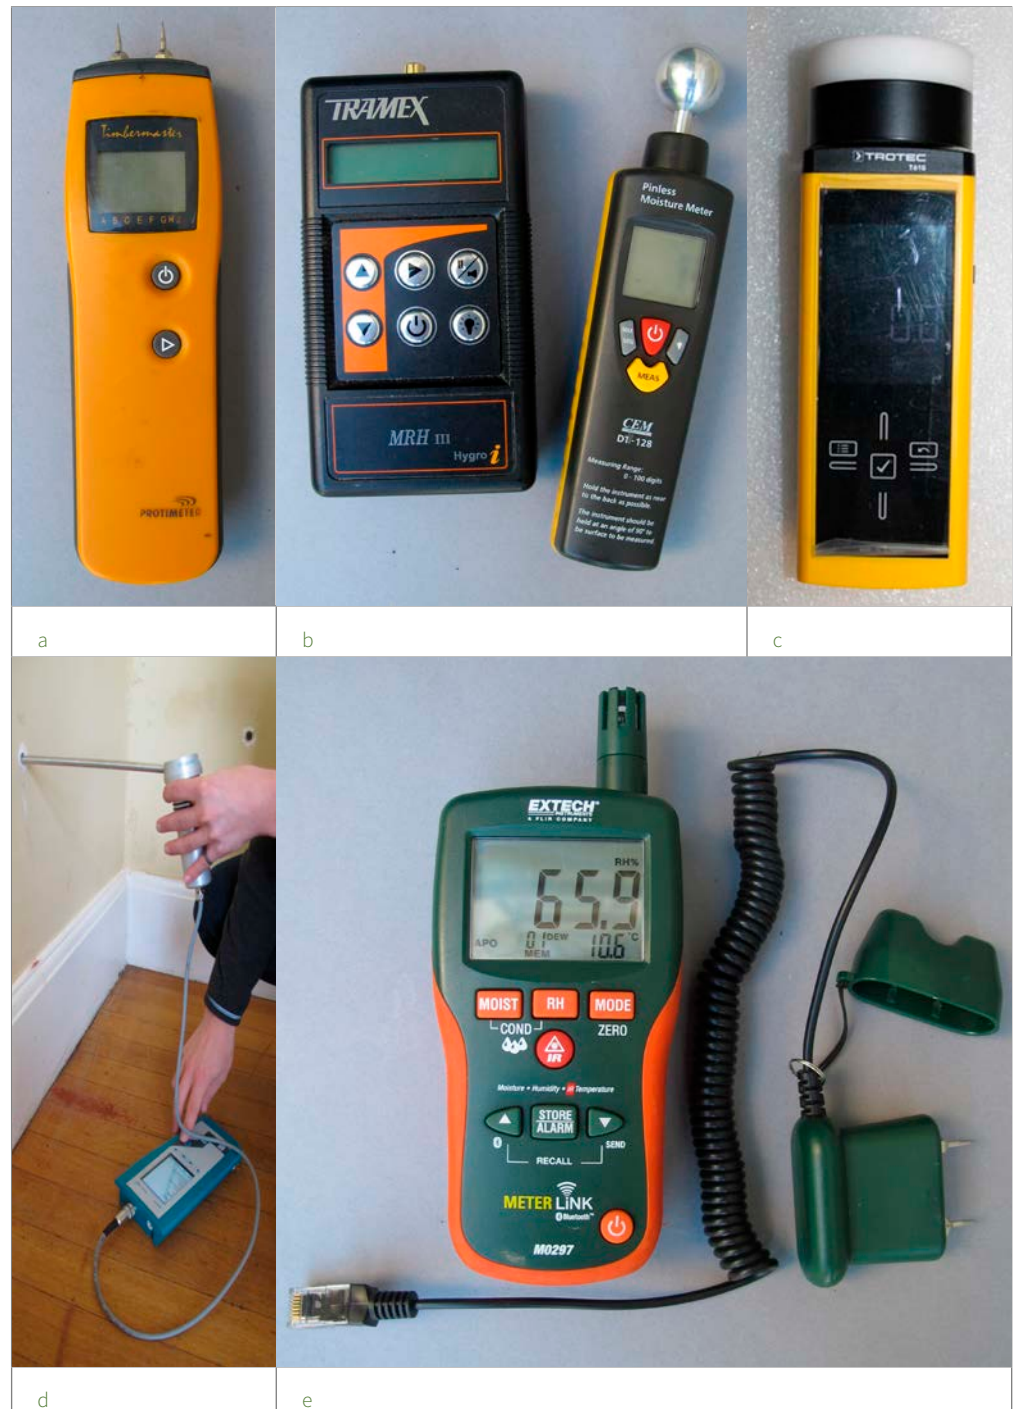
Figure 31:  
Commonly used types of hand-held moisture meter:

- a. Resistance meters. These all have pins that have to be pushed firmly into the materials under investigation. Longer pins, which are insulated except for their tips, can be connected to some devices to obtain readings at depth.
- b. Capacitance ('pinless') meters. Devices usually have sensor heads in the form of a pad or ball.
- c. Microwave meters. Some devices have interchangeable non-invasive sensor heads for differing depths of penetration.
- d. An invasive microwave probe designed to be inserted into a drilled hole. This allows a moisture profile through the thickness of a wall to be obtained.
- e. Multi-function meters. Some meters have both resistance and capacitance modes. In addition, they may incorporate surface and air temperature and relative humidity sensors as well as software for calculating dew point temperatures.

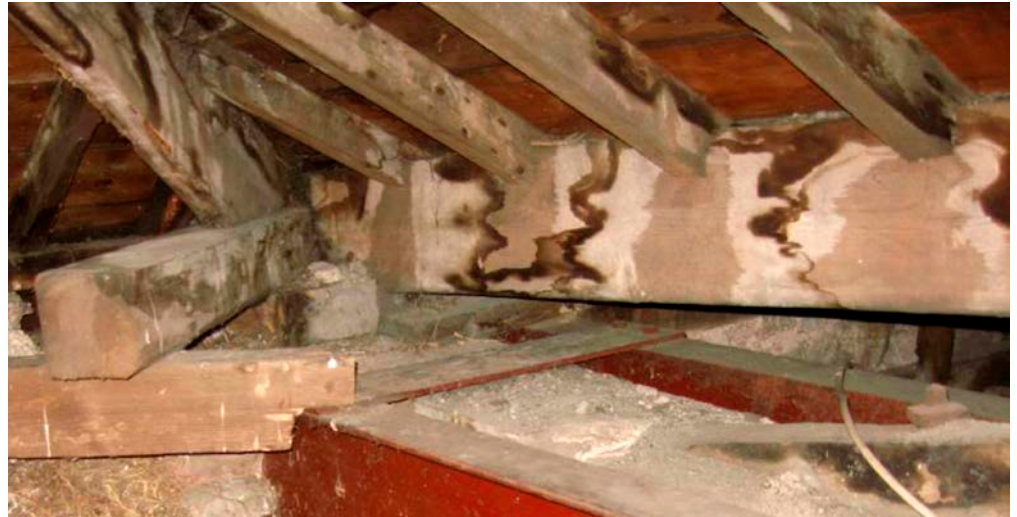
Figure 35:  
Damp staining on roof  
timbers might suggest  
the need for assessment  
with a moisture meter,  
but superficial chemical  
changes in the timber  
or contamination in the  
stained areas may result in  
erroneous readings.

Similar problems may occur because of surface contamination. A surveyor might find an apparently damp-stained timber in a roof and think that it needs to be assessed with a moisture meter (Figure 35). However, the staining may, in fact, be a surface modification and might even contain salts carried from adjacent walls or roof coverings. This can lead to inaccurate and misleading moisture meter readings. If a meter gives a low reading, then the timber is most likely to be dry. But dry timbers may also give high readings if there is surface contamination.

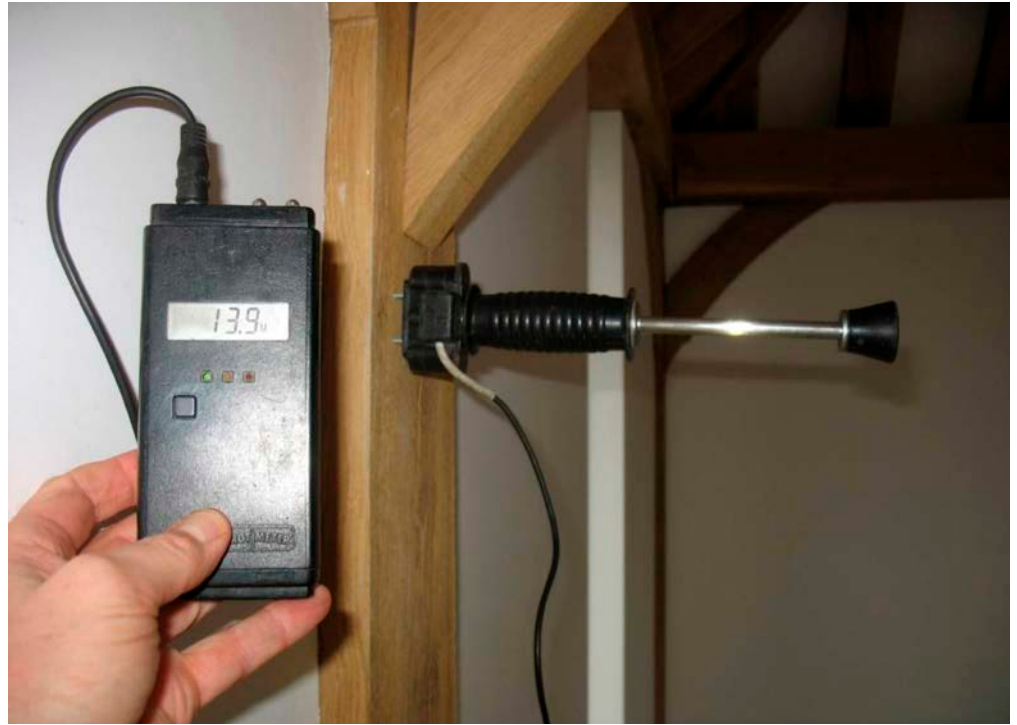
Figure 36:  
A hammer probe has electrodes that are insulated, except at the tip. These can be driven into the timber to various depths to provide a moisture gradient.

Figure 12:  
Equilibrium moisture contents at different depths in a softwood roof in Lincolnshire as measured in February 2019. Readings were obtained from three new and three old timbers using a resistance type moisture meter with a hammer electrode (see Figure 36).

If surface readings are high, it is important to distinguish between some form of superficial phenomenon and actual elevated moisture content in the timber. Hammer probes that allow measurements to be taken at depth are useful for this (Figure 36). The electrodes have insulated shanks and exposed tips so that a moisture content gradient can be determined by driving them to progressively greater depths. In practice, the maximum depth may be limited. For example, electrodes driven 15mm into old dry oak might be very difficult to extract without snapping them. To avoid this, small diameter holes may be drilled to enable measurements to be made at depth.

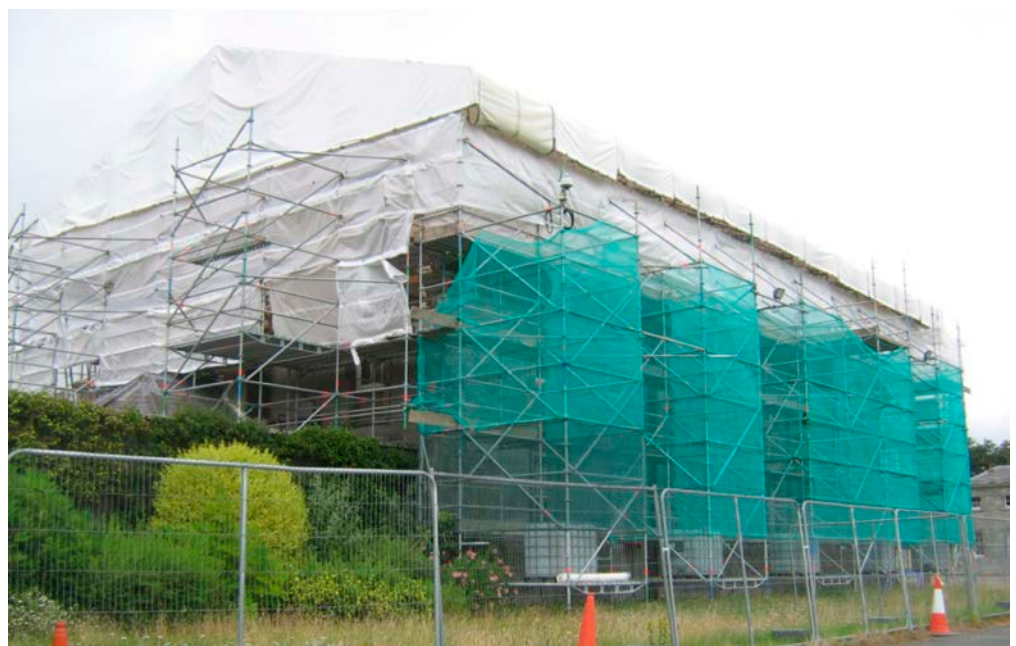
**Figure 44:**  
Temporary roof and  
weatherproofing designed  
to maximise ventilation.

By the time the first damp survey was carried out in March 2010, a temporary roof, designed to maximise ventilation, was in place (Figure 44) and most of the debris had been cleared.

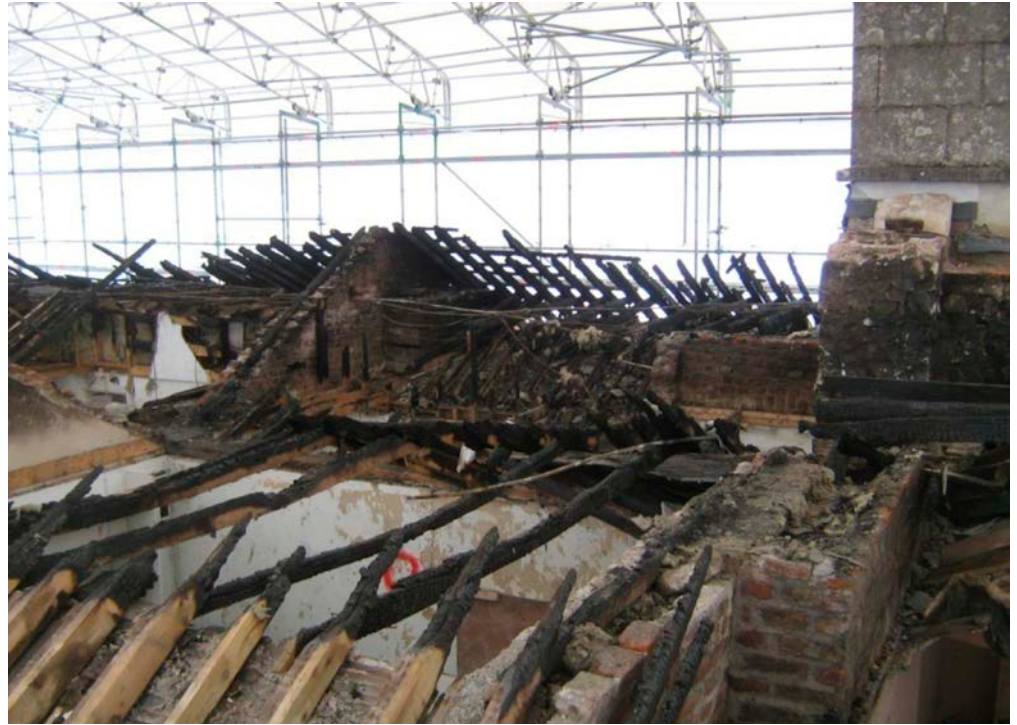
Figure 46:

Although the central portion of the roof was destroyed by the fire, it remained intact above the external walls. The rafter ends were mostly undamaged, as can be seen in the lower left of this image. This protected the wall heads from saturation by water used in fighting the fire.

The water used to fight the fire had mostly soaked the internal central wall, but the external walls were largely unaffected. The fire had destroyed the central portion of the roof, but the rafter ends above the external walls were mostly undamaged. This suggested that the roof had remained largely intact in this location during firefighting, which prevented water ingress at the head of the walls (Figure 46). The damp area in the top left corner of the ground-floor plan in Figure 45 predated the fire (see Case study 2). The brick vaulting, which still retained its lime plaster, was visibly wet, with mould growth developing.

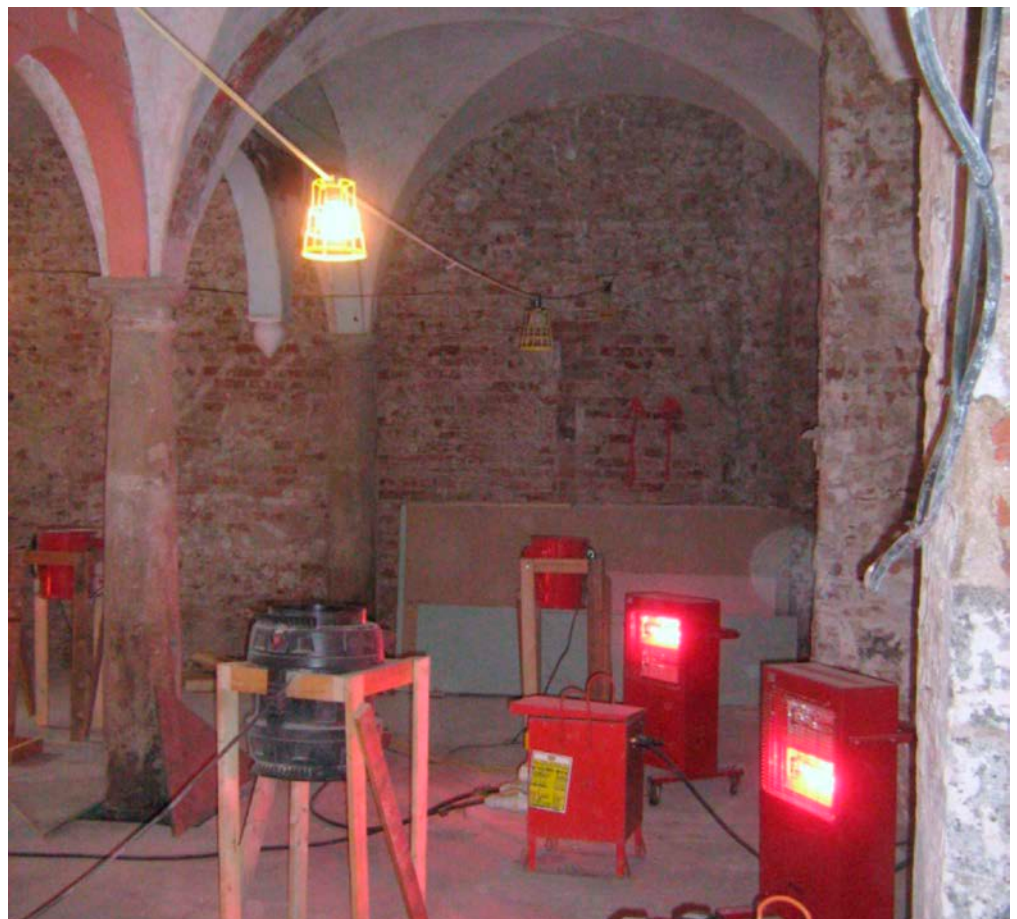
Figure 47:

Heaters and air blowers (pointing upwards in a wooden frame) in use after the hard cementitious finishes had been removed from the external walls to aid drying. The original lime plaster on the vaulting was not removed.

Radiant panel heaters were installed, providing background heating to assist drying. Blowers were used to maintain good air circulation. (Quadrupling the air flow across a surface doubles the rate of evaporation). One heater was placed next to the central wall on the first floor, and two blowers were angled to provide air flow across the wall surface. Eleven heaters were positioned around the walls on the ground floor, with the same number of blowers directed upwards to the vaulting (Figure 47).

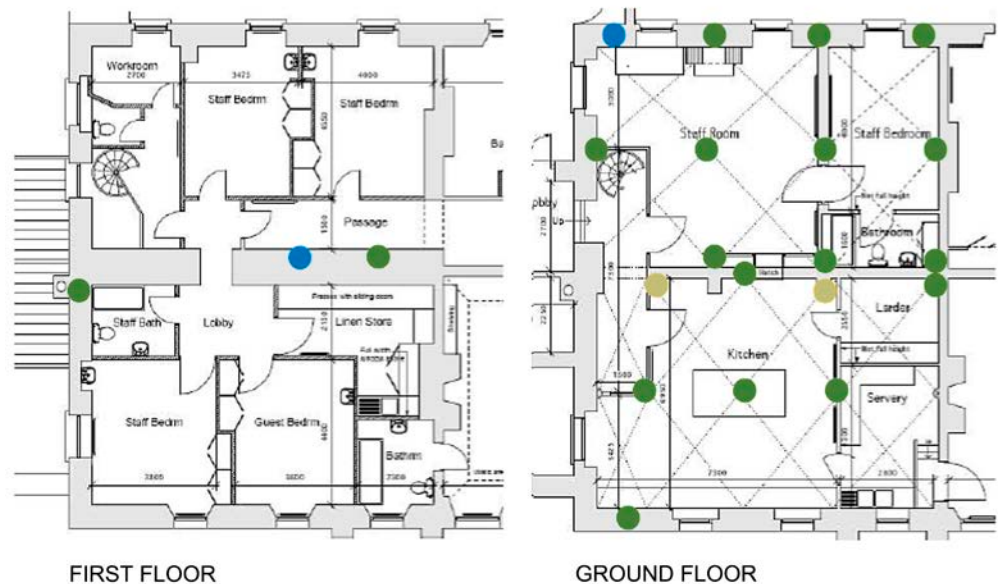
Figure 48:  
Ground and first floor plans showing locations of samples taken in March 2011. A drying environment was maintained by the heating system and blowers. Thermo-hygrometer readings taken around the rooms were 45% relative humidity at 13 to 15° (in three locations) on the ground floor and 45 to 54% relative humidity at 12 to 15°C (in four locations) on the first floor.

The building was revisited a year later, in March 2011. The old radiator system was now working (replacing the radiant panel heaters) and the blowers were still in use. Timber moisture contents were dry, except where they were in contact with recently applied plaster on the first floor. Mortar samples were taken from accessible areas. Results are shown in Figure 48.

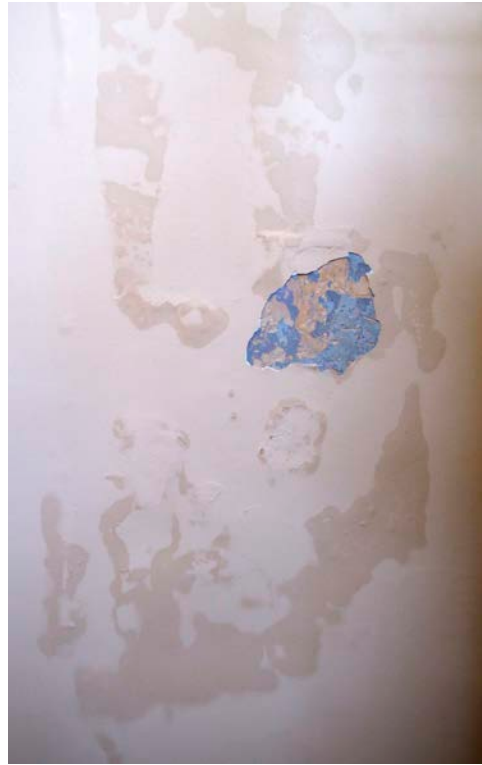
Figure 50 (left):  
Detail of damp patches  
on the interior of the  
north wall. Detachment of  
loose and flaking modern  
coatings revealed blue lime  
wash.

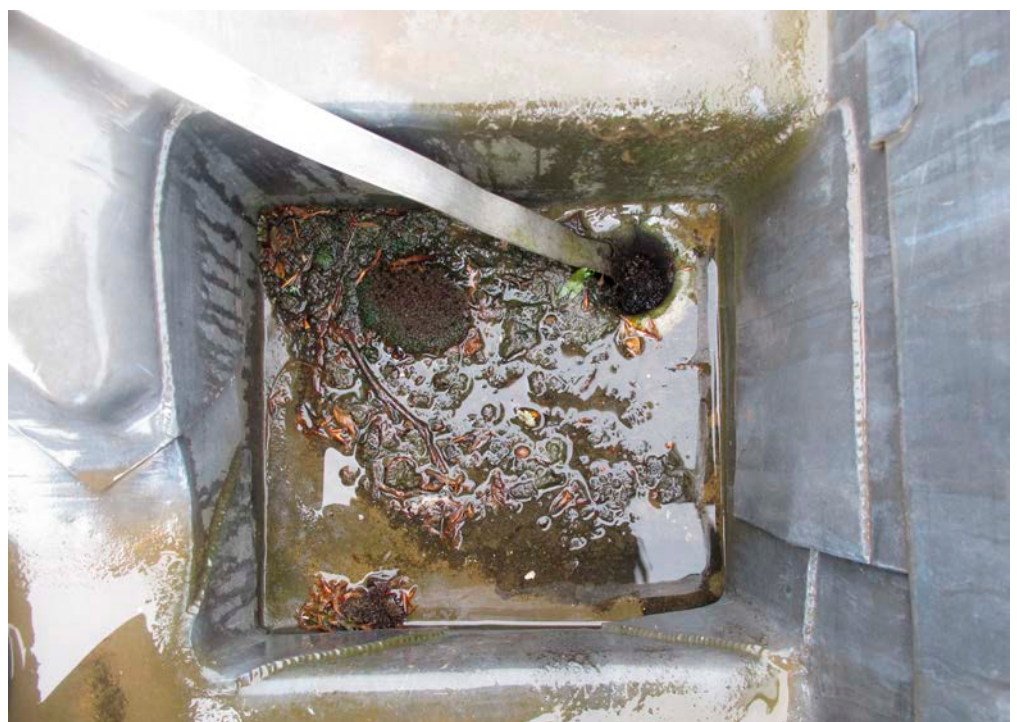
Figure 52:  
Rainwater outlet from  
the parapet gutter on  
the north side of the  
building. The outlet was  
relatively small, and a  
lightning protection down-  
conductor routed through  
it increased the risk of  
blockages.

Externally, there were some localised areas of flaking paintwork at high level on the north elevation; otherwise, the render and paintwork appeared to be in good condition. The lead parapet gutters also seemed to be in sound condition, although some leaves, twigs and moss were partially obstructing the outlets at the west end of the roof (Figure 52). It was noted that the lightning protection down-conductors (which had been routed through the

outlet pipe passing through the parapet for aesthetic reasons) increased the risk of blockages by trapping leaves and debris. Inspection of the roof space revealed no evidence of recent rain penetration. However, the gullies at the base of the rainwater pipes were partially blocked.
