# Assessing Damp in Historic Buildings

A Practical Guide to Investigation and Diagnosis

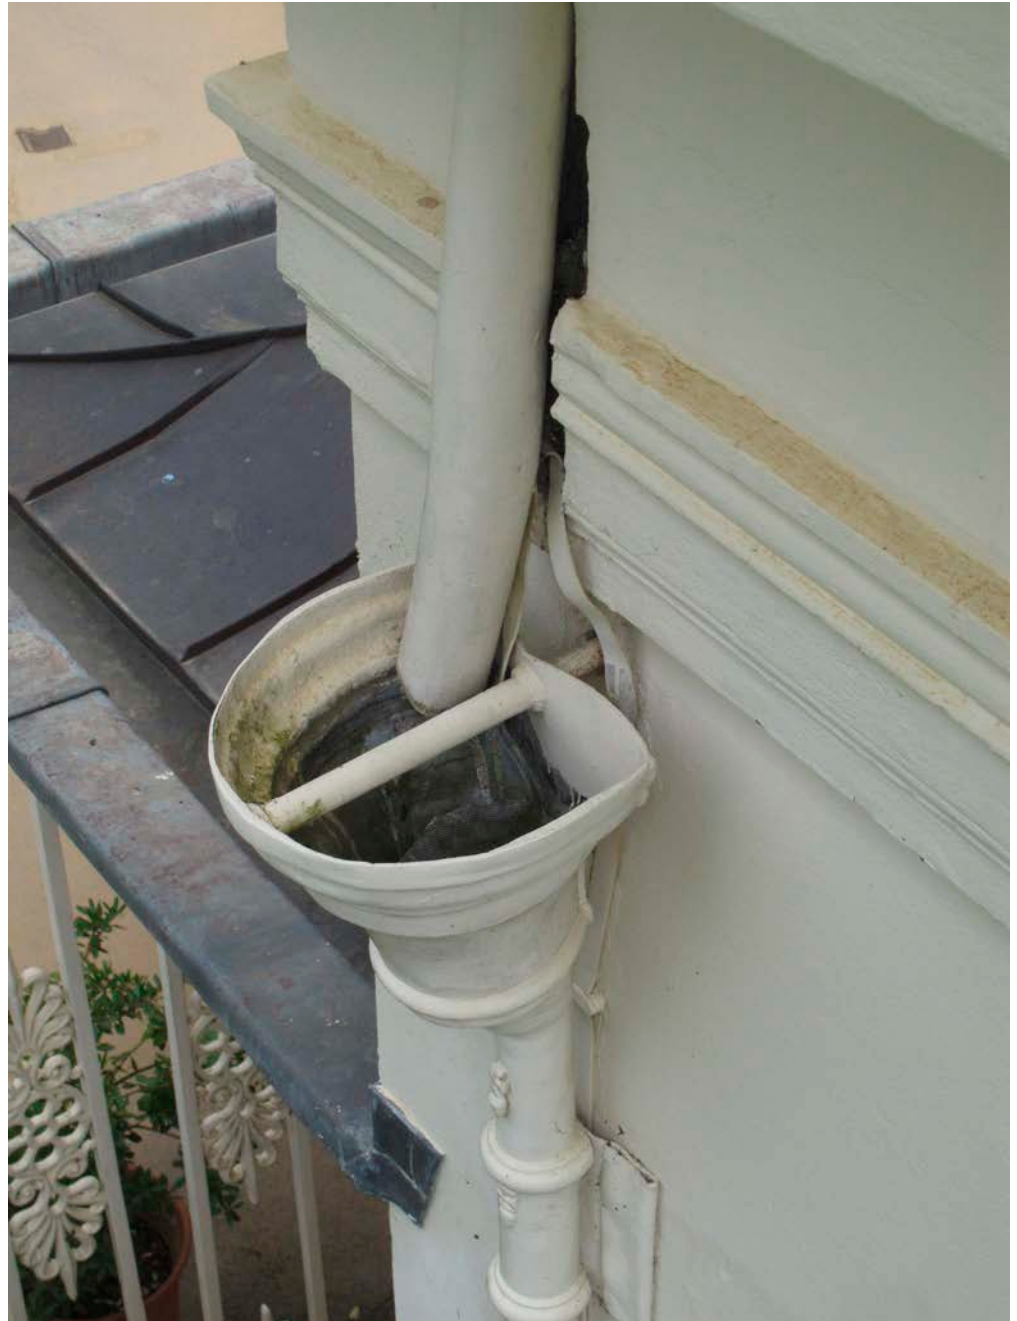
Figure 53:  
Hopper head and  
rainwater pipe from  
parapet gutter on north  
side of building.
